Poynton Lake
Report of the Result of a Periodic Inspection
under Section 10(5) of the Reservoirs Act 1975

On 20 May 2005

August 2005

Halcrow Group Limited

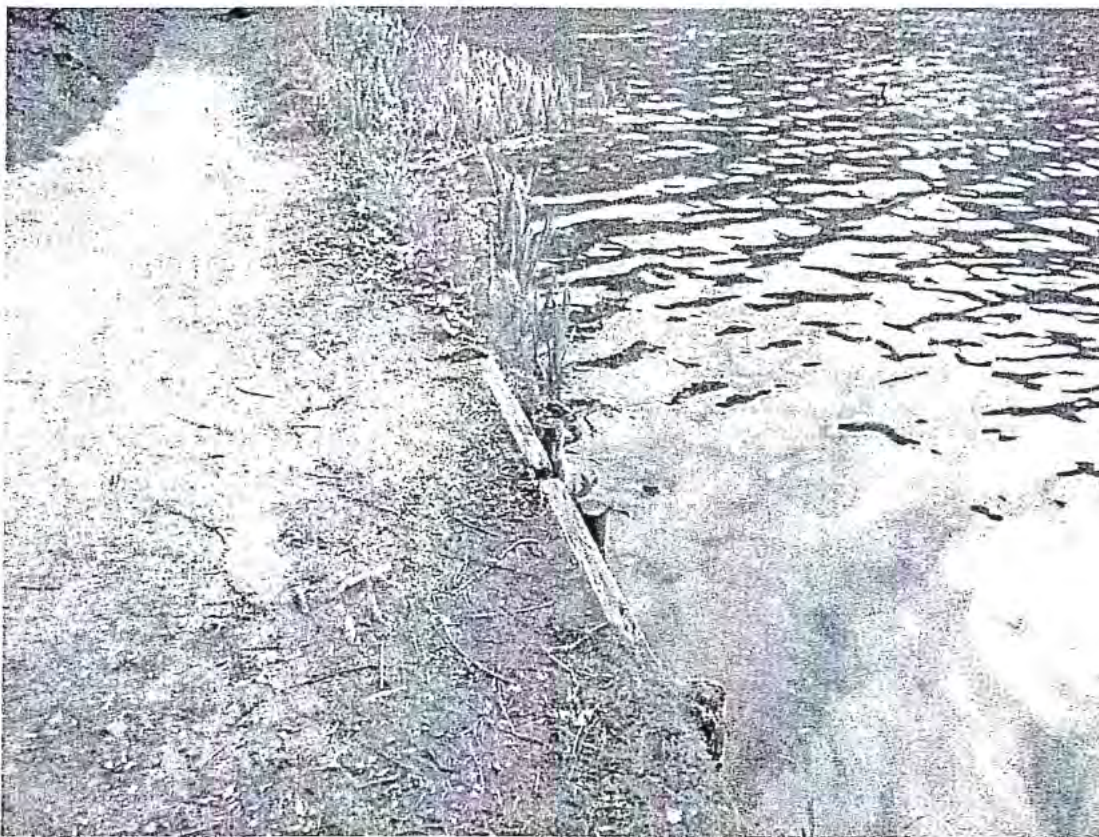
The embankment dam appears to be in generally good condition. The upstream face is largely secure with some selected zones of erosion occurring (Photograph 1 & 2). The extensive tree roots are mostly preventing erosion of the bank and where erosion is occurring it is in the open areas. Where erosion has occurred timber boards have been set at the edges of the crest to prevent further erosion and the area behind backfilled. This ad hoc arrangement of repair as and when required appears to be working well.

Photograph 1 – Timber edging on upstream face

- (a) Repair any areas of erosion along the upstream face.
- (b) Cut back any trees in danger of toppling.
- (c) Remove any trees which have fallen into the reservoir
- (d) Investigate the potential for out of bank flow from the Brook to the south of the reservoir to flow into the reservoir by an overland route rather than via the existing pipe.

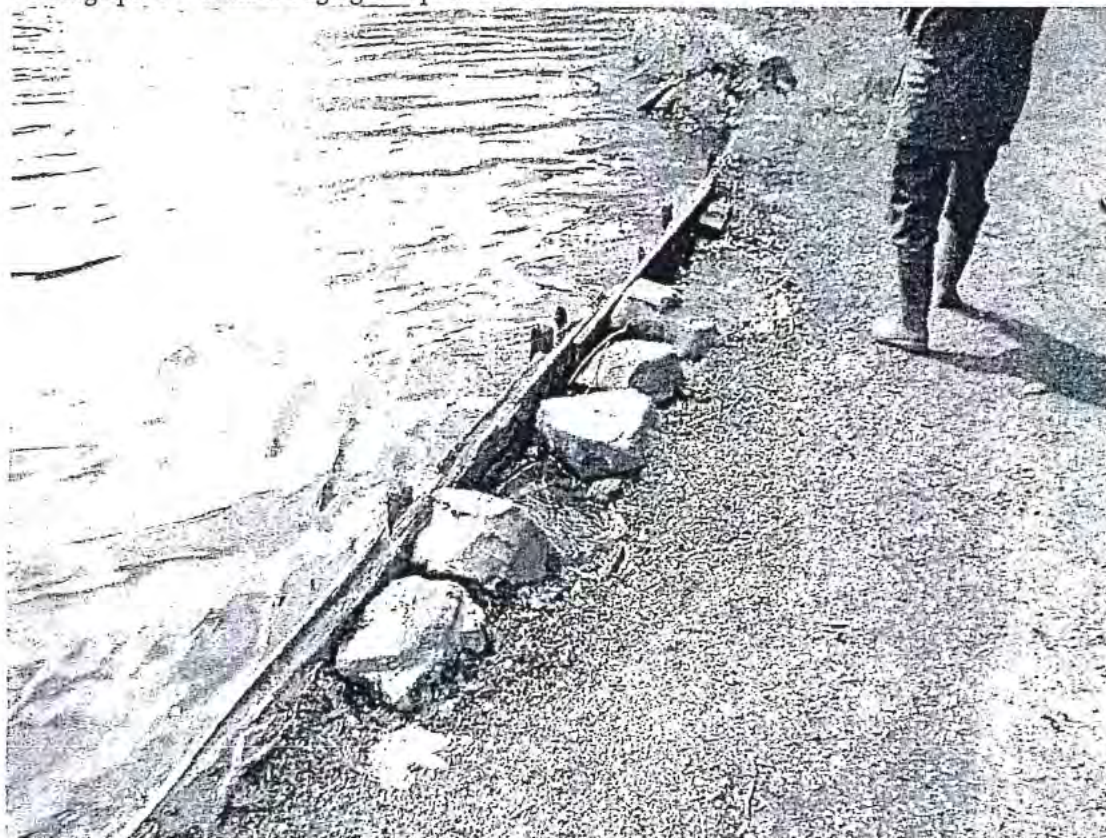
Photograph 2 – Timber edging and stone on upstream face

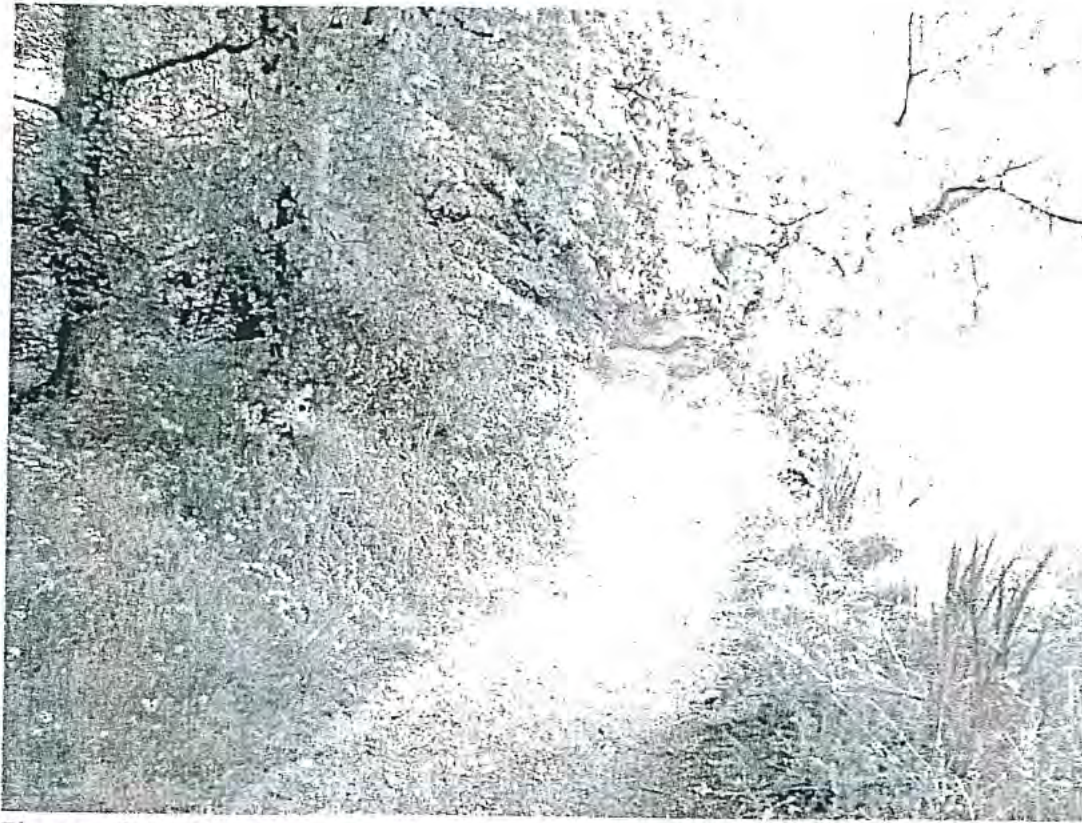
The crest of the embankment is protected by stone on the line of the footpath around the water's edge. This path is being well maintained and is free from settlement or other damage (Photograph 3 & 4). The crest is relatively extensive and a grassed area rises slightly downstream of the track on the crest. This grassed area is approximately 8-10m wide and is extensively covered in trees, some of which are relatively mature. There are also trees along the upstream edge of the crest. These are generally secure but some have been undercut and have fallen, or are in the process of failing, into the reservoir (Photograph 5, 6 & 7). It would be

Photograph 3 – Dam crest

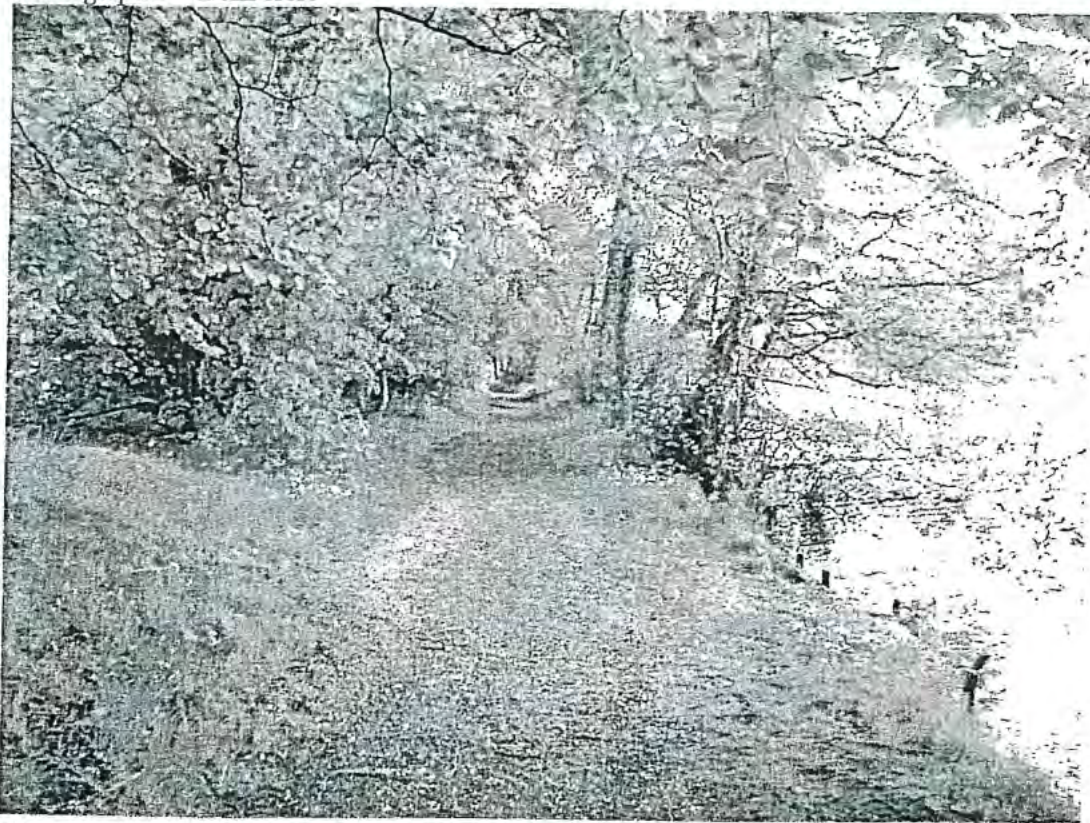
Photograph 4 – Dam crest

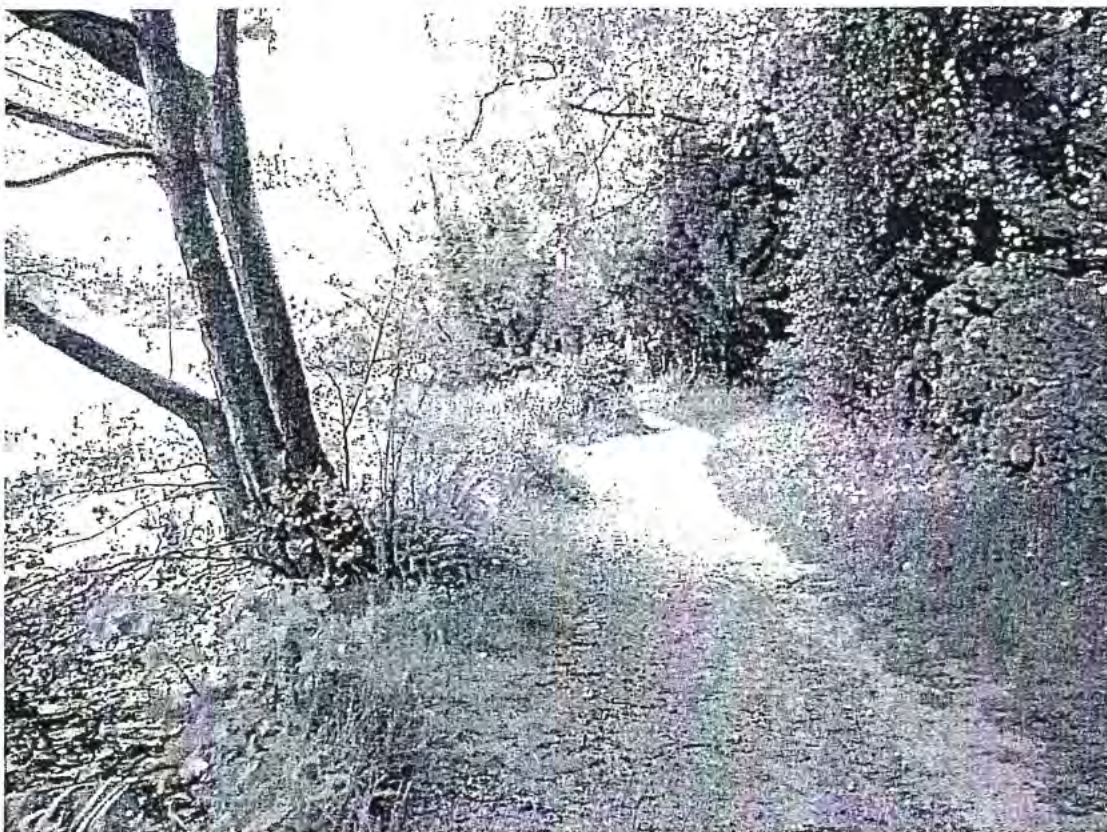
Photograph 5 – Leaning tree on dam crest

prudent to monitor the condition of all of the trees on the crest and to cut these back as and when appropriate to avoid them falling.

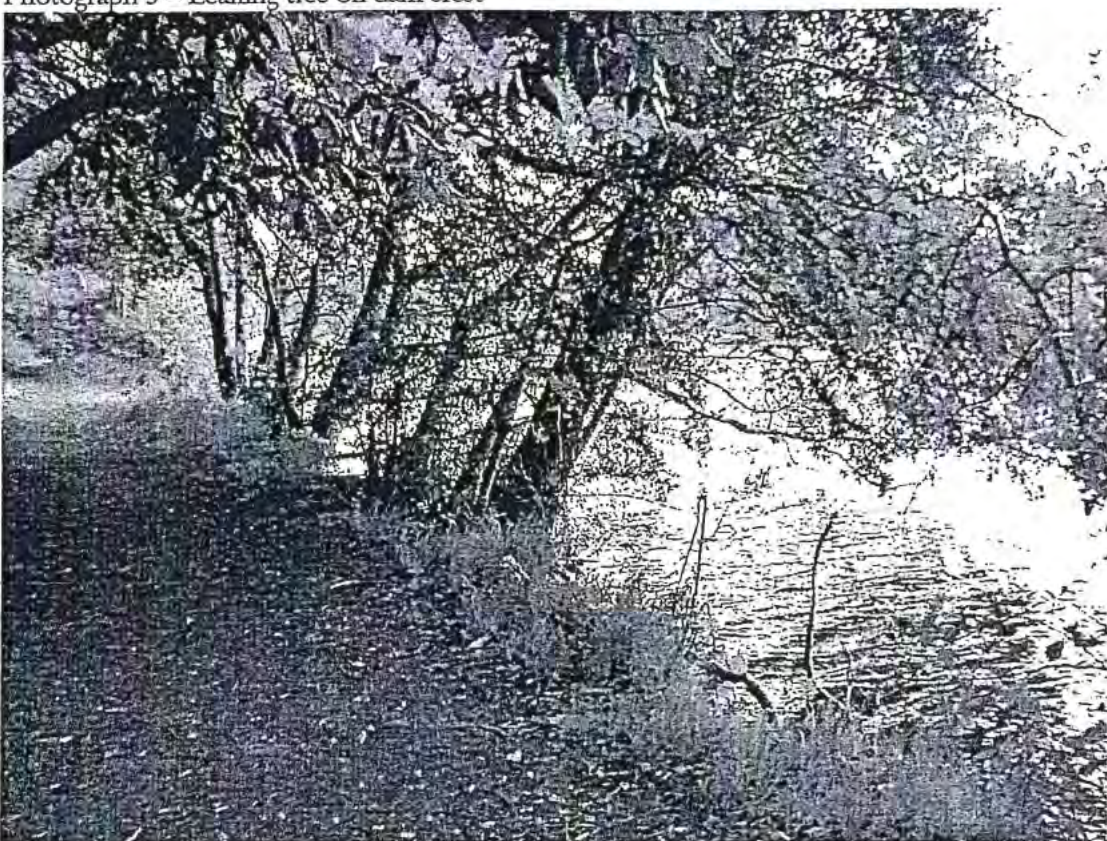
Photograph 6 – Trees on crest at waters edge

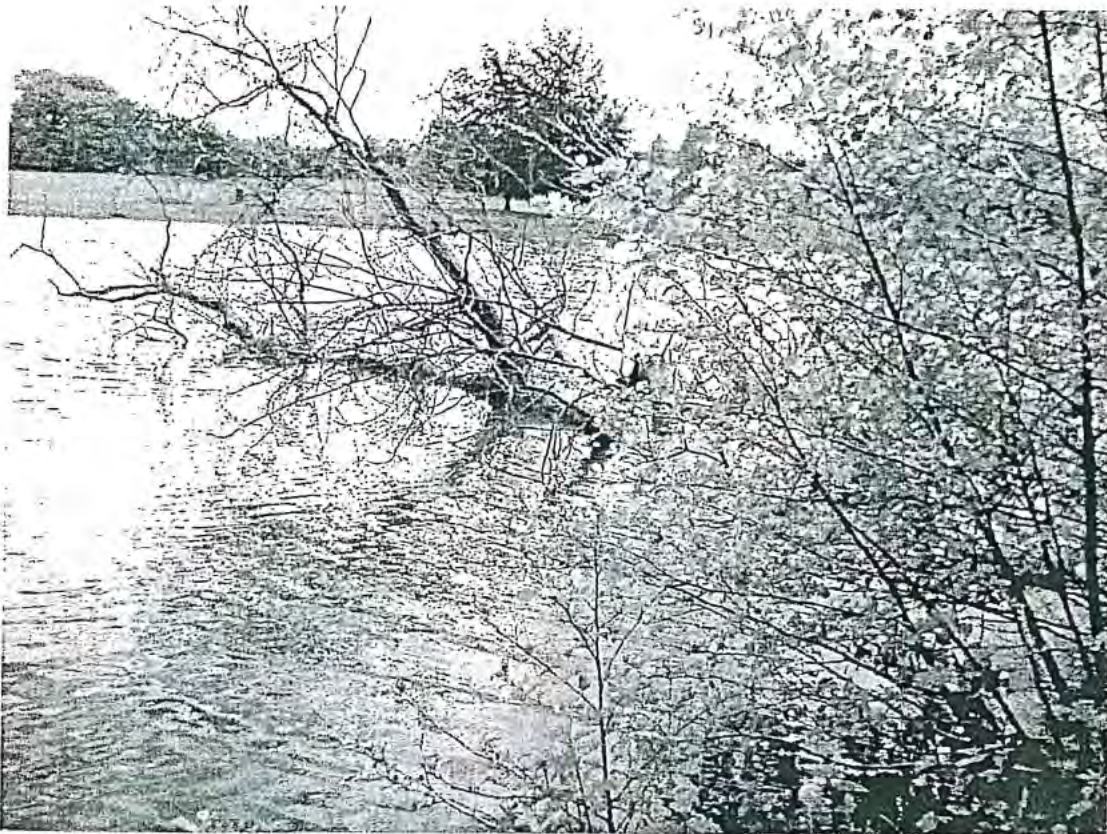
Photograph 7 – Fallen tree

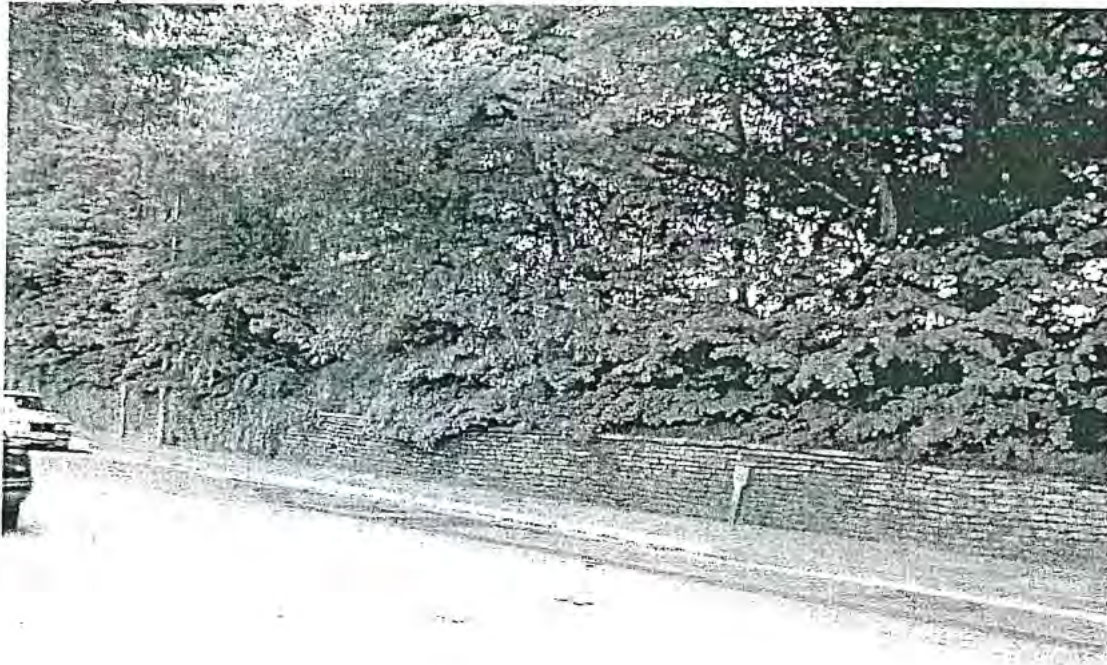
The downstream face comprises a masonry retaining wall between the crest and the road to the east, the road constructed on a berm and a downstream slope below the road. The masonry wall is in generally serviceable condition with no evidence of significant movement or damage. In one area it is apparent that the wall is being disturbed and the joints are opening up. This is thought to be due to the effect of tree roots (Photograph 8 & 9).

Photograph 8 – Wall on downstream side of crest

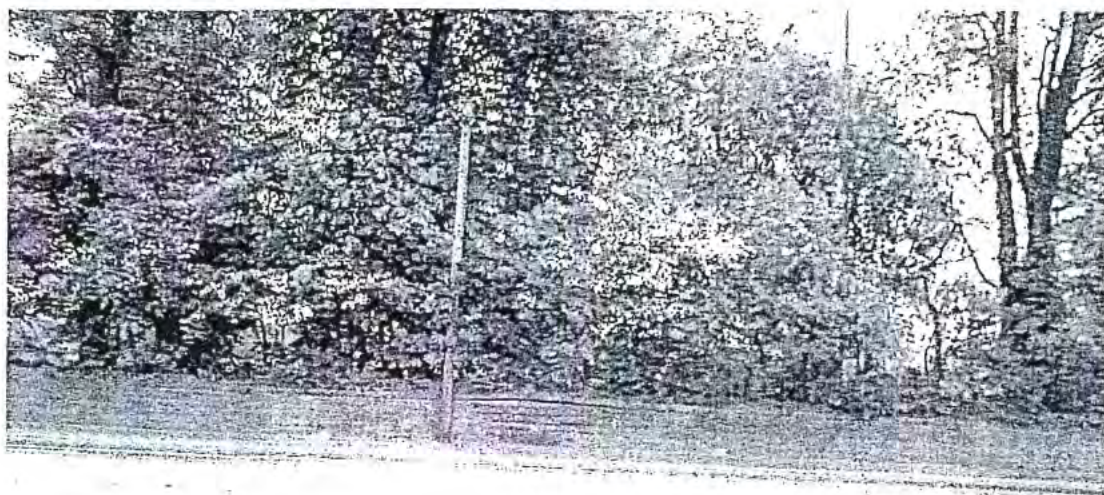
Photograph 9 – Wall on downstream side of crest

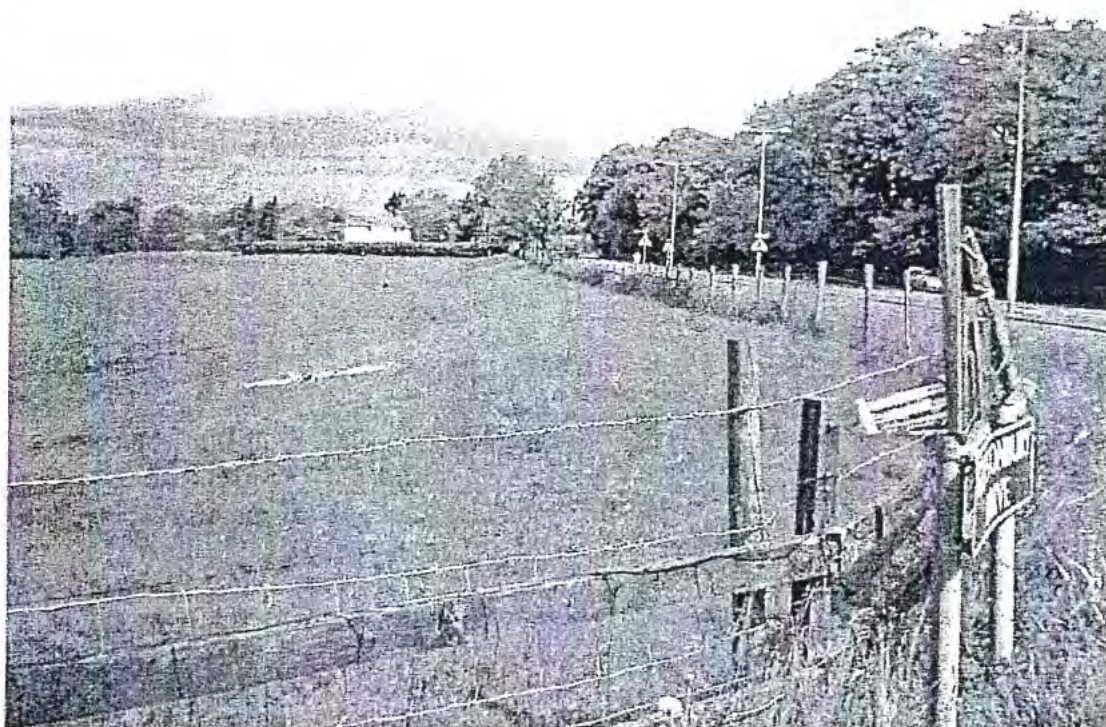
The downstream face of the embankment below the roads is grassed and shows no evidence of slips, bulges or settlement (Photograph 10 & 11).

Photograph 10 – Downstream slope

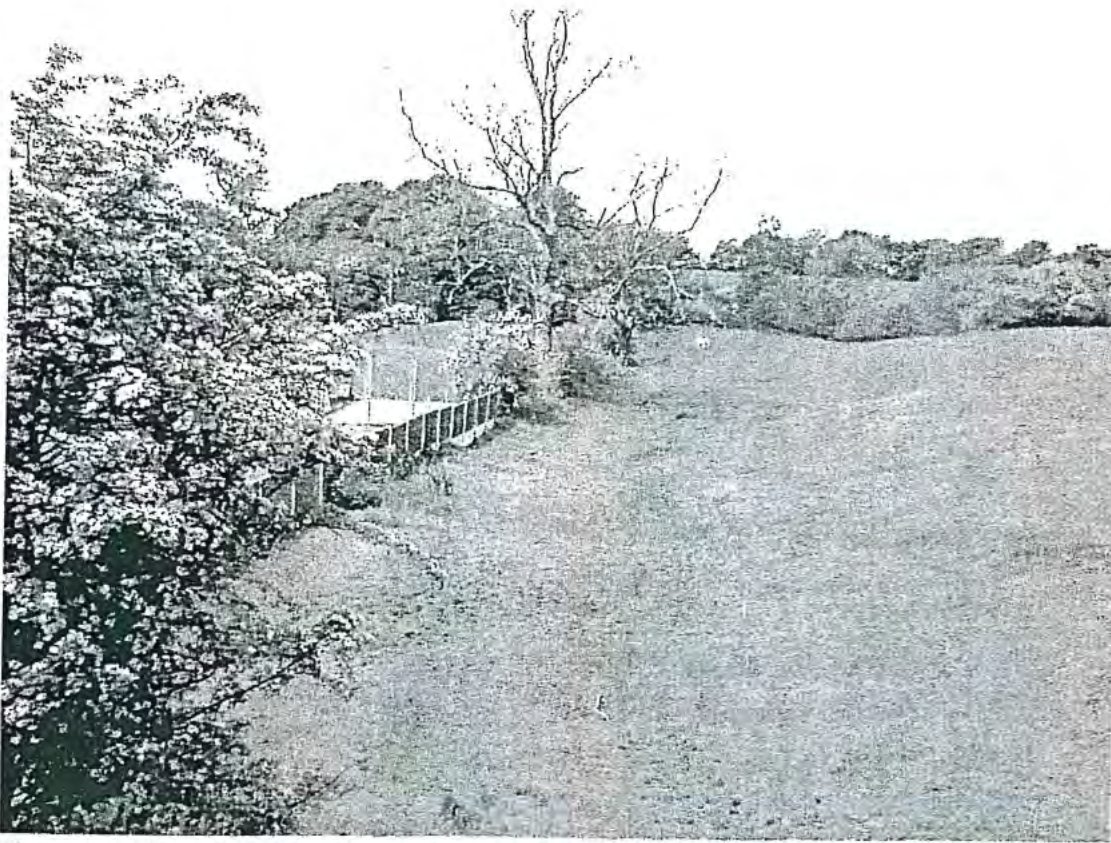
The culvert appeared to be free to discharge and was operating as intended at the time of the inspection. The outfall structure on the culvert as it enters the Brook was found to be secure and was preventing erosion of the bank (Photograph 13). It was reported that the culvert was CCTV surveyed several years ago and that all joints were found to be tight and secure.

Photograph 13 – Line of overflow pipe to river at tree line

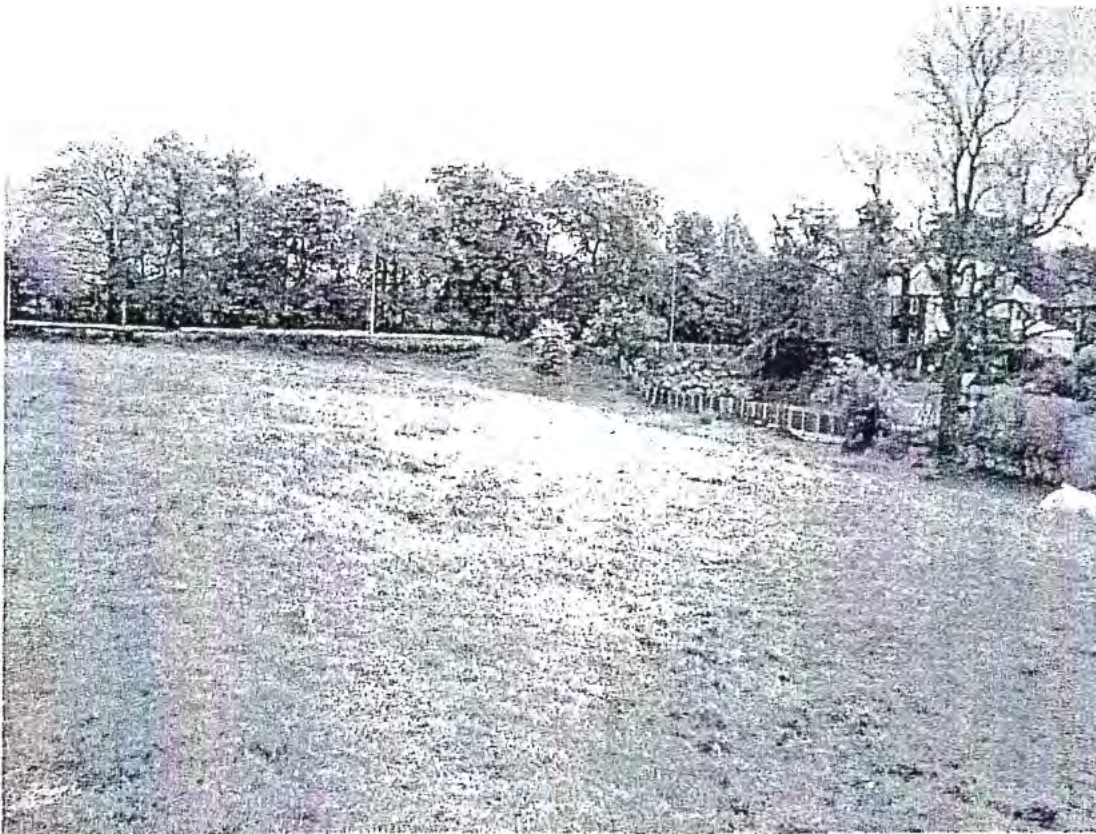
Photograph 11 – Downstream slope at highest point

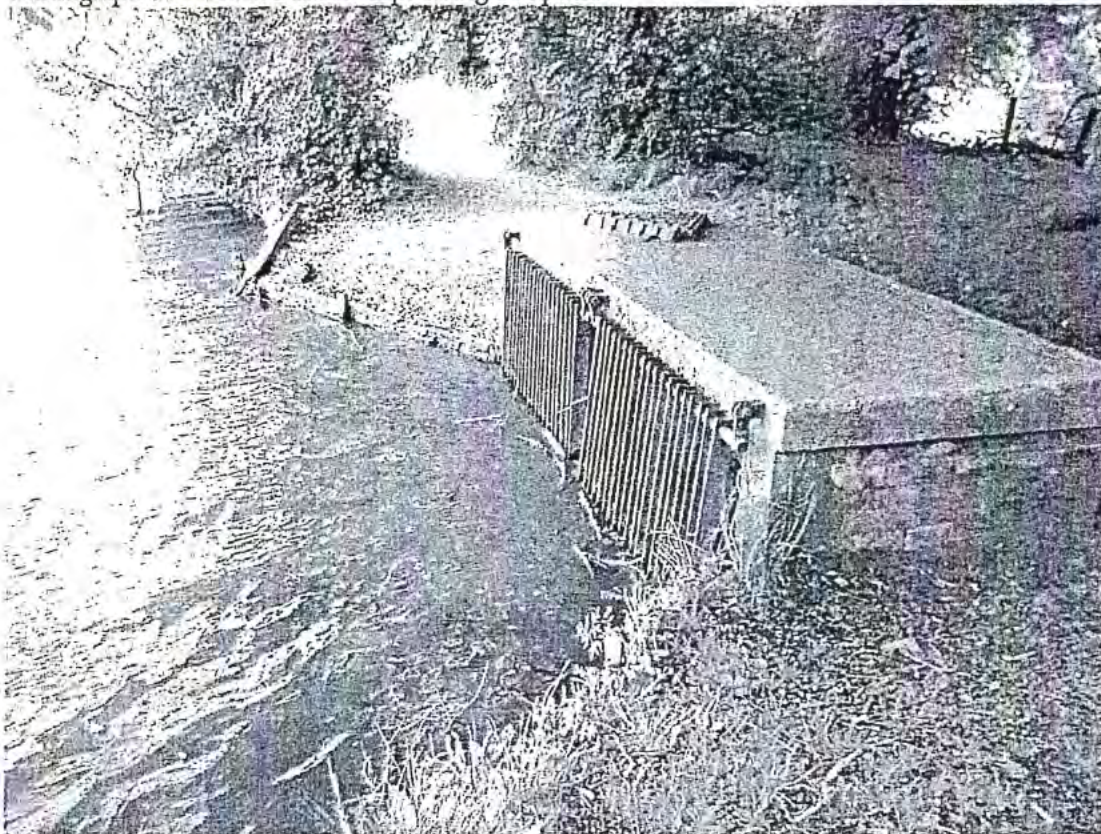
The concrete and brick overflow structure was found to be in good condition and free to discharge flood flows (Photograph 12). The steel screens on the upstream face of the overflow appeared to be collecting debris on the water and it was apparent that the screens are being routinely cleared. The drop chamber behind the sill was clear and free from obstruction and is working well to channel water to the 600mm drain culvert away from the dam.

Photograph 12 – Overflow spillway
