# Reservoirs Act 1975 Poynton Lake Reservoir

Report of an Inspection under Section 10(2) of  
the Act

August 2016

Cheshire East Council

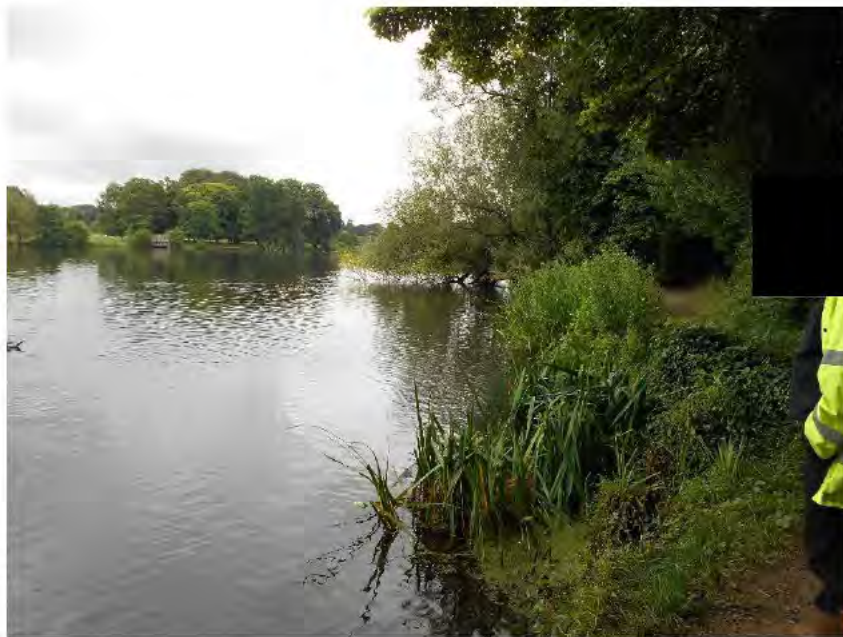
**Photograph A1: General view of the lake at the northern end**

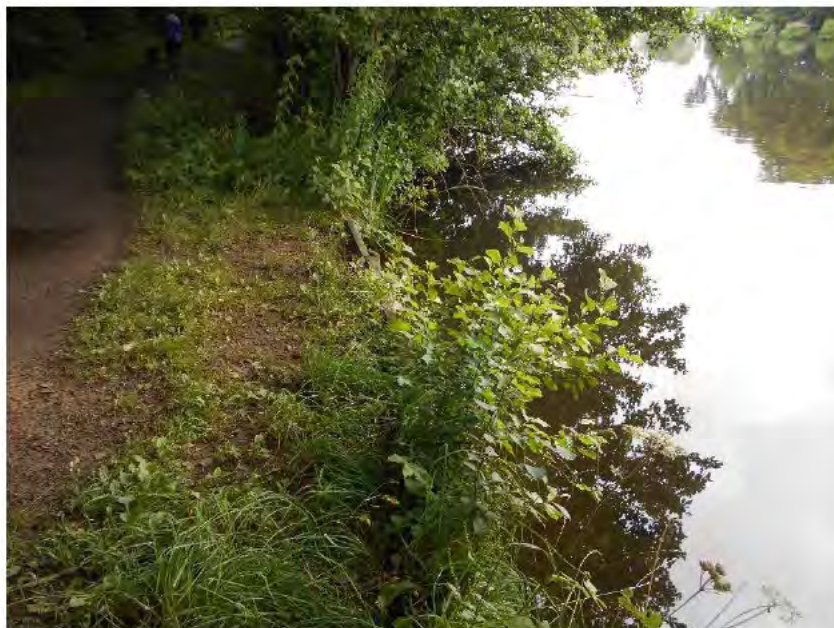
There is no engineered protection to the face and it is evident that some areas have suffered minor erosion damage and loss of material as a result of wave action. It is likely that this has been an on-going situation for many years and to minimise the damage timber board revetments have been installed at certain parts of the crest, particularly towards the northern end. A typical example of this timber protection is shown in Photograph A2. These timber boards have been in place for many years and appear to be functioning well. However in some cases the boards are beginning to bulge and show signs of decay, or holes have started to form in the fill material behind the boards. In this respect the presence of vegetation and roots pushing down behind the revetment will tend to displace the timber and lead to further damage. From the Supervising Engineer's statement of 2012 it is clear that similar conditions were observed and reported at that time. In fact photographs taken at that time, which were during the winter when there was less vegetation cover, showed various examples where repair work was needed. It is not clear what repairs, if any, have been implemented in the past 4 years. However, the need to inspect and repair the face protection is an on-going

**Photograph A2: Section of upstream edge of the crest with timber revetment providing support**

maintenance requirement. I recommend that a detailed and comprehensive assessment of the condition of the boards should be carried out to identify those parts that are in need of repair or replacement. These localised repairs should then be implemented. Typical repair/reinstatement work will involve removal of vegetation (saplings and small bushes) from along the face, filling of voids behind the timber boards, provision of additional timber posts to support the boards and replacement of boards that are found to be rotten.

- a) An assessment of the condition of the revetment boards along the upstream face should be carried out to identify those parts that are in need of repair or replacement. These localised repairs should then be implemented.

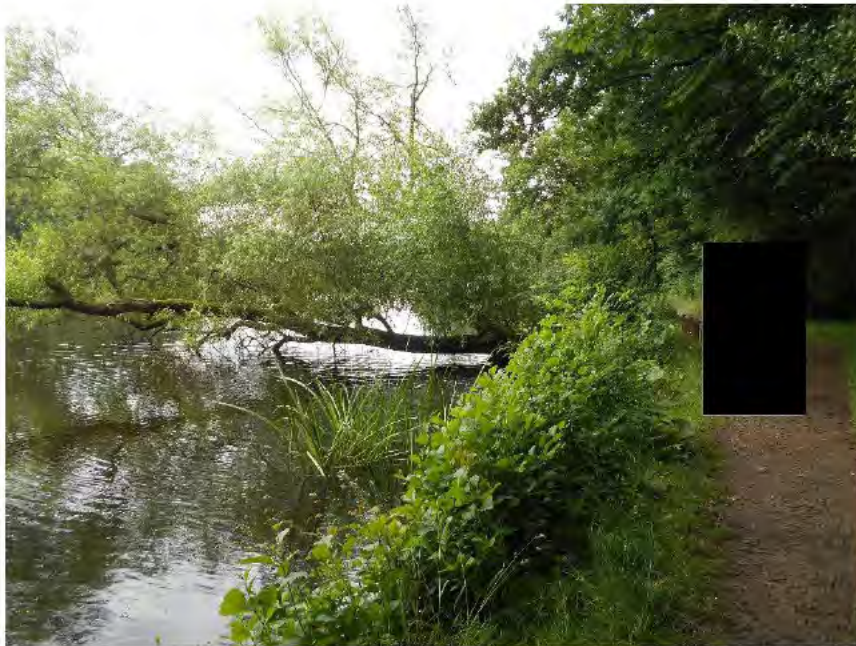
A further potential problem is the presence of many mature trees that exist on the dam. It is not an ideal situation to have large trees on a water retaining embankment. However given that this is a small dam and that the trees have been in existence for many years, it is acceptable provided that the trees are managed in a proper manner. Walking along the crest it was noted that several trees are leaning towards the water and in some cases the trees have actually toppled over (see Photograph A3). When a tree falls over the movement of the root bowl causes further disturbance to the fill and in the vicinity of the upstream edge this can lead to a weakened area that will then be susceptible to erosion. In conjunction with the repairs to the revetment protection works I recommend that any fallen or leaning trees that are threatening the integrity of the face should be removed. When the roots and stumps have been cleared away, the upstream face should be reinstated to the correct line and new revetment boards should be installed in order to provide erosion protection.

**Photograph A3: Fallen tree at the upstream face**

- c) The trees on all parts of the embankment should be managed and checked on a regular basis. Any trees that become unhealthy and which may be in danger of toppling should be removed. If the tree canopy becomes too dense then I recommend that careful pollarding of the trees should be carried out to reduce the height of the trees and to let more light through to the ground beneath.

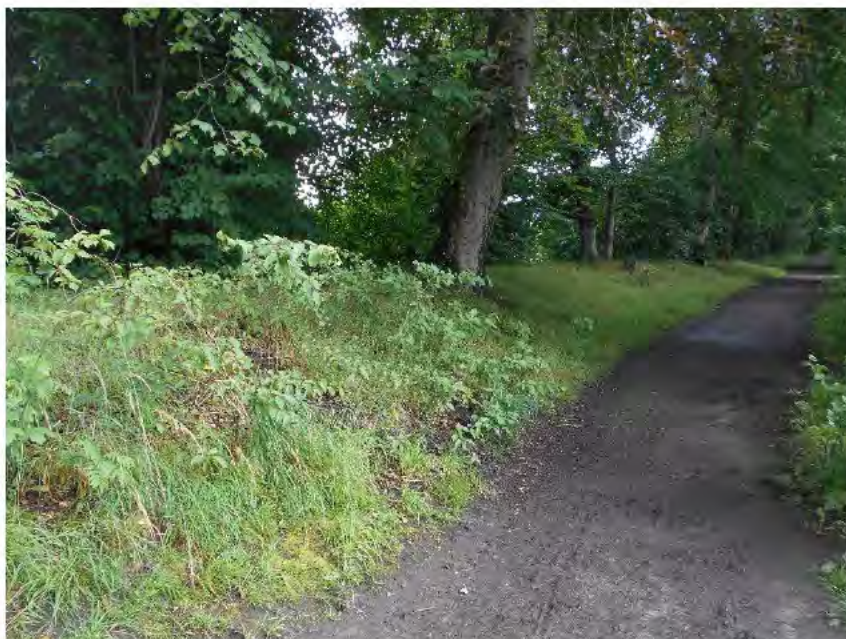
The downstream part of the crest is shown in Photographs A4 and A5. These areas are grass covered but also support numerous mature trees. Between the trees the grass and other soft vegetation was of moderate length and from time to time this should be cut back as part of normal ground maintenance. Walking through these areas the ground was a little uneven but once again there were no signs of unexpected movement. With regard to the trees it is recommended that they should be managed and checked on a regular basis. Any trees that become unhealthy and which may be in danger of toppling should be removed. If the tree canopy becomes too dense then I recommend that careful pollarding of the trees should be carried out to reduce the height of the trees and to let more light through to the ground beneath to encourage healthy grass growth.

**Photograph A4: Crest of dam towards south end with raised area at the downstream side**

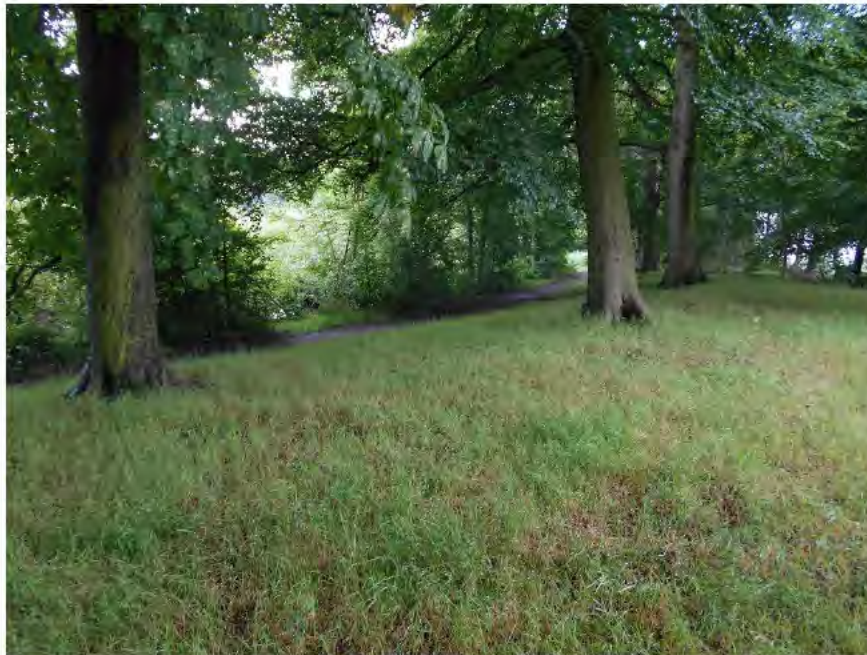
**Photograph A5: Broad crest of dam in vicinity of the old Council Yard**

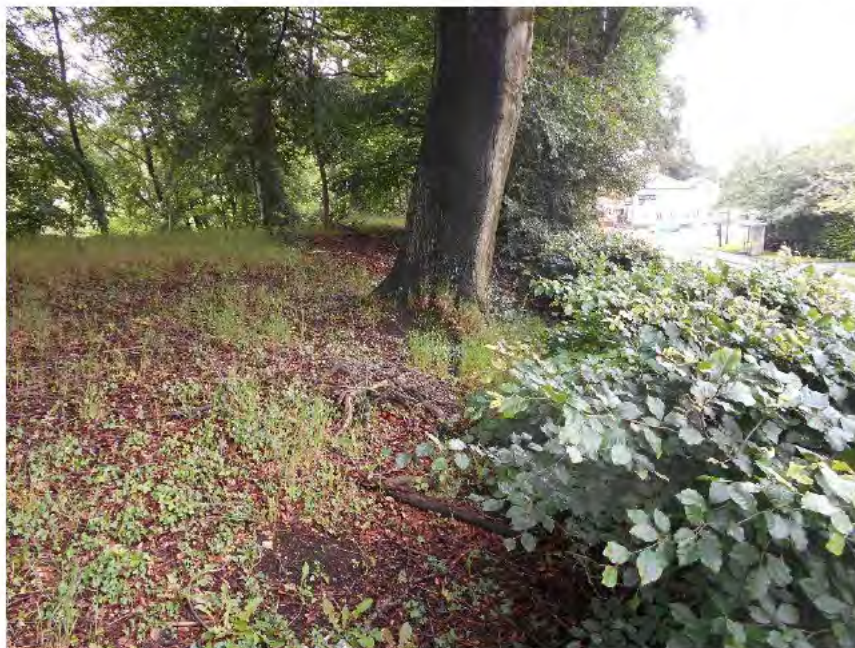
As reported above the downstream face varies; in some places there is a masonry wall at the toe whilst in other parts the face slopes down directly to the path alongside the road. Various views of the face are shown in Photographs A6 to A9. In many places a detailed assessment of the condition was hampered by the vegetation which tends to obscure the ground surface, but in general the slope of the face was fairly regular with no indication of movement or instability. As far as could be determined and taking due account of the curvature of the dam, it appeared that the alignment of the face (both the wall section and the sloping face) was regular and has not suffered any serious displacement. As with the grassy parts of the crest, it is recommended that regular ground clearance activities are carried out to minimise the spread of the undergrowth and in order to expose the dam profile in the areas between the large trees.

**Photograph A6: Typical slope of the downstream face above the wall**

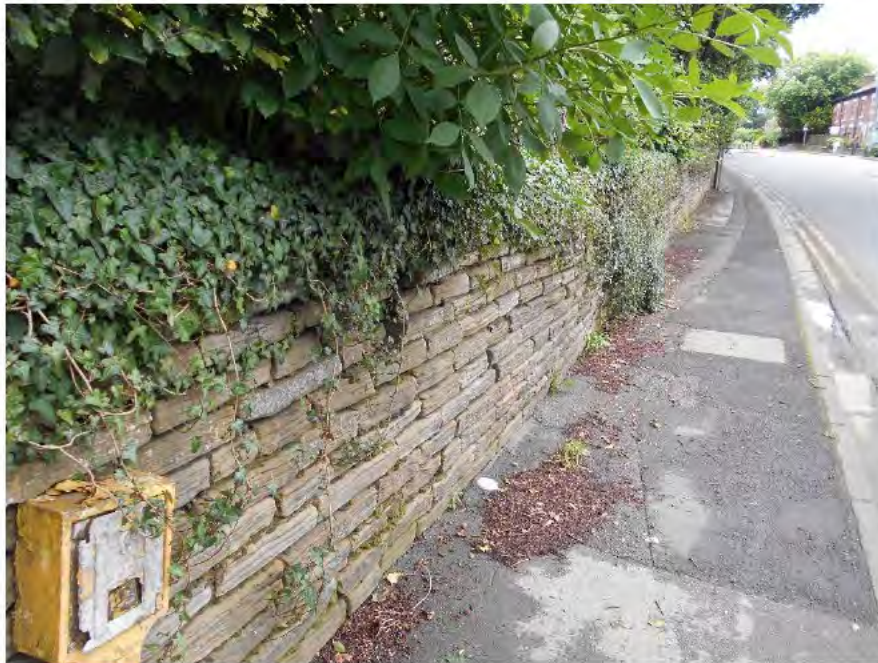
The masonry retaining wall is shown in Photographs A7 and A8. The overall alignment was reasonable as it follows the line of the footpath. The wall appears to be stable and there were no indications of imminent collapse. However there were several areas noted (see Photograph A8) where individual stones have been displaced and where localised bulging is occurring. It is recommended that the parts of the wall that have experienced this type of damage and movement should be repaired. Reference to the Annual Statement of 2012 seems to indicate that localised damage to parts of the wall has been a feature for several years. It is not known whether the responsibility for repairs to the wall lies with the undertakers for the reservoir (Cheshire East Council) or with the Highway Authority, but clearly any misunderstanding needs to be resolved in order that the appropriate repair work can be implemented.

**Photograph A7: Masonry retaining wall alongside the A523**

- e) A detailed inspection of the masonry wall that retains the embankment toe shall be carried out to identify those parts of the wall that are showing signs of distress with missing stones, open joints and bulging of the surface. Localised repair work shall then be carried out to those parts that have suffered damage in order to fill the gaps and to reinstate the wall to the correct profile.

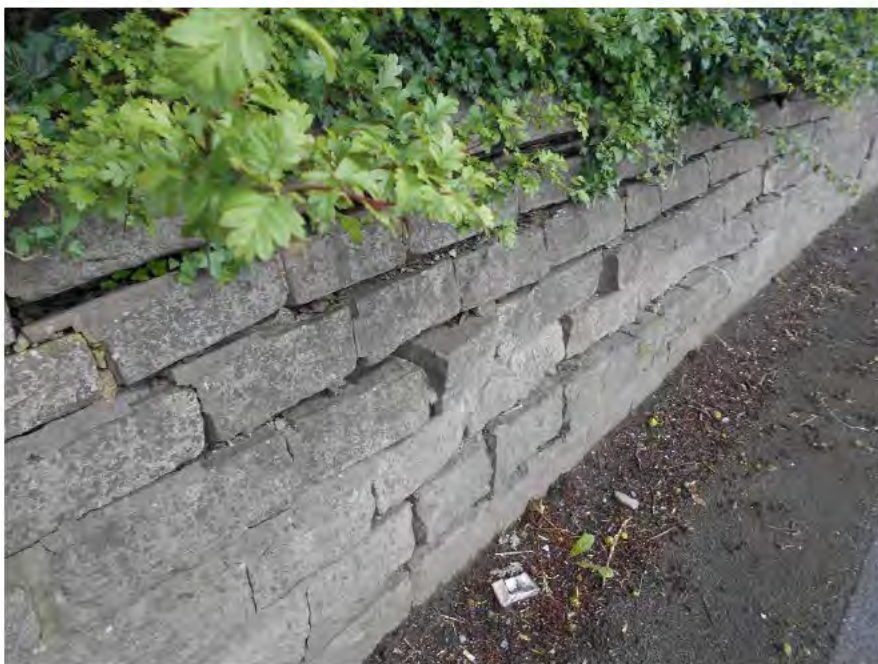
**Photograph A8: Bulging and displaced stonework within the wall**

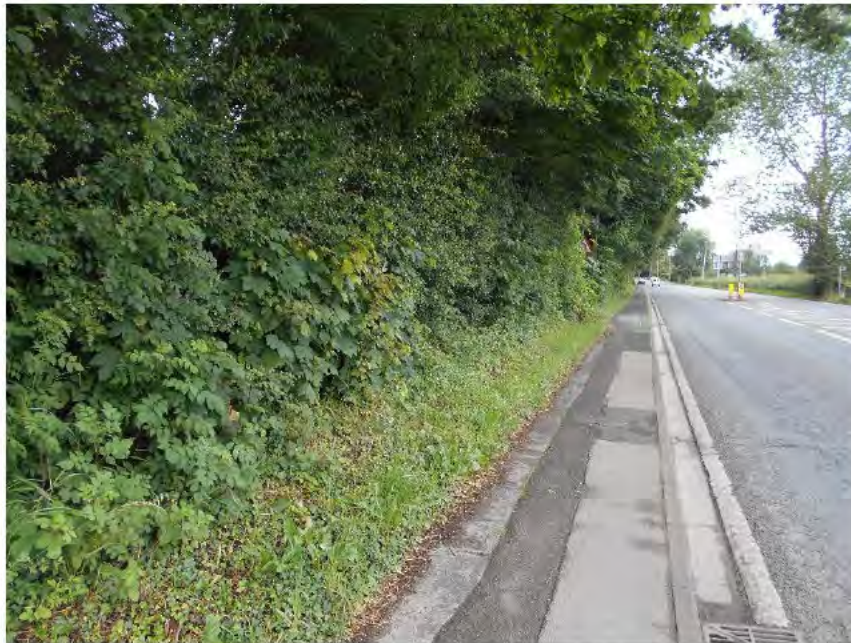
**Photograph A9: Downstream face at the northern end (no wall)**

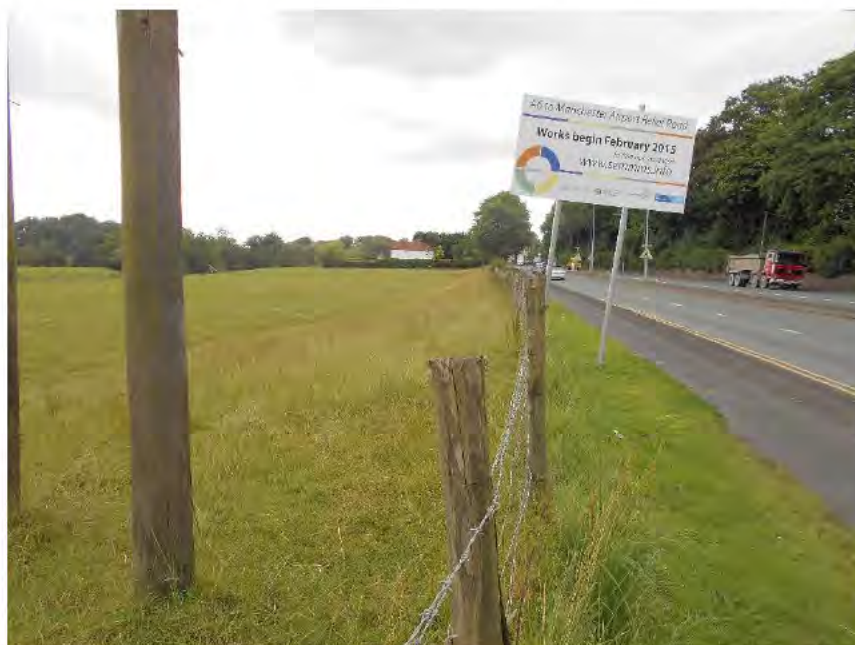
**Photograph A10: Downstream face at the highest section as seen at the downstream (west) side of the road**

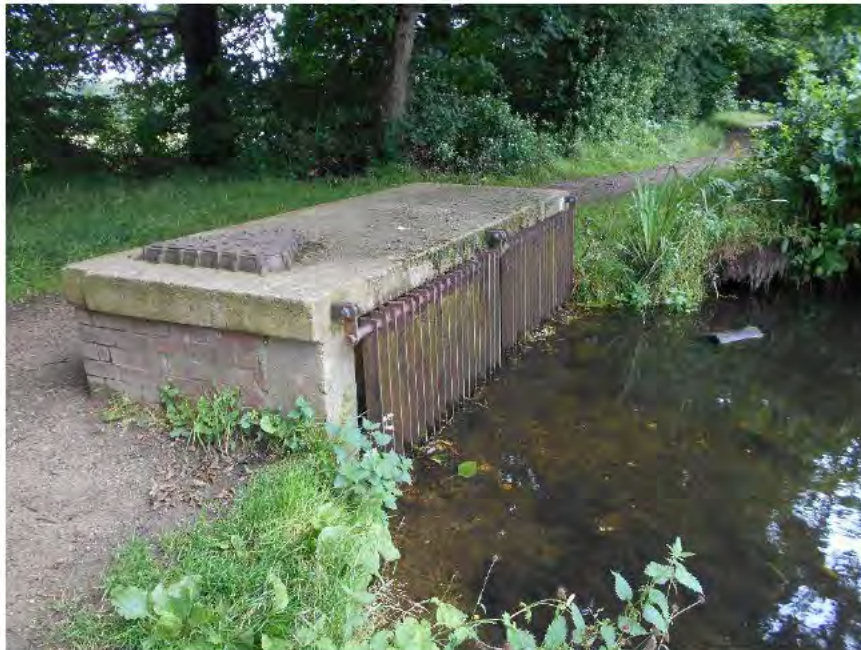
**Photograph A11: Inlet structure with screen at the upstream end of the overflow pipe**

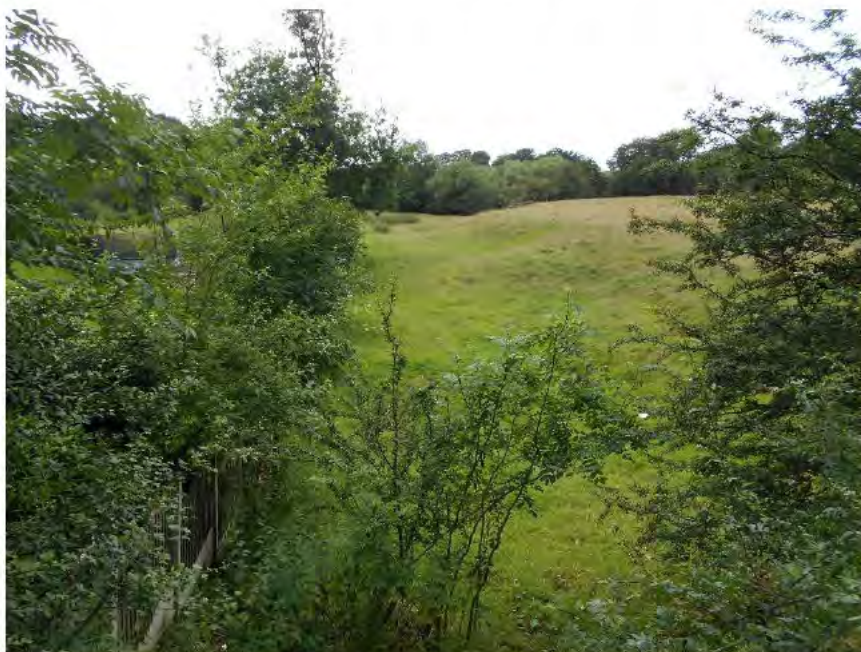
**Photograph A12: Route of overflow pipe in the downstream valley**

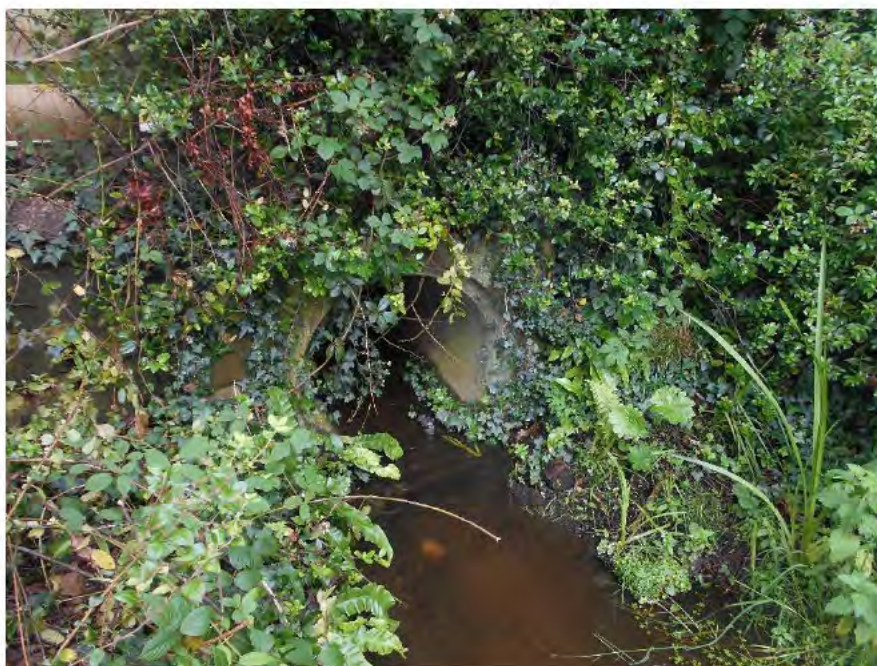
**Photograph A13: Inlet pipe to reservoir at southern end (Poynton Brook)**

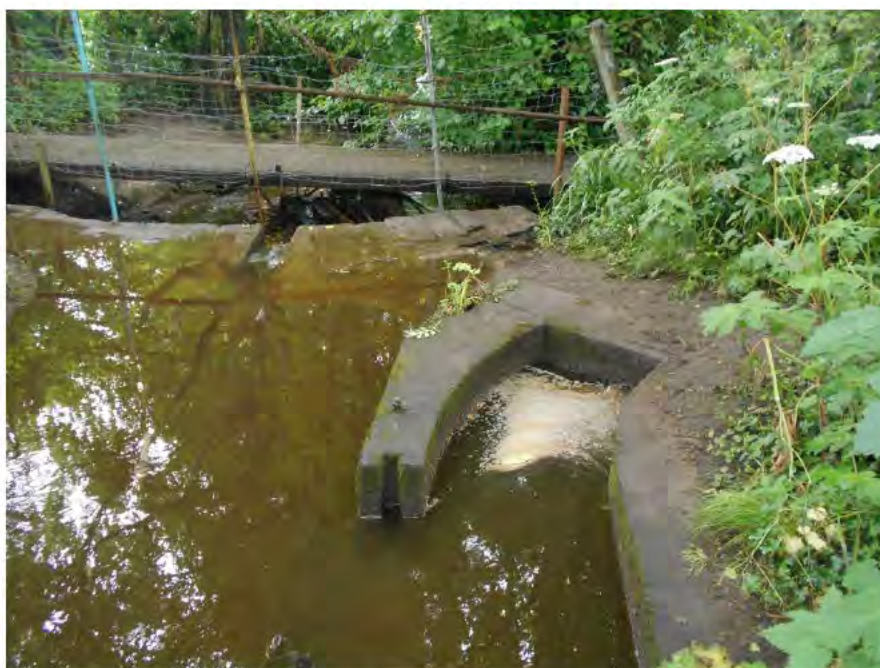
**Photograph A14: Weir and bifurcation structure on the Poynton Brook at upstream side of Parklands Way**

the discharge that might enter the reservoir. In this regard I recommend that the incoming flow conditions including the characteristics of the bi-furcation should be checked and incorporated in an updated flood study for the reservoir. Further details are given in Section 11.2.
