Our Ref: JRB\2022s1424-S-L001-1

27th November 2022

Re: Poynton Pool – Proposed Works to the dam

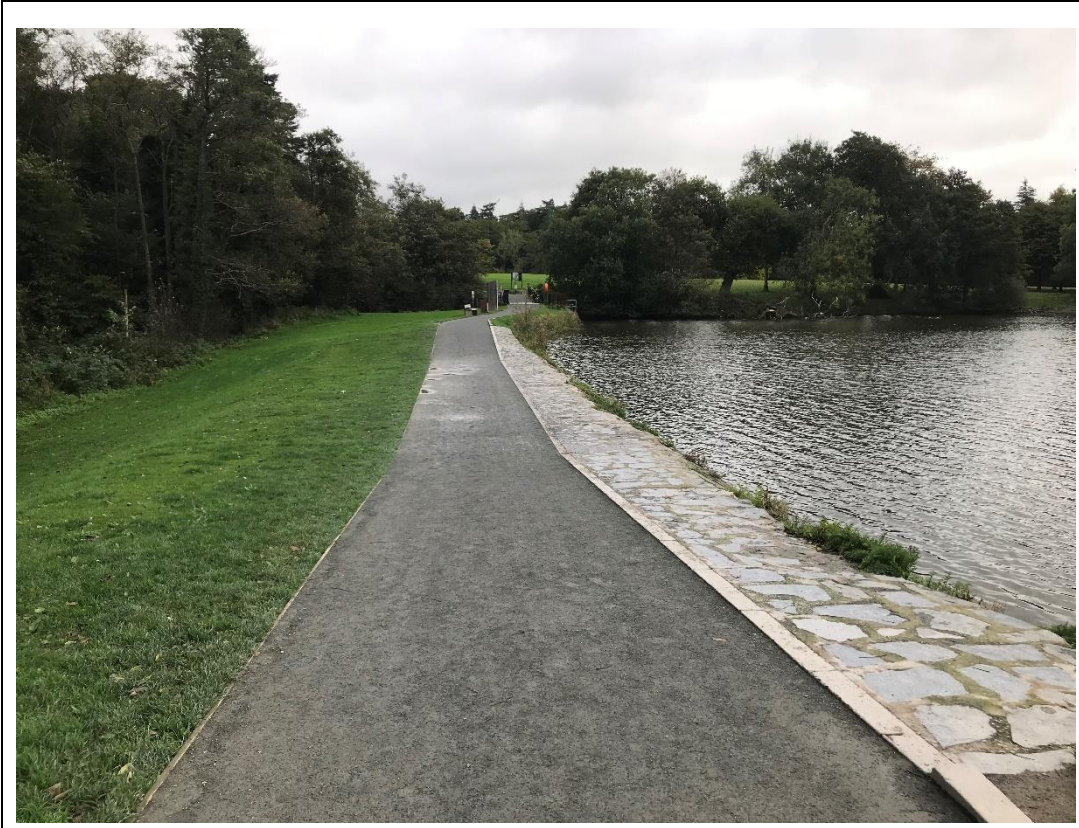
Photograph 1: Hillsborough Castle, Northern Ireland

I attach some photographs (Photos 1 and 2) to illustrate how the proposed work may look when completed. I also include a photograph from Tabley Mere (Photo 3) showing works undertaken earlier this year to create a new crest path and to even out the dam crest. These may help in visualising what the work may be involve.

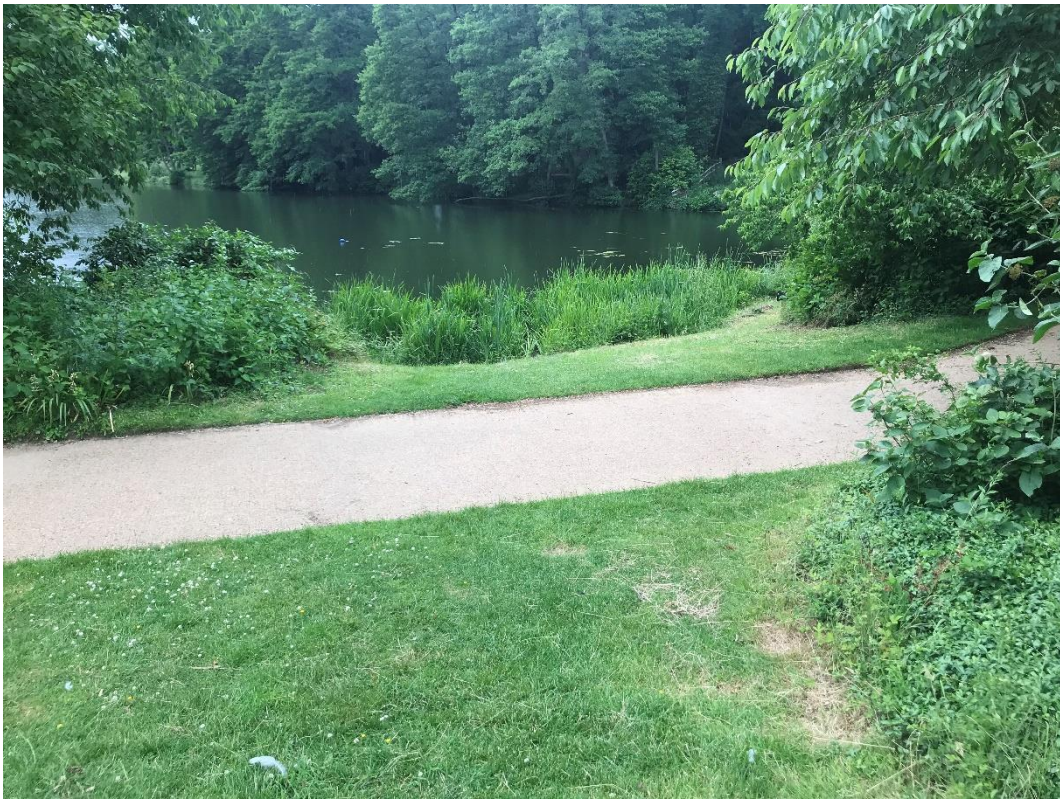
Photograph 2: National Trust Stowe (Buckinghamshire)

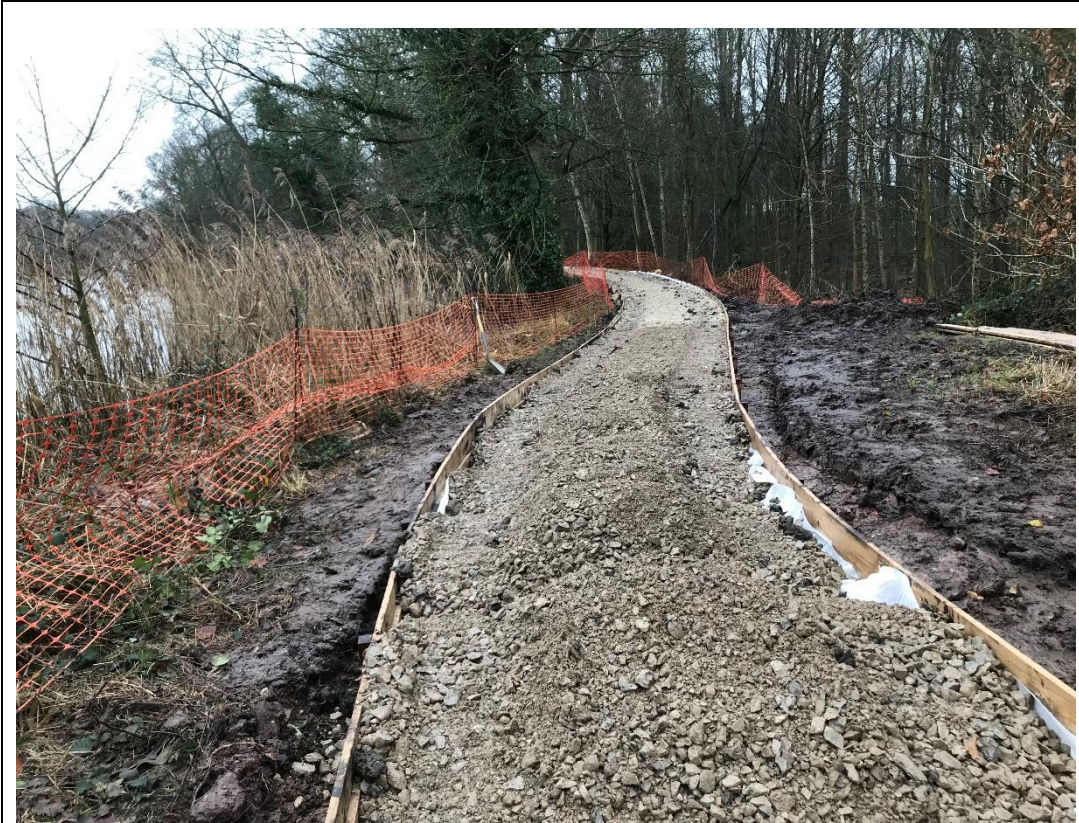
Photograph 3: Raising of dam crest - Tabley Mere, Cheshire (note this is for a relatively small raising of c. 0,2 metres), January 2022 during construction.

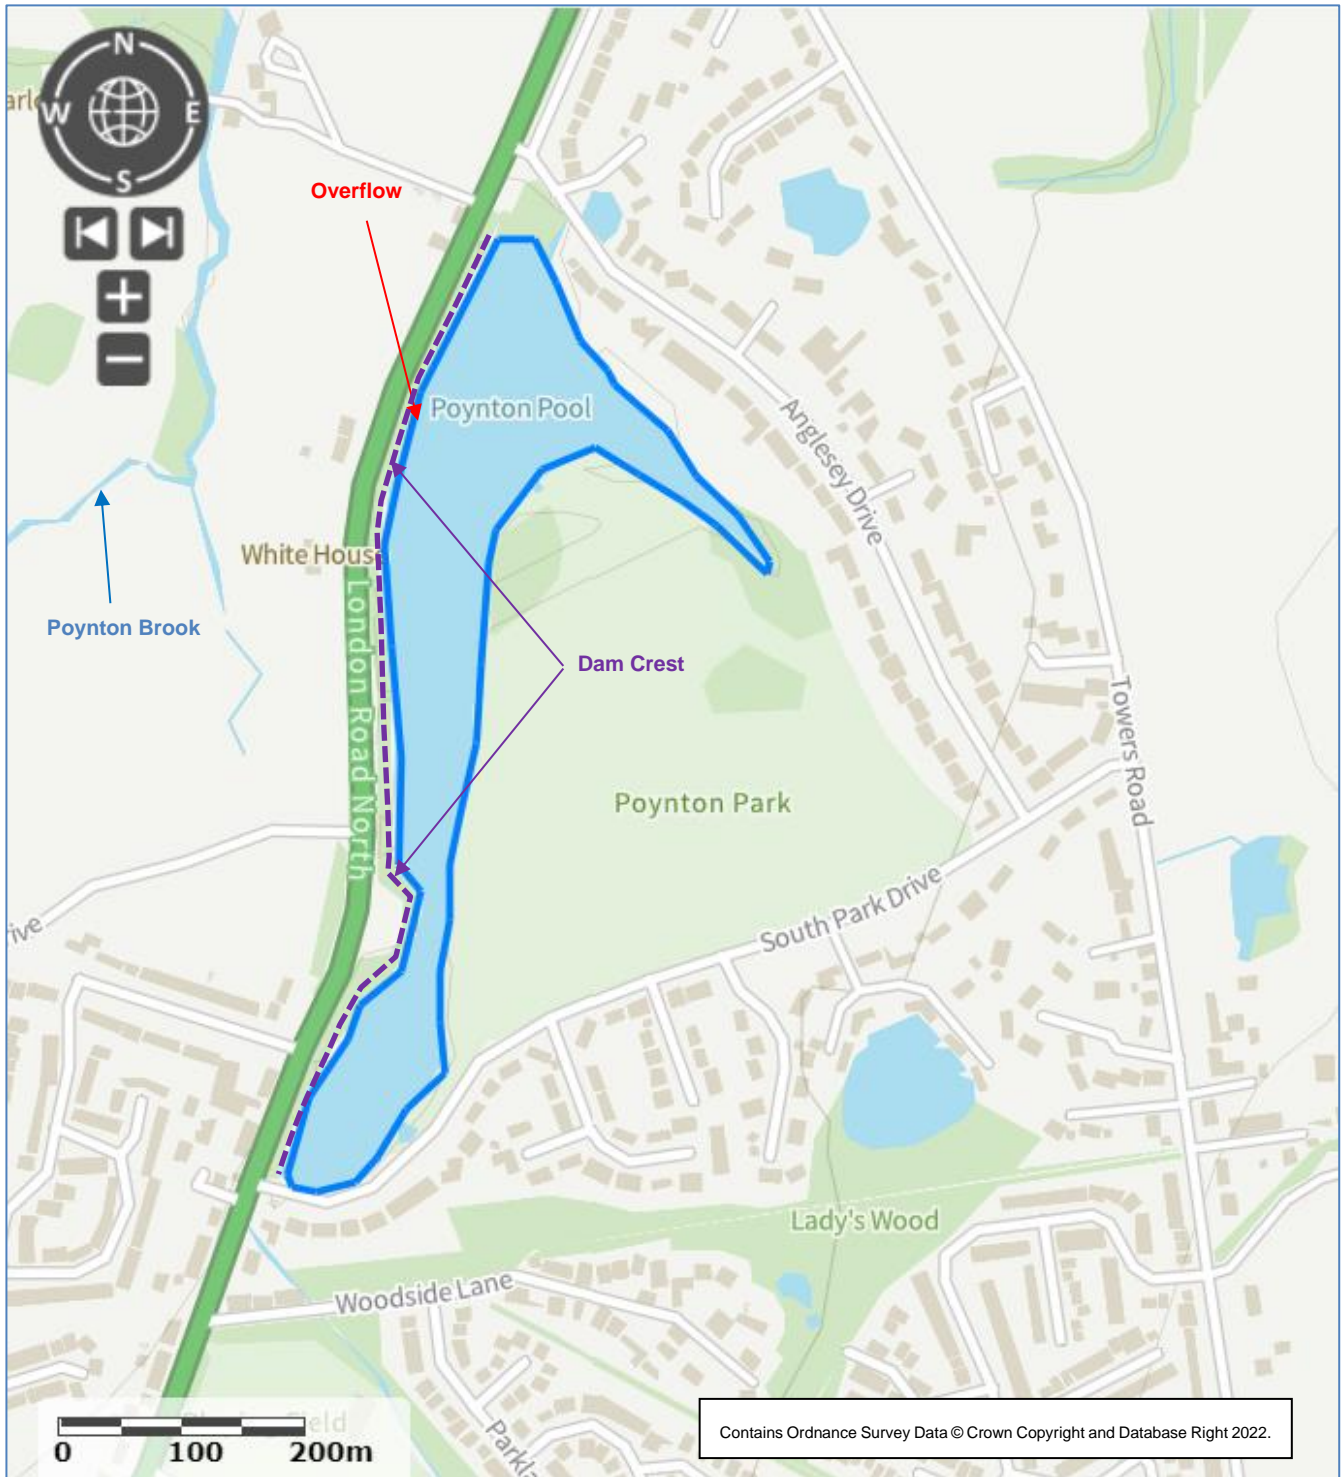
The Pool has been formed by the construction of an earth embankment dam running parallel and to the east of the A523 London Road along a north-south axis for a distance of approximately 800 metres (see Figure 2). The dam varies in width and height but is highest in the location of the overflow (which probably coincides with the original watercourse 'valley').

Water levels in the Pool are controlled by an outlet weir located approximately 145 metres from the northern end of the dam. The inlet weir has a security/debris screen to prevent unauthorised access and to collect larger debris. Flow from the weir cascades into a brick chamber before entering a pipe culvert which carries it through and under the dam and the A523 road to discharge into an open watercourse channel to the west.

Figure 2: Key features of Poynton Pool

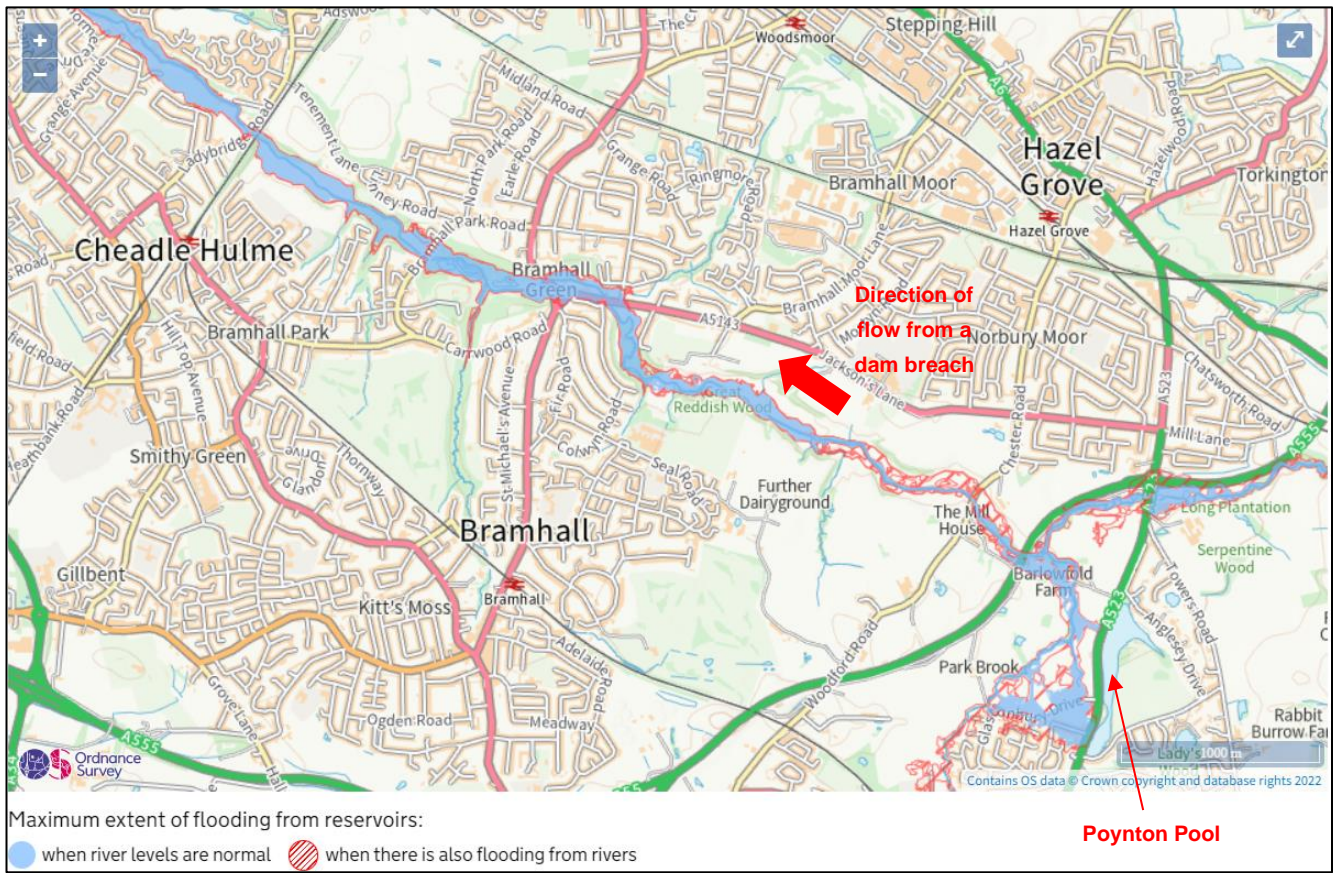
The Pool has been designated as a 'High Risk' reservoir under Section 2A of the RA1975 by the Environment Agency as it is considered that in the event of an uncontrolled release of water from the reservoir, human life could be endangered. This designation will have been based on, amongst other things, the results from a computer simulation of the potential flood depths and velocities to land downstream in the event of a dam breach. An excerpt from the map showing the possible consequence is provided in Figure 3. This shows the A523 road and property in Bramhall Green and Cheadle Hume potentially at risk of flooding. While the modelling will have made some assumptions regarding dam height, location of a breach, etc., given the location of the Pool close to housing, I can see no reason to question the High Risk designation.

Figure 3: Estimated extent of flooding from a breach of the dam at Poynton Pool (source: The Environment Agency)
