**Reservoirs Act 1975  
2019 Annual Supervising  
Engineer's Statement under  
Section 12(2) and Section  
12(2A)**

Poynton Lake

4 October 2019

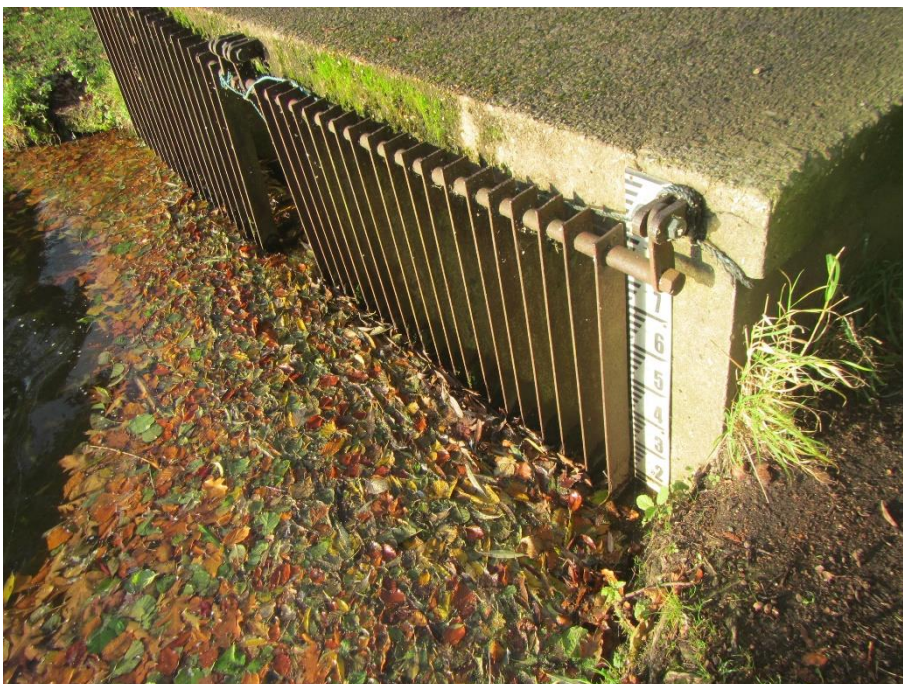
**Photo 2 – Inlet Structure with Screen at the Upstream end of the Overflow Pipe**

The reservoir was full at the time of the inspection, with about 170mm depth overflowing the overflow. The area around the gauge board was clear and an accurate level could be taken (Photo 2). As there is no abstraction from the lake, the natural condition is for the outflow via the overflow to balance the run-off from the catchment.

The inlet overflow was inspected, the screen had some build up of leaves on the screen, but there was a steady flow passing through the screens and over the weir (Photo 2). This flow was discharging into the chamber and into the downstream pipe without hindrance. The majority of the overflow works are buried and cannot be readily inspected; however, as far as could be seen, the overflow was operating satisfactorily, and the modest spill flow was passing through the pipe system to reach the course of the Poynton Brook at the downstream side.

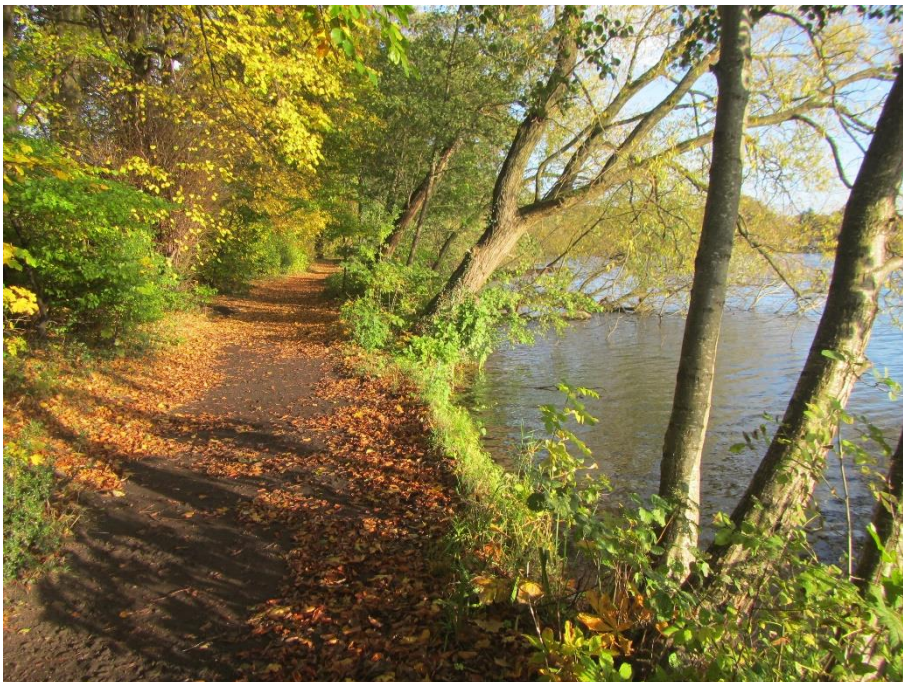
**Photo 4 – Leaning Trees along Upstream Face**

The reservoir was full and, consequently, only a small part of the face that stands above the water surface was exposed. As can be seen in Photo 4 to Photo 6, there are considerable amounts of

vegetation along the upstream edge that obscured the view. In general, the upstream face of the embankment appeared to be reasonably intact.

It was noted that tree management has been ongoing with a number of trees cut down and sections of the upstream face cleared of saplings. However, there are many leaning trees along the upstream face and a number of fallen trees (Photo 4). Fortunately, the crest is very wide and there does not appear to be a risk of the entire crest width being damaged by a fallen tree along the upstream face. **It is recommended that any fallen or leaning trees that are threatening the integrity of the face should be removed, along with any tree saplings before they become established.** When the roots and stumps have been cleared away, the upstream face should be reinstated to the correct line and new revetment boards should be installed to provide erosion protection.

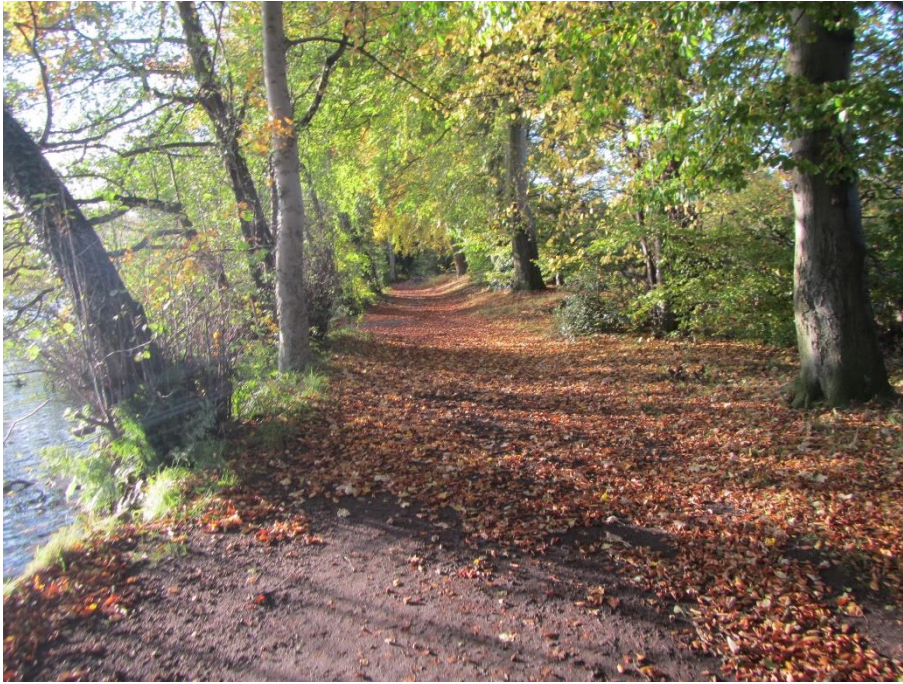
**Photo 5 – Broad Crest Dam south of the Overflow**

The crest of the dam comprises two parts; the gravel path that runs along the upstream edge and the broad expanse of grassy/woody area, sometimes at a higher level than the path. The path was in a good state of repair. It has a regular surface of gravel-type material and appeared to be well maintained. There were a few minor humps and bumps in the path but nothing more than might be expected from localised settlement. There were no signs of excessive disturbance, settlement or cracking that might arise from movement of the embankment (Photo 5 and Photo 6).

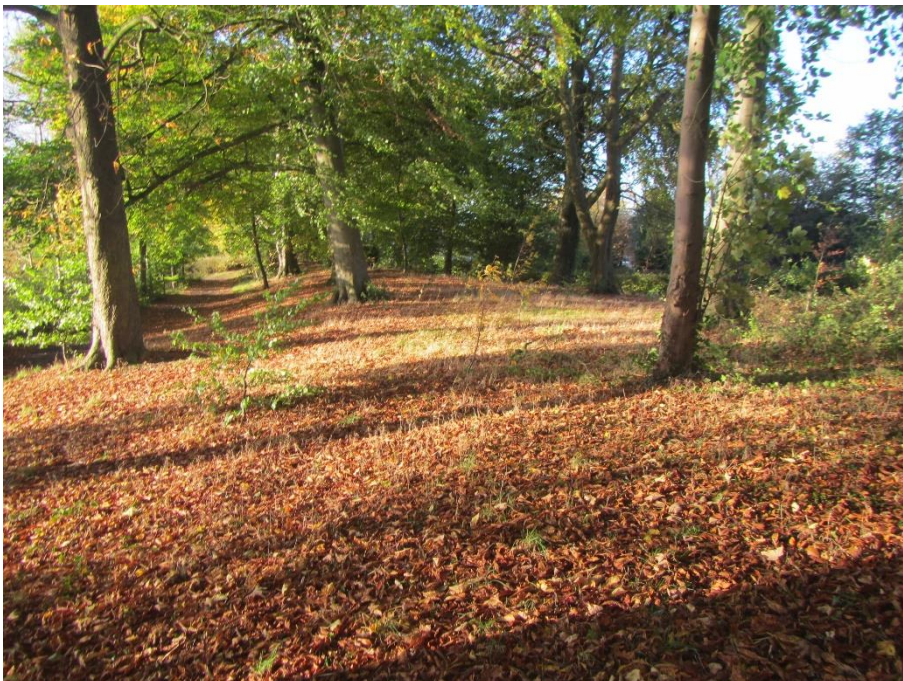
**Photo 6 – Example of what vegetation management is expected along entire length of embankment**

The site was found to be in reasonable condition – see Sections 3.5 to 3.9. However, the main finding of the visit is that the Undertaker needs to undertake a more robust approach to vegetation management on the embankment with a tree survey undertaken and more clearance to achieve a general appearance as seen on sections of the embankment (Photo 6).

**It is recommended that the trees be managed and checked on a regular basis by an arboriculturist.** Any trees that become unhealthy and which may be in danger of toppling should be removed. If the tree canopy becomes too dense then I suggest that careful pollarding of the trees should be carried out to reduce the height of the trees and to let more light through to the ground beneath to encourage healthy grass growth.

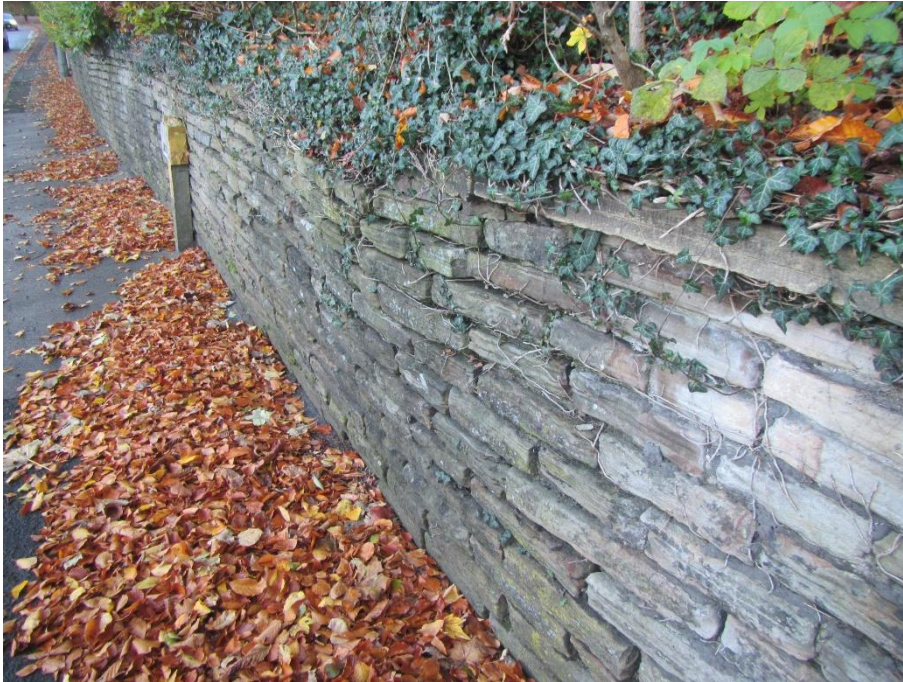
**Photo 7 – Masonry Retaining Wall Alongside the A523 (southern end)**

The masonry retaining wall is shown in Photo 7 to Photo 9. The overall alignment was reasonable as it follows the line of the footpath. The wall appears to be stable and there were no indications of imminent collapse, this is despite having mature trees growing directly behind the wall. However, several areas are noted where individual stones have eroded away and where localised bulging is occurring. The Undertaker has recently completed a structural survey of the masonry wall. It has recommended a number of works, including the removal of trees and large vegetation behind the wall. **The Undertaker is advised to implement the recommendations of the masonry wall structural survey.**

5	<b>3.5.3 Downstream Face and Retaining Wall</b> The Undertaker is advised to implement the recommendations as outlined in the structural assessment of the masonry wall.		
6	<b>3.5.3 Downstream Face and Retaining Wall</b> The Undertaker is to enquire regarding the landownership boundary of the previous highways depot area as sold by the council and whether the wall is included or not.  There is the potential that the new owners can be considered joint undertakers if their ownership includes the masonry wall and will therefore have obligations to

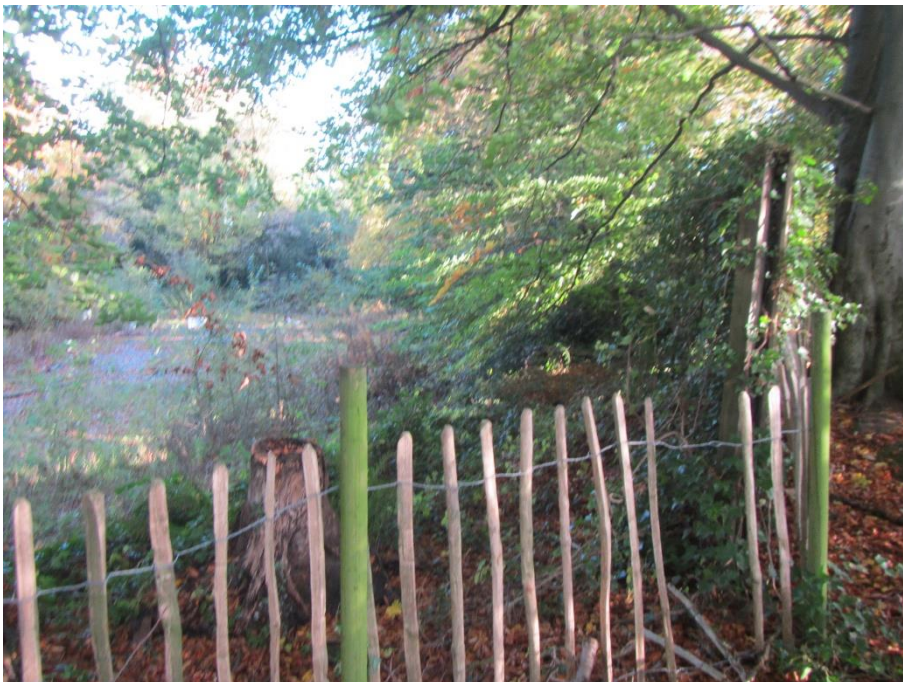
**Photo 8 – Masonry Retaining Wall within the Old Council Depot**

Towards the southern end of the dam there is an old and now disused Council Yard that occupies the land between the road and the dam. The yard has now been sold to a [REDACTED] with unknown intentions for the land. The area continues to be in a state of disrepair (Photo 8) and neglect and this includes the perimeter wall at the east side of the yard that forms a boundary with the face of the embankment. **It is recommended that the Undertaker finds out the new ownership boundary and to confirm if it retains rights to access and maintain the wall. If not, the Undertaker should advise the owner of their responsibilities as a joint Undertaker.**

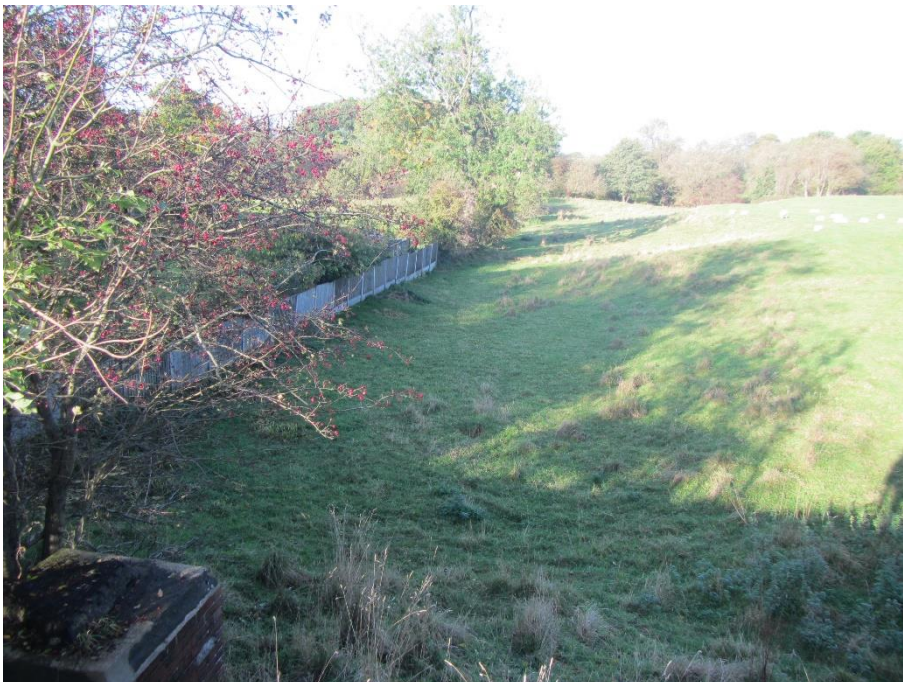
**Photo 10 – Downstream face at the highest section**

The highest section of the dam is towards the northern end and at this point the downstream face continues on the downstream (western) side of the road. This section of the face is shown in Photo 10, and within a field that is [REDACTED]. It was fenced off and there was no access during the visit. The overall alignment appeared to be satisfactory.

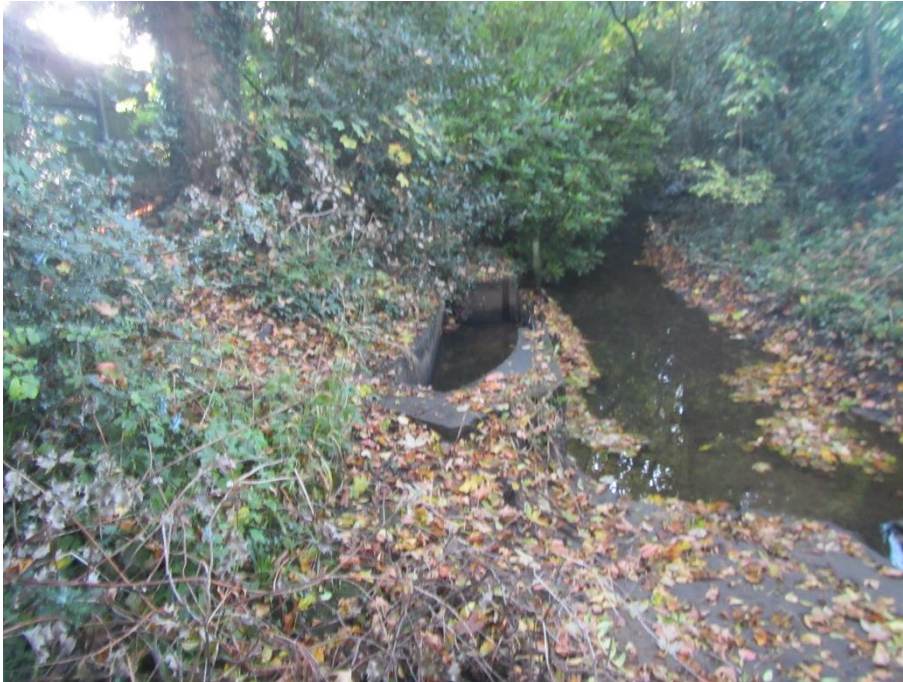
**Photo 11 – Inlet Arrangement – behind Parklands Drive**

The inlet from the indirect catchment at the southern end, behind Parklands Way, was visited and found to be relatively clear except for recent leaf fall (Photo 11).
