**Reservoirs Act 1975  
2021 Annual Supervising  
Engineer's Statement under  
Section 12(2) and Section  
12(2A)**

Poynton Lake

11 November 2021

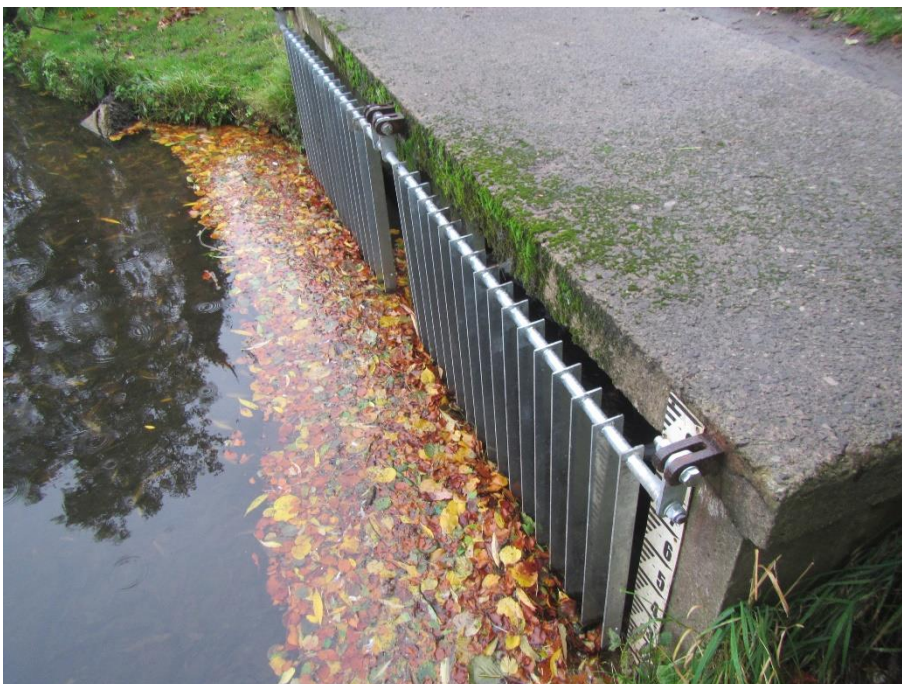
The reservoir was full at the time of the inspection, with about 190mm depth overflowing the overflow. The area around the gauge board was clear and an accurate level could be taken (Photo 2). As there is no abstraction from the lake, the natural condition is for the outflow via the overflow to balance the run-off from the catchment.

The inlet overflow was inspected, the debris/trash screen has recently been replaced. The screen had some build-up of leaves on the screen, but there was a steady flow passing through the screens and over the weir (Photo 2). This flow was discharging into the chamber and into the downstream pipe without hindrance. The majority of the overflow works are buried and cannot be readily inspected; however, as far as could be seen, the overflow was operating satisfactorily, and the modest spill flow was passing through the pipe system to reach the course of the Poynton Brook at the downstream side.

**Photo 2 – Inlet structure with new screen at the upstream end of the overflow pipe**

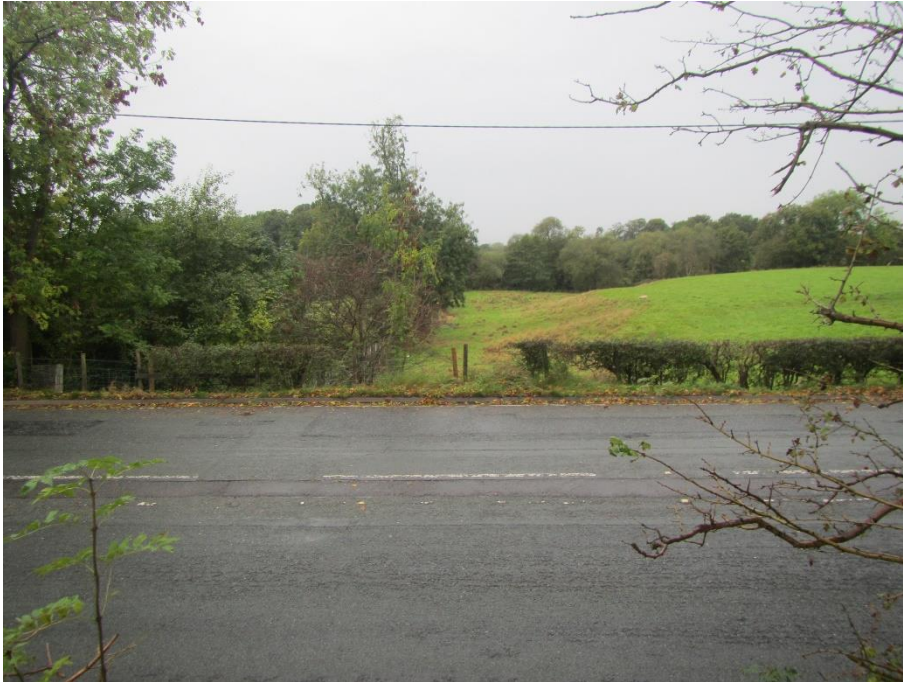
**Photo 3 – Route of overflow pipe in downstream valley**

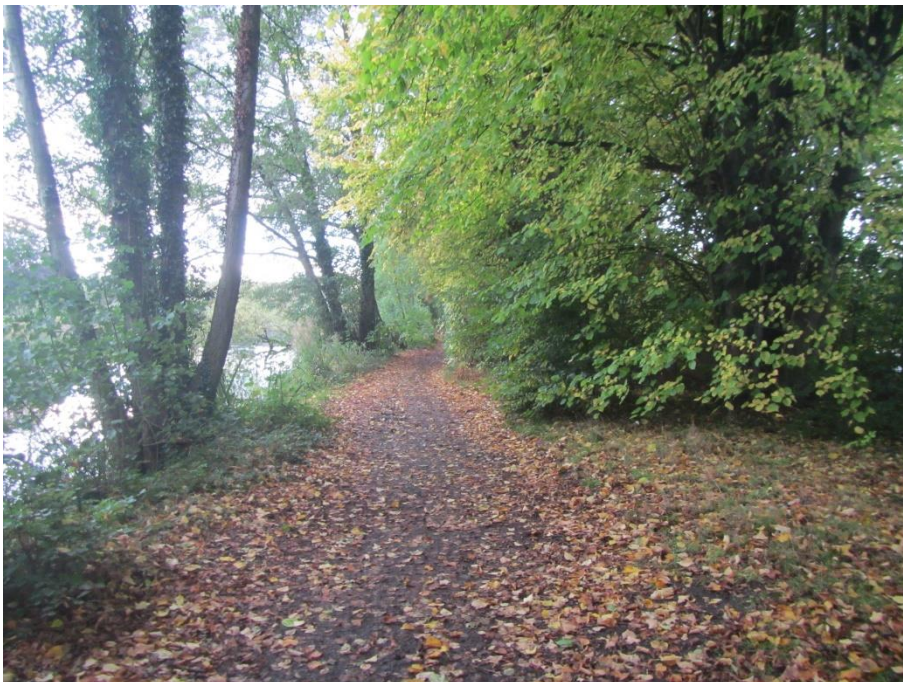
It was noted that tree management has been ongoing with a number of trees cut down and sections of the upstream face cleared of saplings. Fortunately, the crest is very wide and there does not appear to be a risk of the entire crest width being damaged by a fallen tree along the upstream face.

**Photo 4 – Leaning trees along upstream face**

**It is recommended that the trees continue to be managed and checked on a regular basis by an arborist.** Any trees that become unhealthy and which may be in danger of toppling should be removed. If the tree canopy becomes too dense then I suggest that careful pollarding of the trees should be carried out to reduce the height of the trees and to let more light through to the ground beneath to encourage healthy grass growth.

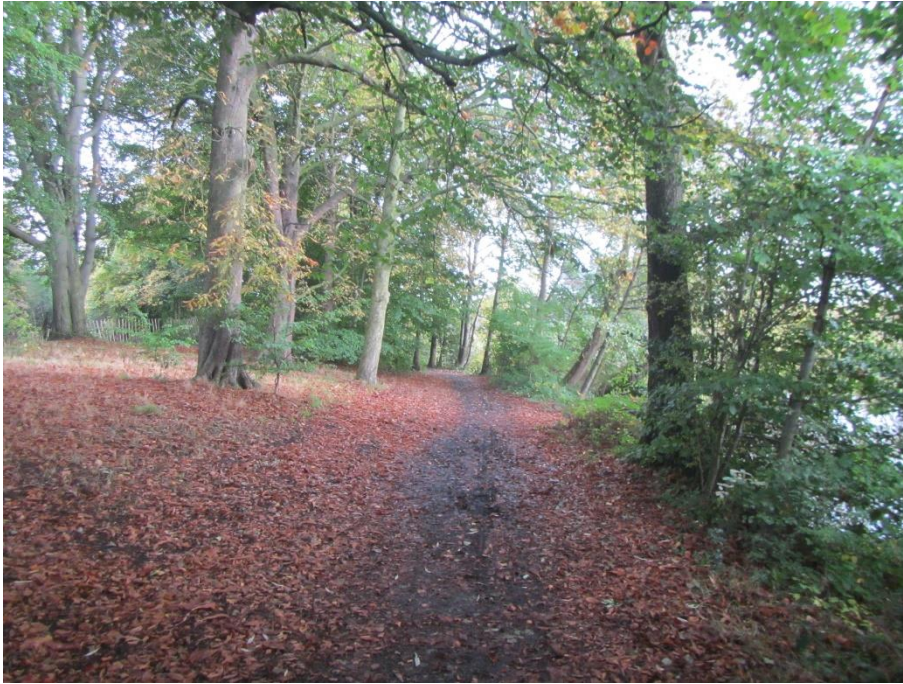
The crest of the dam comprises two parts; the gravel path that runs along the upstream edge and the broad expanse of grassy/woody area, sometimes at a higher level than the path. The path was in a good state of repair. It has a regular surface of gravel-type material and appeared to be well maintained. There were a few minor humps and bumps in the path but nothing more than might be expected from localised settlement. There were no signs of excessive disturbance, settlement or cracking that might arise from movement of the embankment (Photo 5 and Photo 6).

**Photo 5 – Broad crest dam south of the overflow**

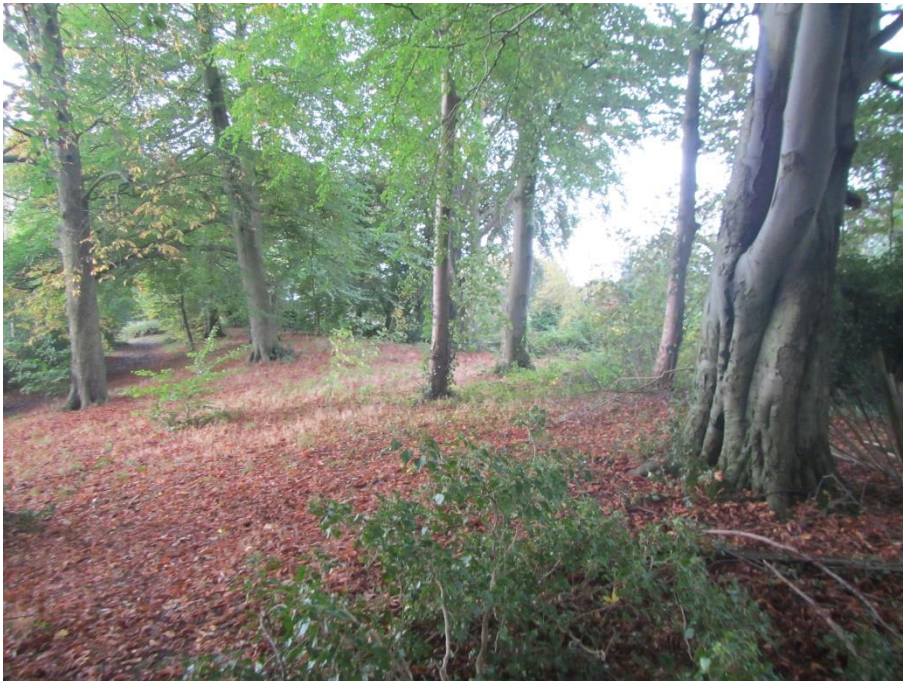
The site was found to be in reasonable condition – see Sections 3.5 to 3.9. The annual visit was accompanied by the park rangers and the council's tree arborist to discuss the expected level of management and ground clearance. It was generally agreed that management will try to achieve a general appearance as seen on sections of the embankment (Photo 6).

**Photo 6 – Example of what vegetation management is expected along entire length of overtopping embankment**

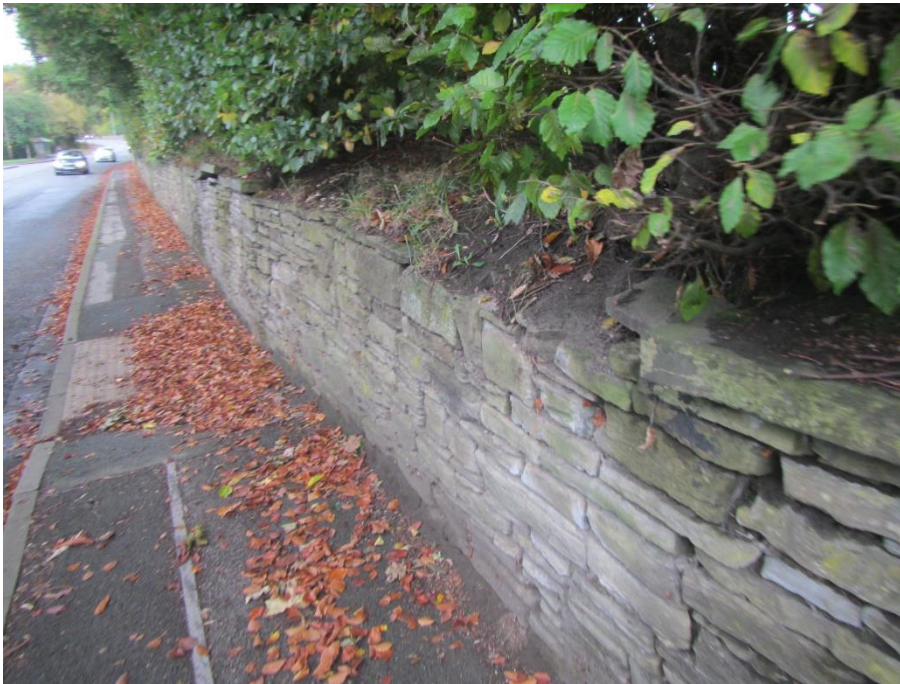
The masonry retaining wall is shown in Photo 7 to Photo 9. The overall alignment was reasonable as it follows the line of the footpath. The wall appears to be stable and there were no indications of imminent collapse, this is despite having mature trees growing directly behind the wall. However, several areas are noted where individual stones have eroded away and where localised bulging is occurring. The Undertaker has recently completed a structural survey of the masonry wall. It has recommended a number of works, including the removal of trees and large vegetation behind the wall. **The Undertaker is advised to implement the recommendations of the masonry wall structural survey.**

**Photo 7 – Masonry retaining wall alongside the A523 (southern end)**

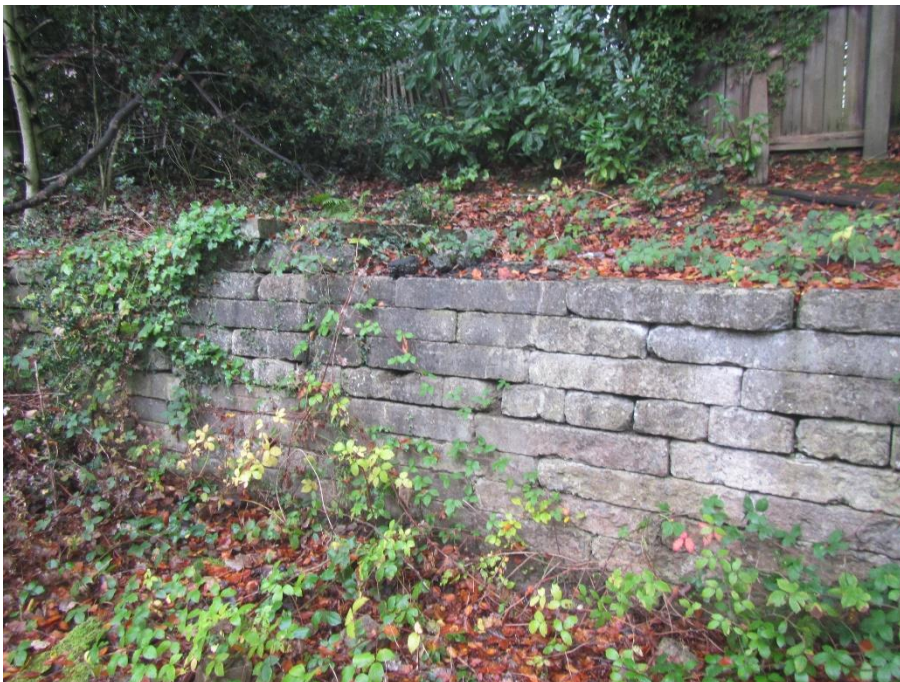
Towards the southern end of the dam there is an old and now disused Council Yard that occupies the land between the road and the dam. The yard has now been sold [REDACTED] with unknown intentions for the land. The area continues to be in a state of disrepair (Photo 8) and neglect and this includes the perimeter wall at the east side of the yard that forms a boundary with the face of the embankment. **It is recommended that the Undertaker finds out the new ownership boundary and to confirm if it retains rights to access and maintain the wall. If not, the Undertaker should advise the owner of their responsibilities as a joint Undertaker.**

**Photo 8 – Masonry Retaining Wall within the Old Council Depot**

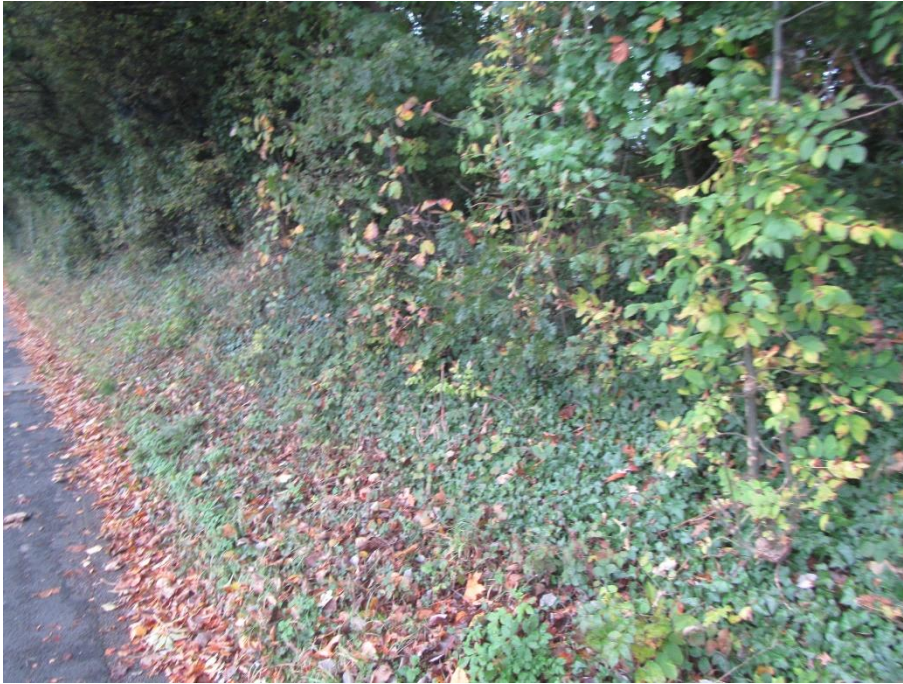
**Photo 9 – Northern section of where masonry wall runs-out and which is over-toppable**

The alignment of the 400m length of over-toppable embankment corresponds to where the downstream face is sloped and not retained by a masonry wall (Photo 9). **It is recommended that where the downstream slope is not retained by a masonry wall, then the face is regularly cut to encourage grass growth.**

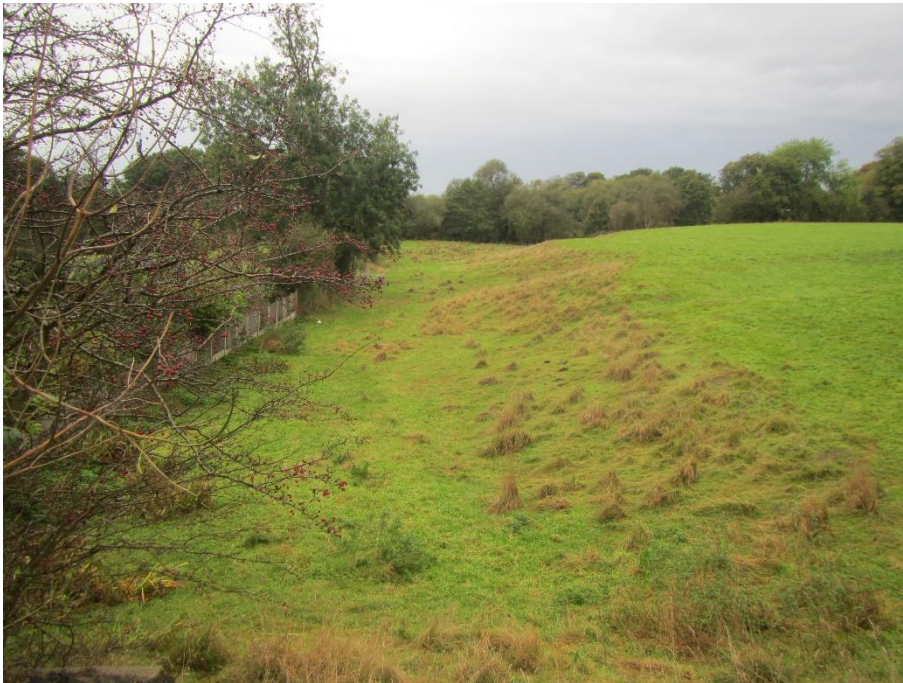
The downstream face varies; in some places there is a masonry wall at the toe whilst in other parts the face slopes down directly to the path alongside the road. Various views of the face are shown in Photo 7 to Photo 10. As far as could be determined and, taking due account of the curvature of the dam, it appeared that the alignment of the face (both the wall section and the sloping face) was regular and on the whole, has not suffered any serious displacement. As with the grassy parts of the crest, **it is recommended that regular ground clearance activities are carried out to minimise the spread of the undergrowth and in order to expose the dam profile in the areas between the large trees.**

**Photo 10 – Downstream face at the highest section**

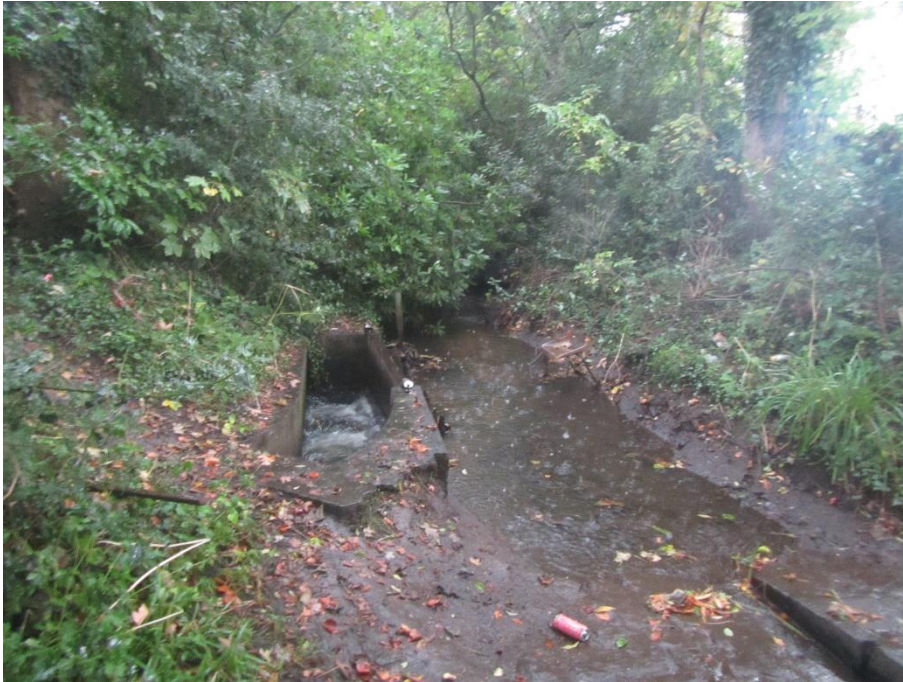
The inlet from the indirect catchment at the southern end, behind Parklands Way, was visited and found to be relatively clear (Photo 11). It was noted that the stoplogs were installed to minimise the flow being diverted to Poynton Lake but there was significant seepage through them. It has been confirmed that Council's Highways team had installed them whilst some drainage works are undertaken and will be removed upon completion of these works in November 2021.

**Photo 11 – Inlet Arrangement – behind Parklands Drive**

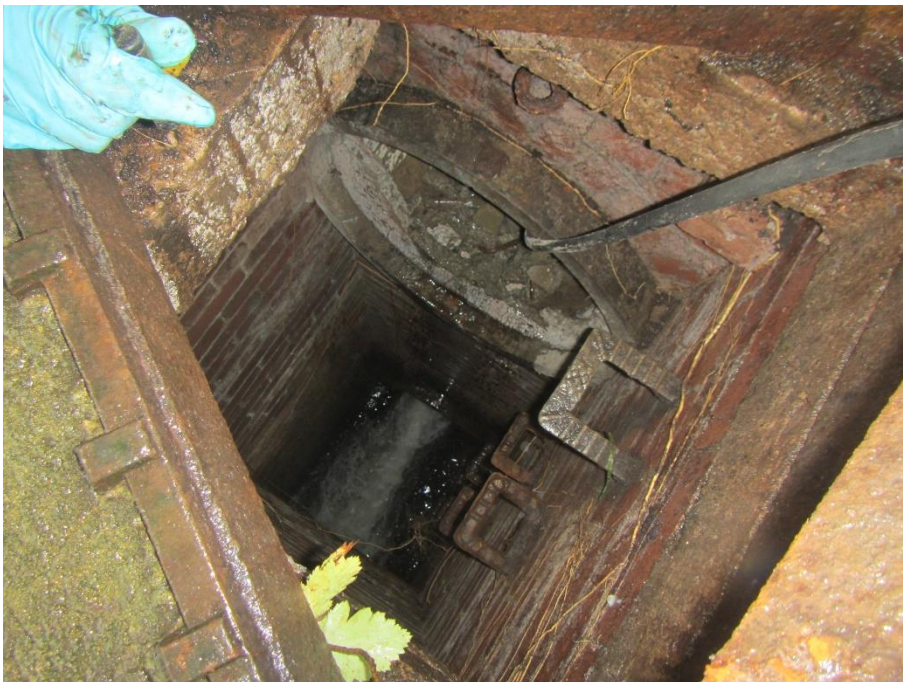
**Photo 12 – Chamber Downstream of Overflow Chamber (2019)**

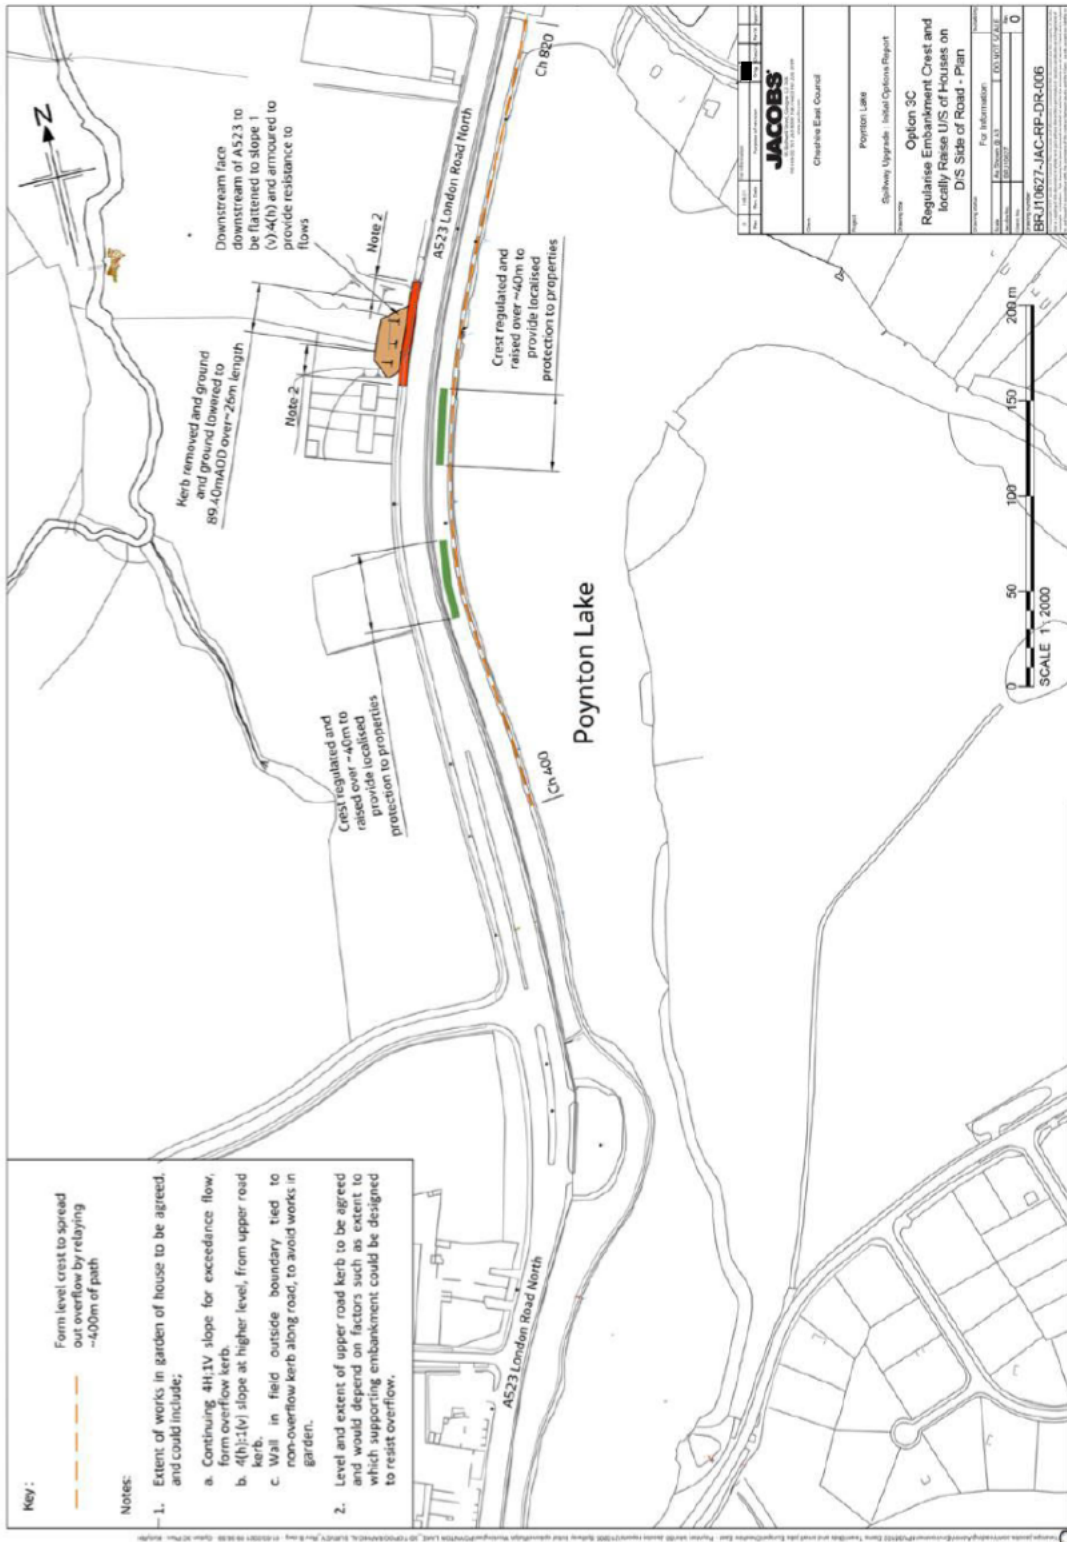
## **C. Proposed works to enable safe overtopping**

The council has received options on how to provide a 400m section of over-toppable embankment by the construction of low level walls. It is planned that significant tree clearance along the front face will be undertaken during January and February 2022, with the civil works undertaken during September to November 2022. An outline arrangement has been provided in Appendix C.
