**Reservoirs Act 1975  
2022 Annual Supervising  
Engineer's Statement under  
Section 12(2) and Section  
12(2A)**

Poynton Lake

September 2022

Cheshire East Council  
Municipal Buildings  
Earle Street  
Crewe  
Cheshire  
CW1 2BJ

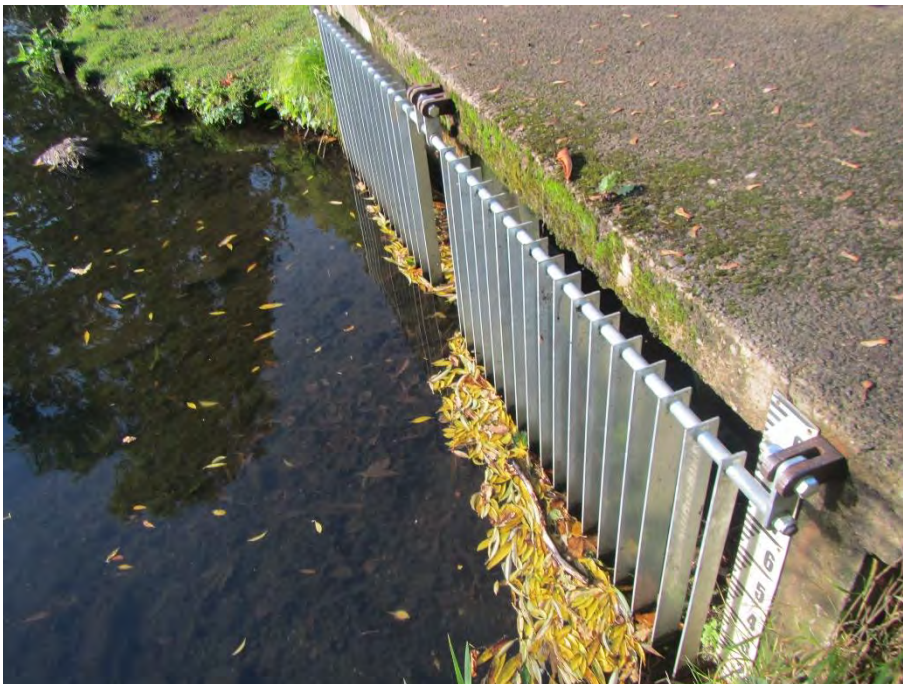
The reservoir was full at the time of the inspection, with about 170mm depth overflowing the overflow. The area around the gauge board was clear and an accurate level could be taken (Photo 2). As there is no abstraction from the lake, the natural condition is for the outflow via the overflow to balance the run-off from the catchment.

The inlet overflow was inspected. The debris/trash screen which had recently been replaced, had some build-up of leaves, but there was a steady flow passing through the screens and over the weir (Photo 2). This flow was discharging into the chamber and into the downstream pipe without hindrance. The majority of the overflow works are buried and cannot be readily inspected; however, as far as could be seen, the overflow was operating satisfactorily, and the modest spill

**Photo 2 – Inlet structure with new screen at the upstream end of the overflow pipe**

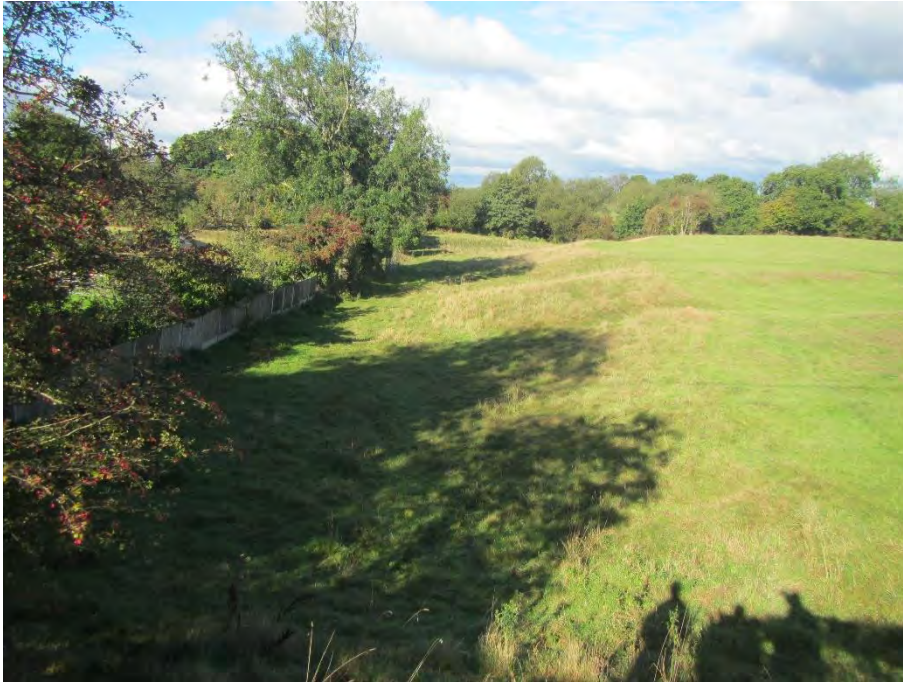
**Photo 3 – Route of overflow pipe in downstream valley**

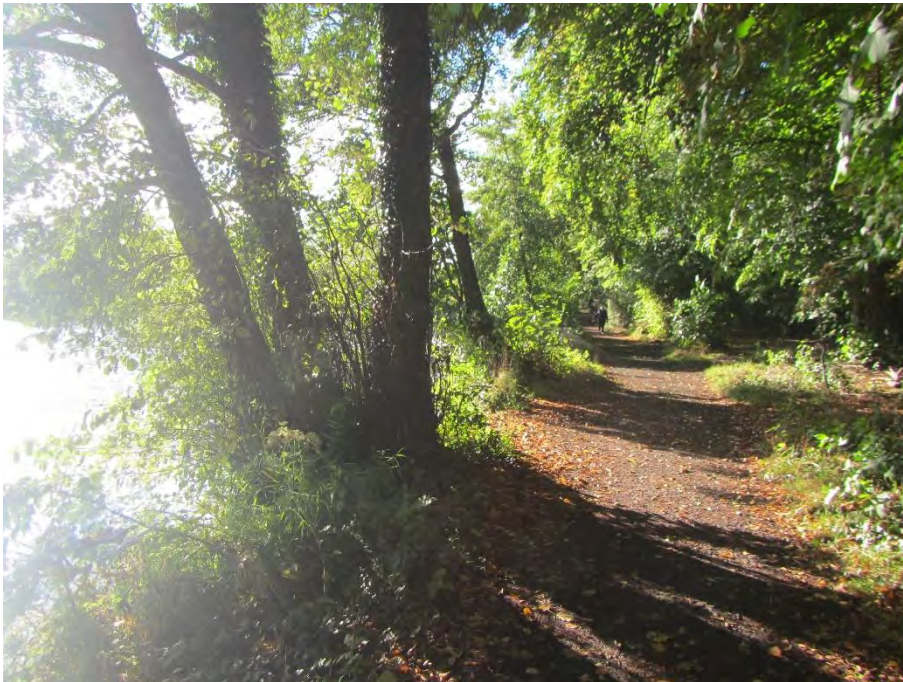
It was noted that tree management has been ongoing with a number of trees cut down and sections of the upstream face cleared of saplings. Fortunately, the crest is very wide and there does not appear to be a risk of the entire crest width being damaged by a fallen tree along the upstream face.

**Photo 4 – Leaning trees along upstream face**

**It is recommended that the trees continue to be managed and checked on a regular basis by an arborist.** Any trees that become unhealthy and which may be in danger of toppling should

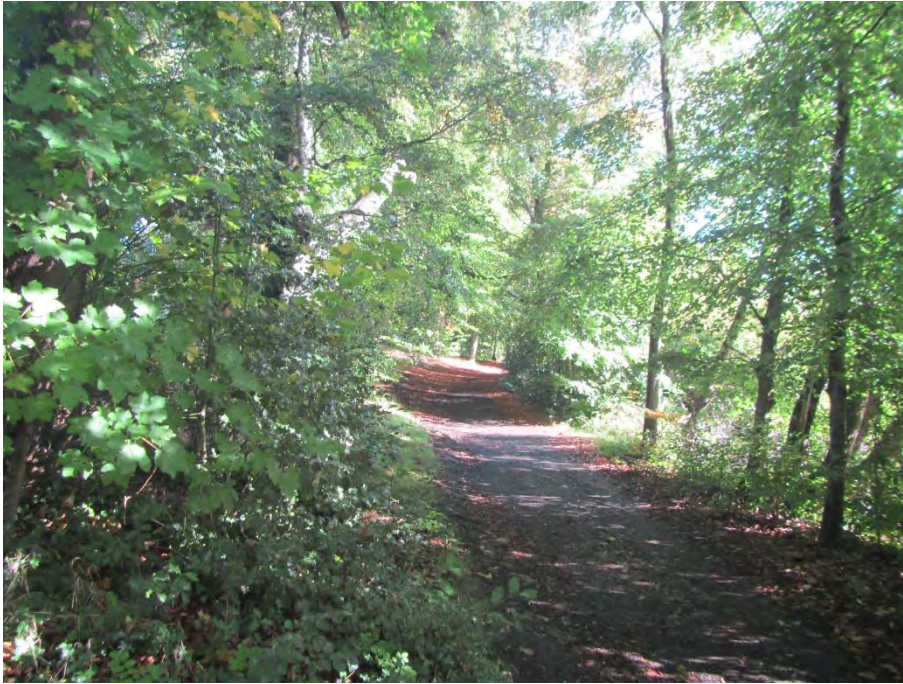
The crest of the dam comprises two parts; the gravel path that runs along the upstream edge and the broad expanse of grassy/woody area, sometimes at a higher level than the path. The path was in a good state of repair. It has a regular surface of gravel-type material and appeared to be well maintained. There were a few minor humps and bumps in the path but nothing more than might be expected from localised settlement. There were no signs of excessive disturbance, settlement or cracking that might arise from movement of the embankment (Photo 5 and Photo 6).

**Photo 5 – Broad crest dam south of the overflow**

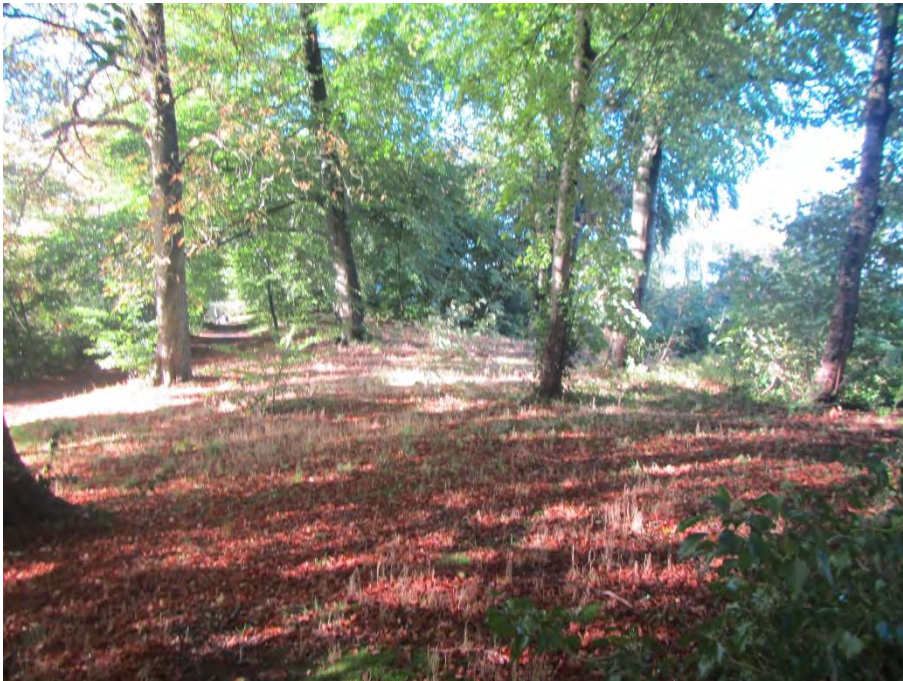
The site was found to be in reasonable condition – see Sections 3.5 to 3.9. It was generally agreed that management will try to achieve a general appearance as seen on sections of the embankment south of the old depot (Photo 6).

**Photo 6 – Example of what vegetation management is expected along entire length of overtopping embankment**

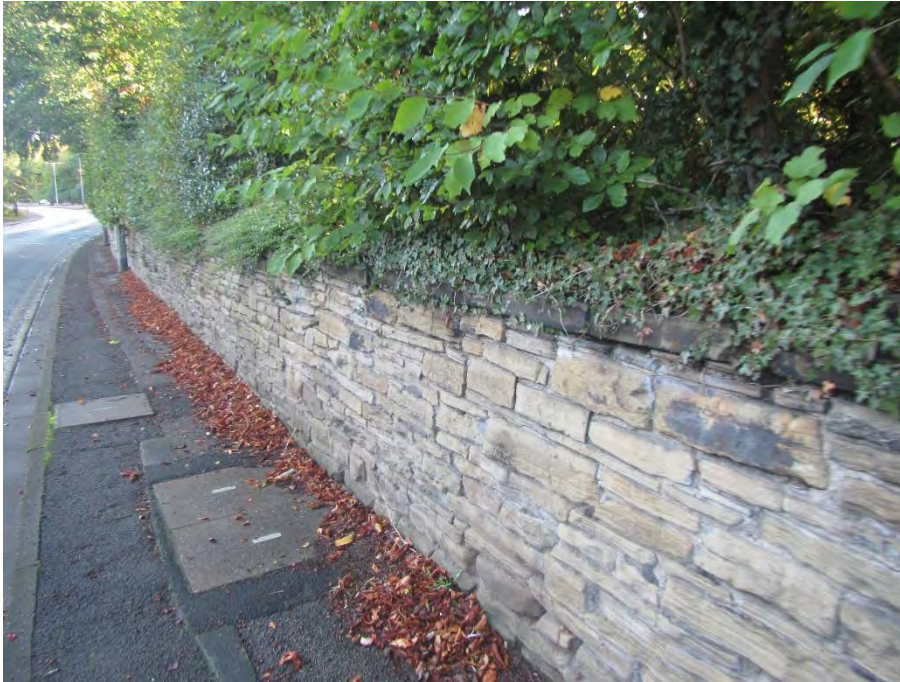
The masonry retaining wall is shown in Photo 7 and Photo 8. The overall alignment was reasonable as it follows the line of the footpath. The wall appears to be stable and there were no indications of imminent collapse, this is despite having mature trees growing directly behind the wall. However, several areas are noted where individual stones have eroded away and where localised bulging is occurring. The Undertaker has recently completed a structural survey of the masonry wall. It has recommended a number of works, including the removal of trees and large vegetation behind the wall. **The Undertaker is advised to implement the recommendations of the masonry wall structural survey. There are also sections of masonry wall requiring ivy to be removed.**

**Photo 7 – Masonry retaining wall alongside the A523 (southern end)**

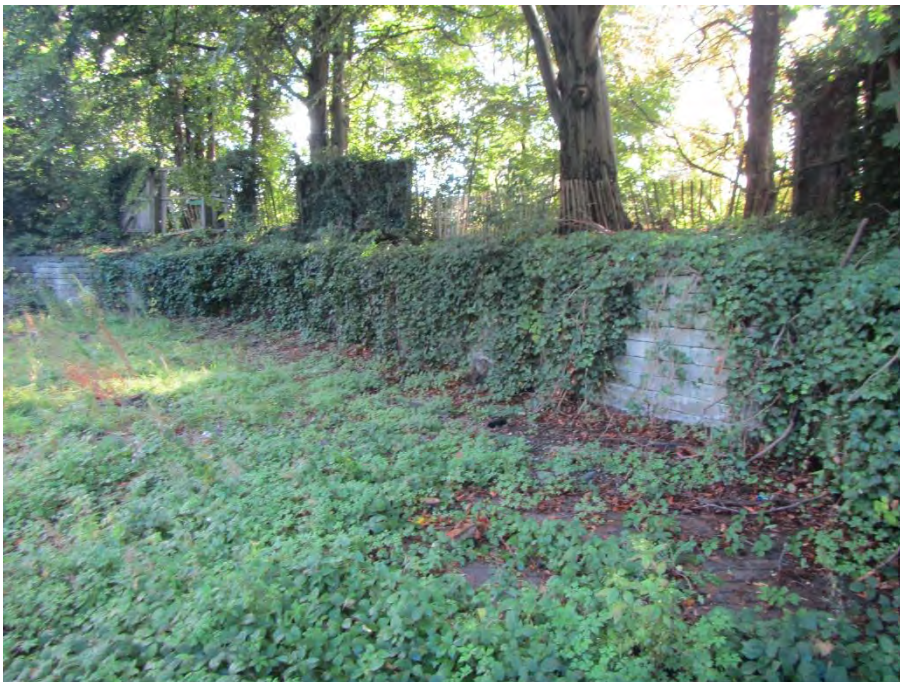
Towards the southern end of the dam there is an old and now disused Council Yard that occupies the land between the road and the dam. The yard has now been sold to [REDACTED] with intentions to develop for housing. The area continues to be in a state of disrepair (Photo 8) and neglect and this includes the perimeter wall at the east side of the yard that forms a boundary with the face of the embankment. **It is recommended that the Undertaker finds out the new ownership boundary and to confirm if it retains rights to access and maintain the wall. If not, the Undertaker should advise the owner of their responsibilities as a joint Undertaker.**

**Photo 8 – Masonry Retaining Wall within the Old Council Depot**

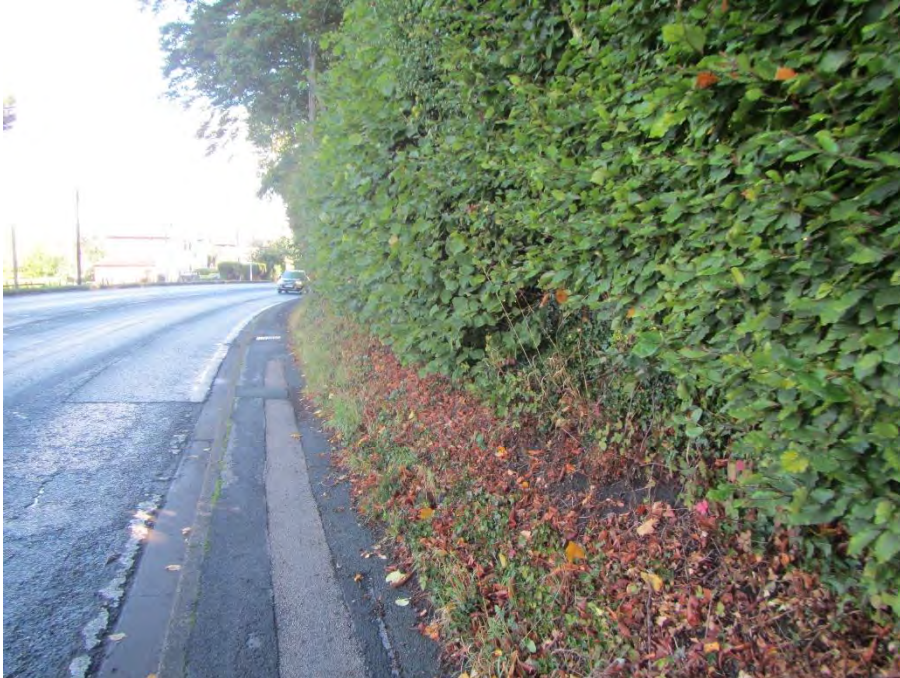
The alignment of the 400m length of over-toppable embankment corresponds to where the downstream face is sloped and not retained by a masonry wall (Photo 9). **It is recommended that where the downstream slope is not retained by a masonry wall, then the face is regularly cut to encourage grass growth.**

**Photo 9 – Northern section of downstream face, where masonry wall runs-out and which is over-toppable**

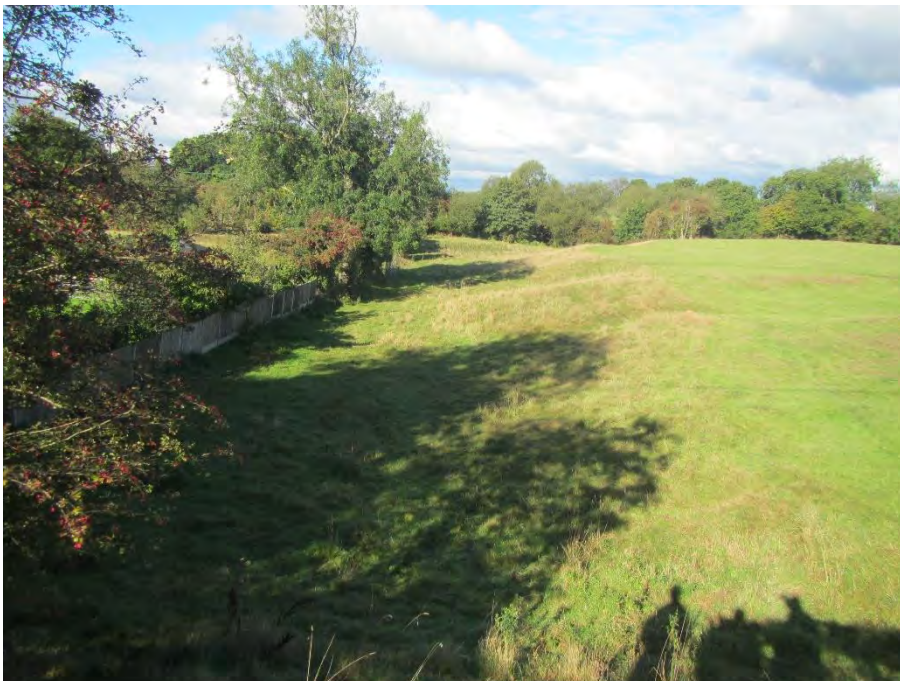
The downstream face varies; in some places there is a masonry wall at the toe whilst in other parts the face slopes down directly to the path alongside the road. Various views of the face are shown in Photo 7 to Photo 10. As far as could be determined and, taking due account of the curvature of the dam, it appeared that the alignment of the face (both the wall section and the sloping face) was regular and on the whole, has not suffered any serious displacement. As with the grassy parts of the crest, **it is recommended that regular ground clearance activities are carried out to minimise the spread of the undergrowth and in order to expose the dam profile in the areas between the large trees.**

**Photo 10 – Downstream face at the highest section**

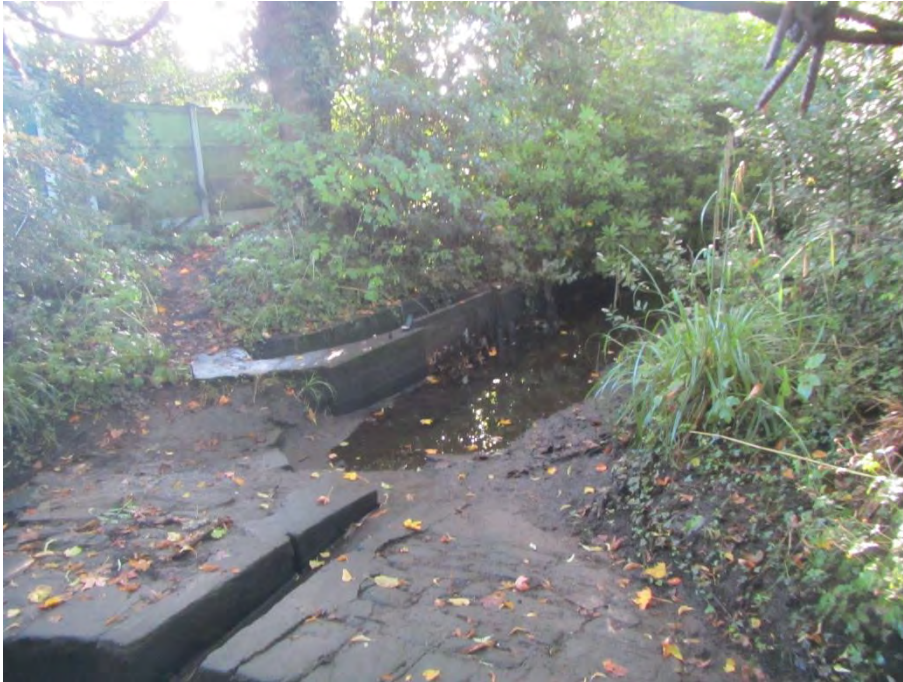
The inlet from the indirect catchment at the southern end, behind Parklands Way, was visited and found to be relatively clear (Photo 11). It was noted that stoplogs have been permanently installed to minimise the flow being diverted to Poynton Lake but there was seepage through them. It has been confirmed that Council's Highways team had installed them whilst some drainage works are undertaken but these have not since been removed.

**Photo 11 – Inlet Arrangement – behind Parklands Drive**

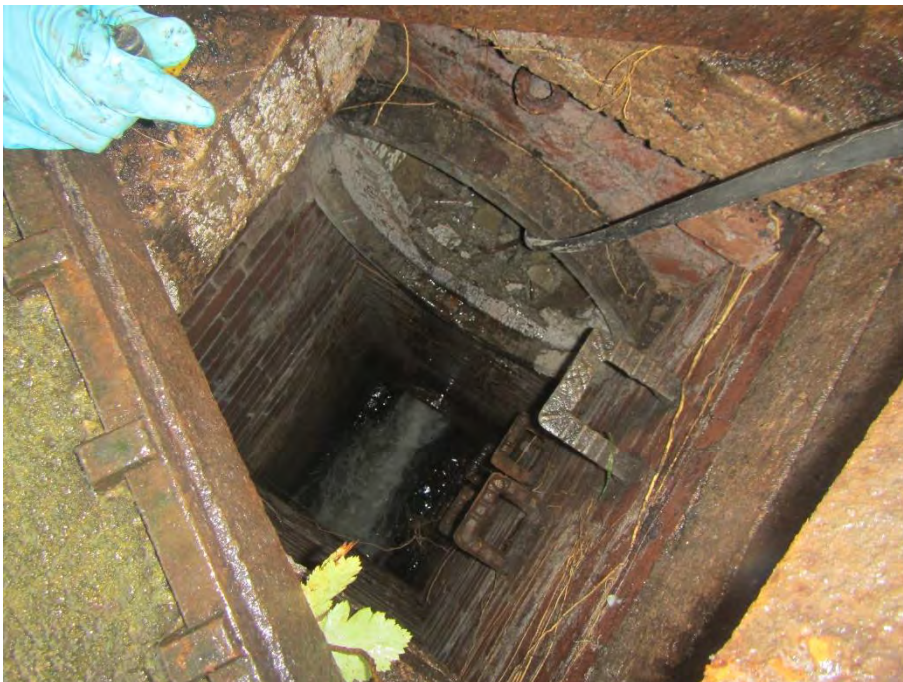
**Photo 12 – Chamber Downstream of Overflow Chamber (2019)**
