Reservoirs Act 1975 2019 Annual Supervising Engineer's Statement

Poynton Lake

4 October 2019

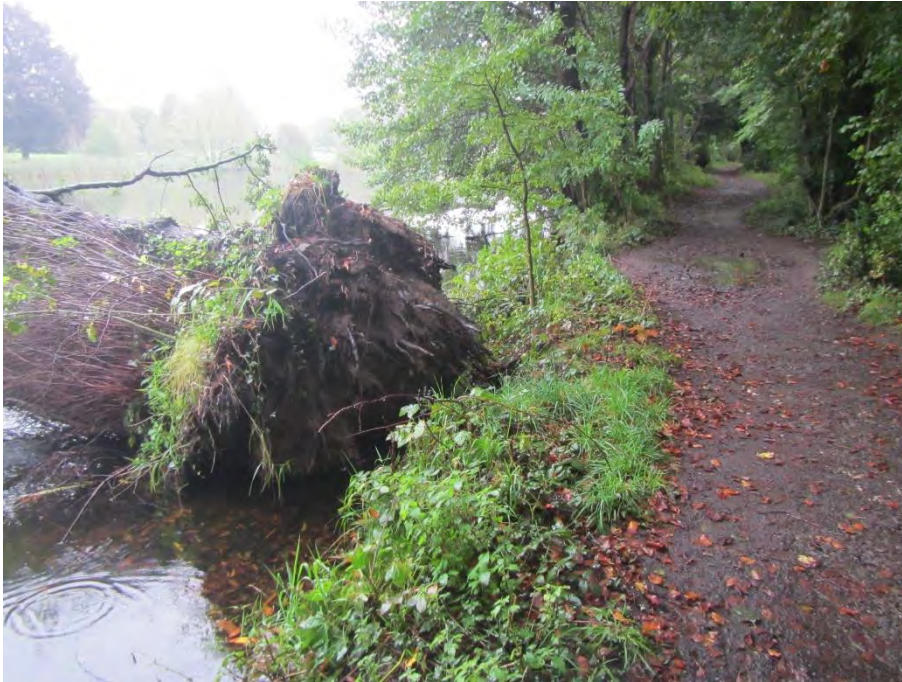
Photo 5 – Fallen Tree along Upstream Face

The reservoir was full and, consequently, only a small part of the face that stands above the water surface was exposed. As can be seen in Photo 5 to Photo 7, there are considerable amounts of vegetation along the upstream edge that obscured the view. In general, the upstream face of the embankment appeared to be reasonably intact.

It was noted that tree management has been ongoing with a number of trees cut down and sections of the upstream face cleared of saplings. However, there has recently been a tree fall over which has taken with it a portion of the embankment (Photo 5). Fortunately the tree was located mostly off the crest so there has been very little taken out of the embankment. **It is recommended that any fallen or leaning trees that are threatening the integrity of the face should be removed along with any tree saplings before they become established.** When the roots and stumps have been cleared away, the upstream face should be reinstated to the correct line and new revetment boards should be installed to provide erosion protection.

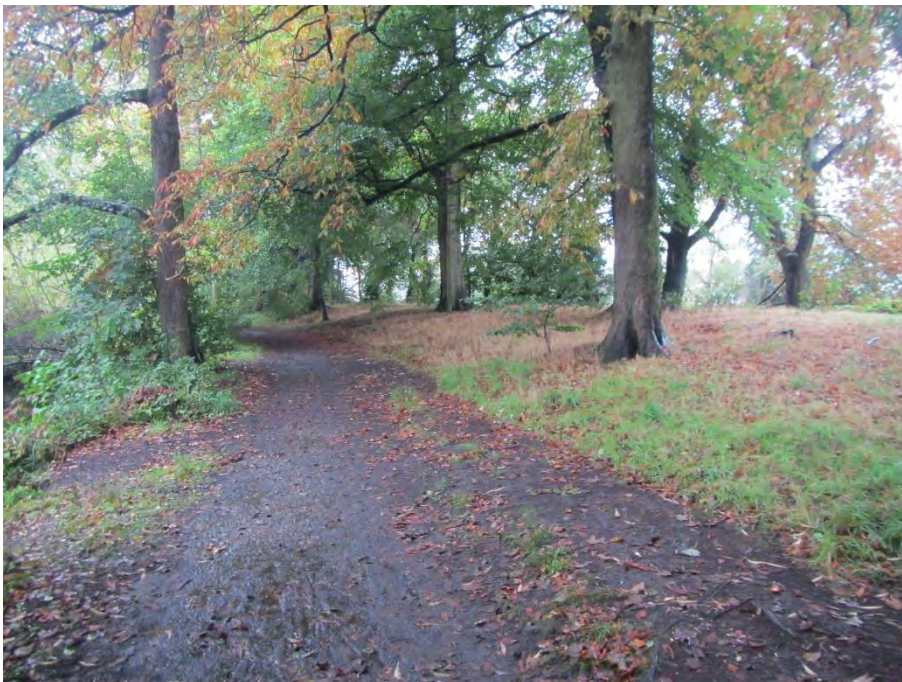
Photo 6 – Broad Crest Dam south of the Overflow

The crest of the dam comprises two parts; the gravel path that runs along the upstream edge and the broad expanse of grassy/woody area, sometimes at a higher level than the path, which generally runs along the upstream edge. The path itself was found to be in a good state of repair. It has a good regular surface of gravel-type material and appeared to be well maintained. There were a few minor humps and bumps in the path but nothing more than might be expected from localised settlement. There were no signs of excessive disturbance, settlement or cracking that might arise from movement of the embankment (Photo 6 and Photo 7).

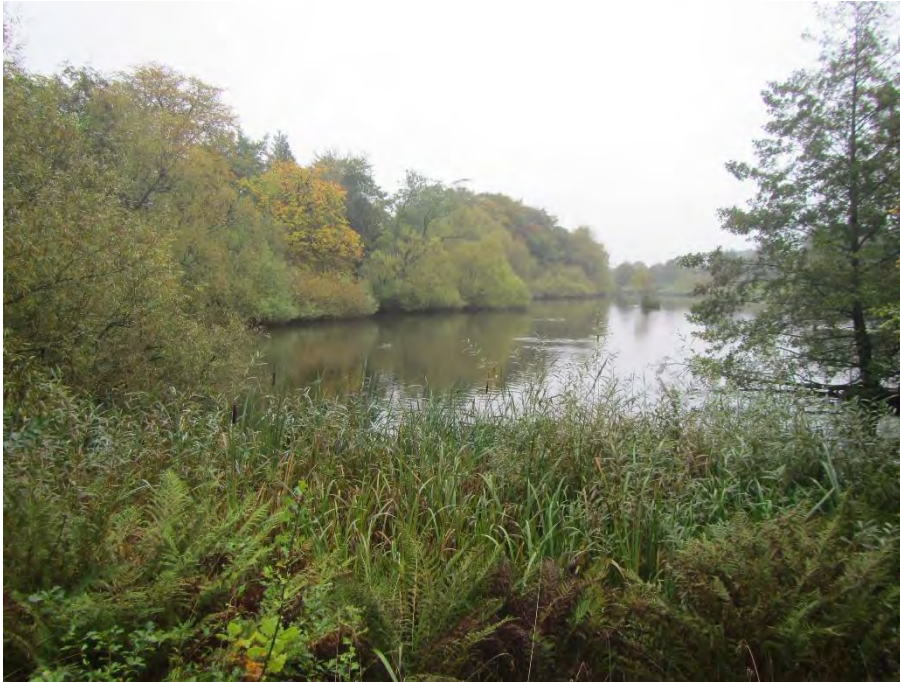
Photo 7 – Upstream Face of Crest with Protection Boards

Where erosion has taken place, timber revetment boards have been installed to provide protection and reinstate the path width. Where these are present there is evidence of some erosion at either end, but in general these all appeared to be in reasonable condition. The latest visit was undertaken after significant leaf fall and some recent vegetation clearance and it was found that the erosion at the ends of the revetment boards is not significant and similar to previous visits.

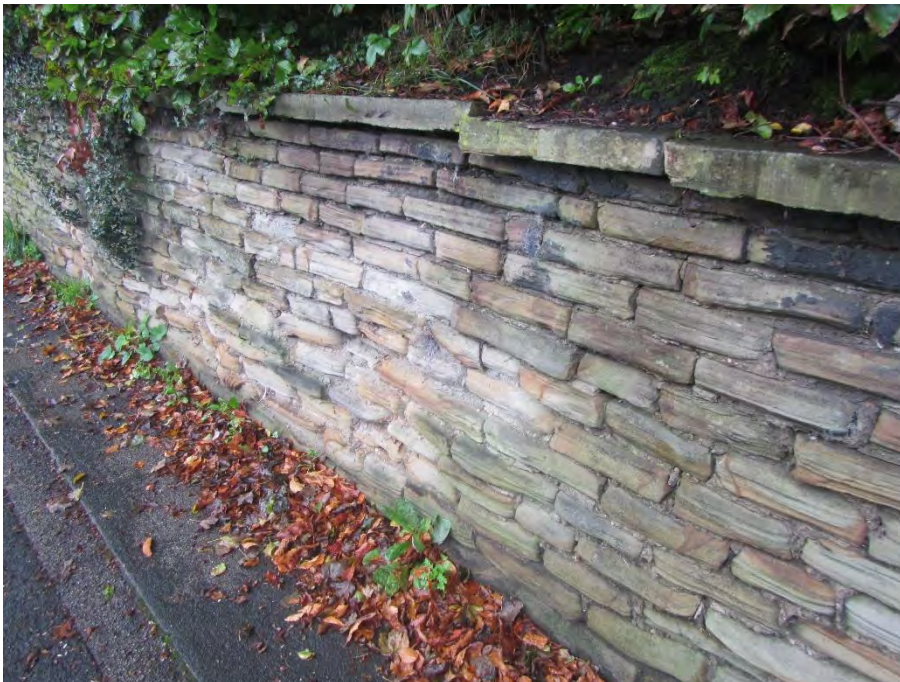
Photo 8 – Masonry Retaining Wall Alongside the A523 (southern end)

The downstream face varies; in some places there is a masonry wall at the toe whilst in other parts the face slopes down directly to the path alongside the road. Various views of the face are shown in Photo 8 to Photo 13. In many places a detailed assessment of the condition was hampered by the vegetation which obscures the ground surface but, in general, the slope of the face was fairly regular with no indication of movement or instability. As far as could be determined and, taking due account of the curvature of the dam, it appeared that the alignment of the face (both the wall section and the sloping face) was regular and on a whole, has not suffered any serious displacement. As with the grassy parts of the crest, **it is recommended that regular ground clearance activities are carried out to minimise the spread of the undergrowth and in order to expose the dam profile in the areas between the large trees.**

The masonry retaining wall is shown in Photo 8 to Photo 11. The overall alignment was reasonable as it follows the line of the footpath. The wall appears to be stable and there were no indications of imminent collapse, this is despite having mature trees growing directly behind the wall. However, several areas are noted (see Photo 8 and Photo 11) where individual stones have eroded away and where localised bulging is occurring. It is recommended that the parts of the wall that have experienced this type of damage and movement should be repaired. It is understood that the Council's Highways team have been instructed by the Undertaker to carry out repair works to the masonry wall where there is severe deformation, including the replacement of eroded stone work, although this has yet to take place.

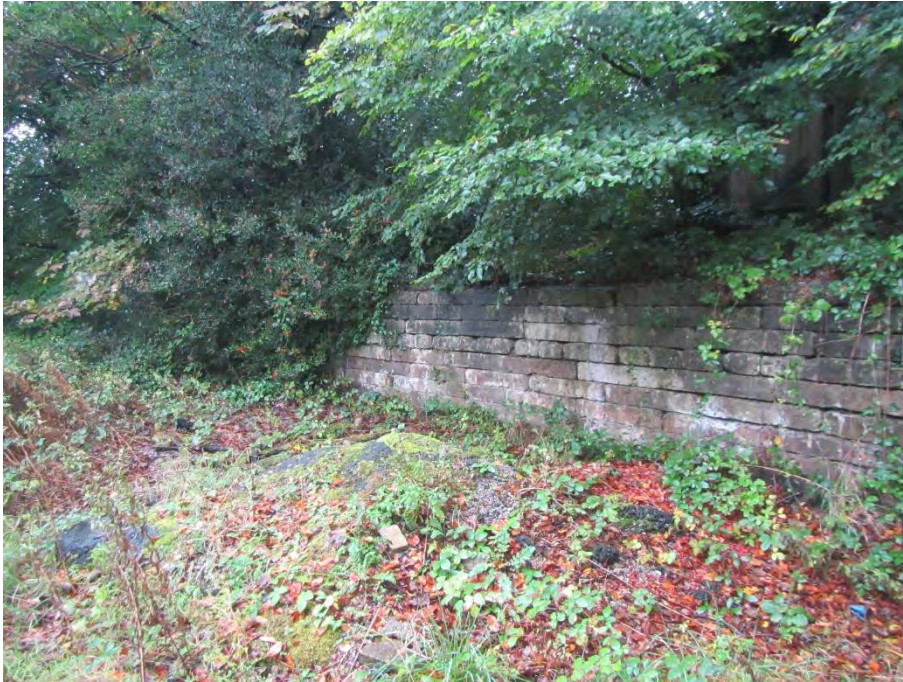
Photo 9 – Masonry Retaining Wall within the Old Council Depot

Towards the southern end of the dam there is an old and now disused Council Yard that occupies the land between the road and the dam. The yard has now been sold to a private developer with unknown intentions for the land. The area continues to be in a state of disrepair (Photo 9) and neglect and this includes the perimeter wall at the east side of the yard that forms a boundary with the face of the embankment. **It is recommended that communication is given to the new owners on the importance of the masonry wall. It is also recommended that the old Council Yard is tidied up in order to facilitate access to this part of the dam and in order that any repairs to the wall within the yard can be carried out.**

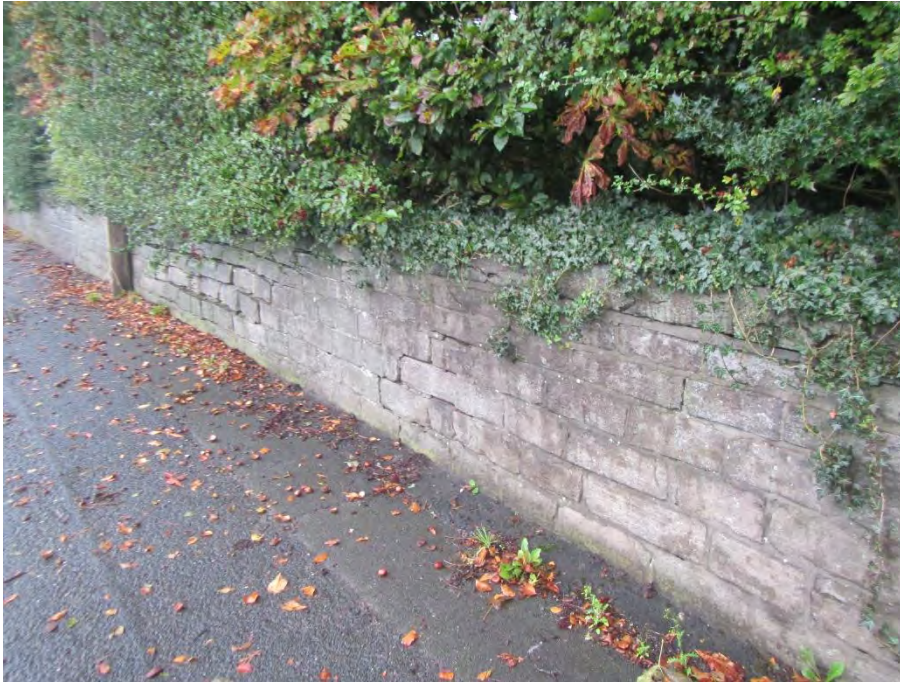
Photo 11 – Bulging and Displaced Stonework within the Wall (central section)

No.	Recommendation by last Inspecting Engineer	Status
3.	The inspection shall include a full walk over survey across the downstream toe of the embankment and along the masonry retaining wall to check for signs of deformation or water egress.	The downstream masonry wall was visually inspected, and no signs of further movement or water egress were noted. The displacement of the masonry wall stone shown in Photo 11 is the result of a vehicle impact and is still to be repaired.

5.	A detailed inspection of the masonry wall that retains the embankment toe shall be carried out to identify those parts of the wall that are showing signs of distress with missing stones, open joints and bulging of the surface. Localised repair work shall then be carried out to those parts that have suffered damage to fill the gaps and to reinstate the wall to the correct profile.	The entire length of the masonry retaining wall was inspected and found generally to be in fair condition. The southern half requires some repointing (refer Photo 8) and there are two specific areas in the northern half requiring reconstruction (refer Photo 11). The Undertaker is instructing their Highways Team to undertake the repair works.

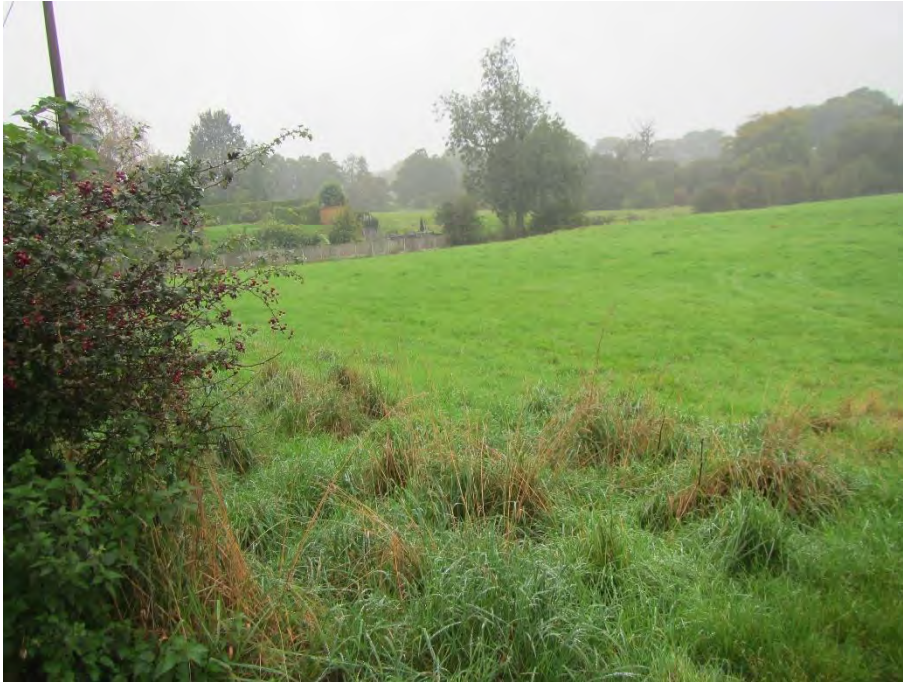
Photo 13 – Downstream face at the highest section

The highest section of the dam is towards the northern end and at this point the downstream face continues on the downstream (western) side of the road. This section of the face is shown in Photo 13. This part of the face is within a field that is owned by a local farmer. It was fenced off such that there was no access during the visit. Whilst the overall alignment appeared to be satisfactory, it is important that all parts of the embankment structure are accessible. **I recommend that the Council should enter into dialogue with the farmer in order to agree appropriate access arrangements into the field and onto the downstream face.**

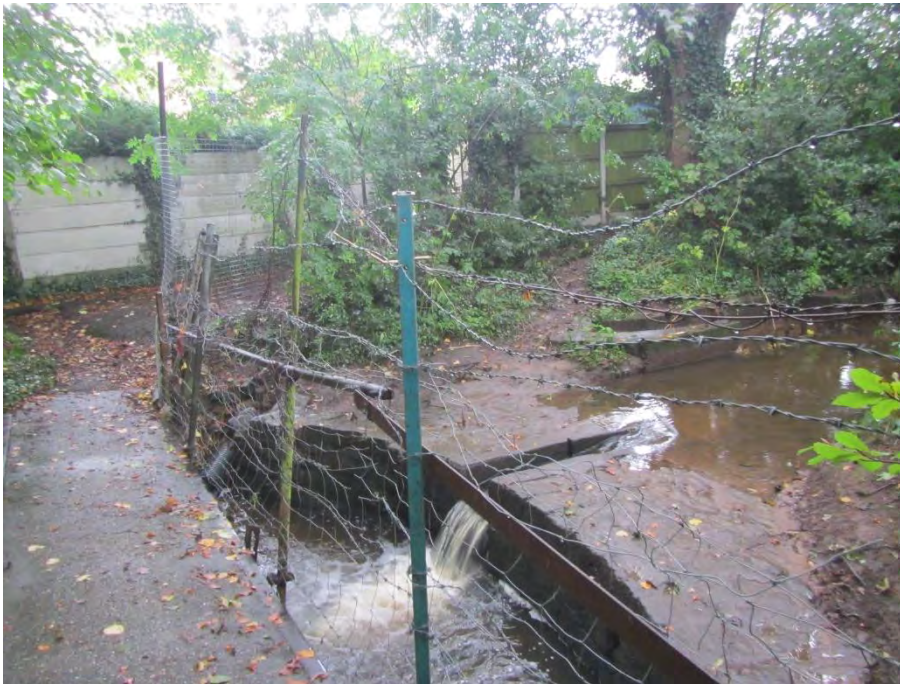
Photo 17 – Inlet Arrangement – behind Parklands Drive

The inlet from the indirect catchment at the southern end, behind Parklands Way, was visited and found to be relatively clear except for recent leaf fall (Photo 17).

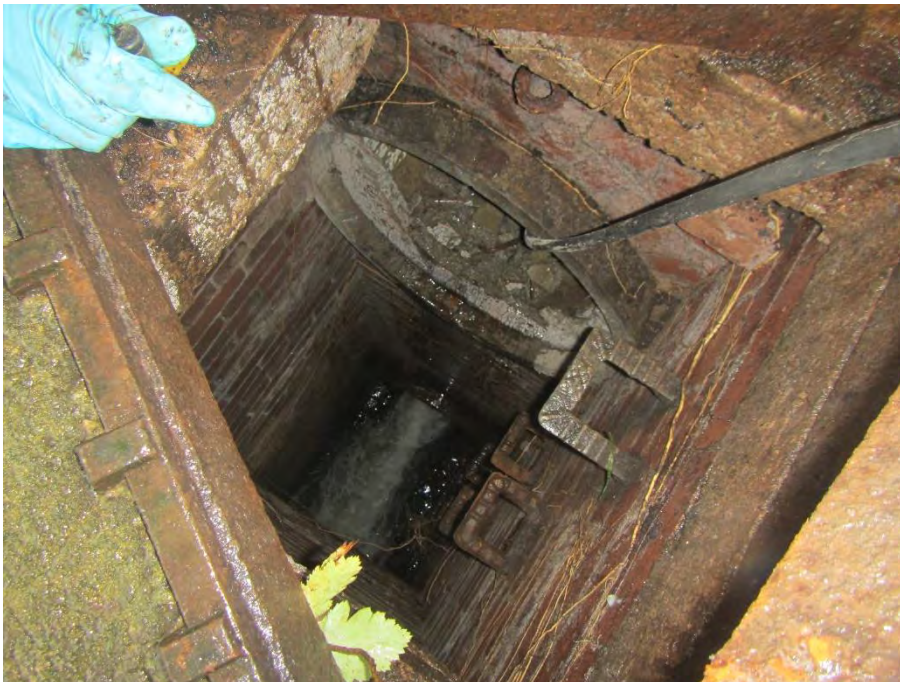
Photo 18 – Chamber Downstream of Overflow Chamber

At the time of the visit, the overflow pipe was being cctv'd so the opportunity was taken to view the chamber downstream of the overflow (Photo 18).
