# Poynton Pool Reservoir Flood Resilience Improvement Scheme

## Bat Survey Report

BRJ10627-JAC-XX-XX-RP-EN-0003

## Poynton Pool Reservoir Flood Resilience Improvement Scheme – Bat Tree Climb Survey Report

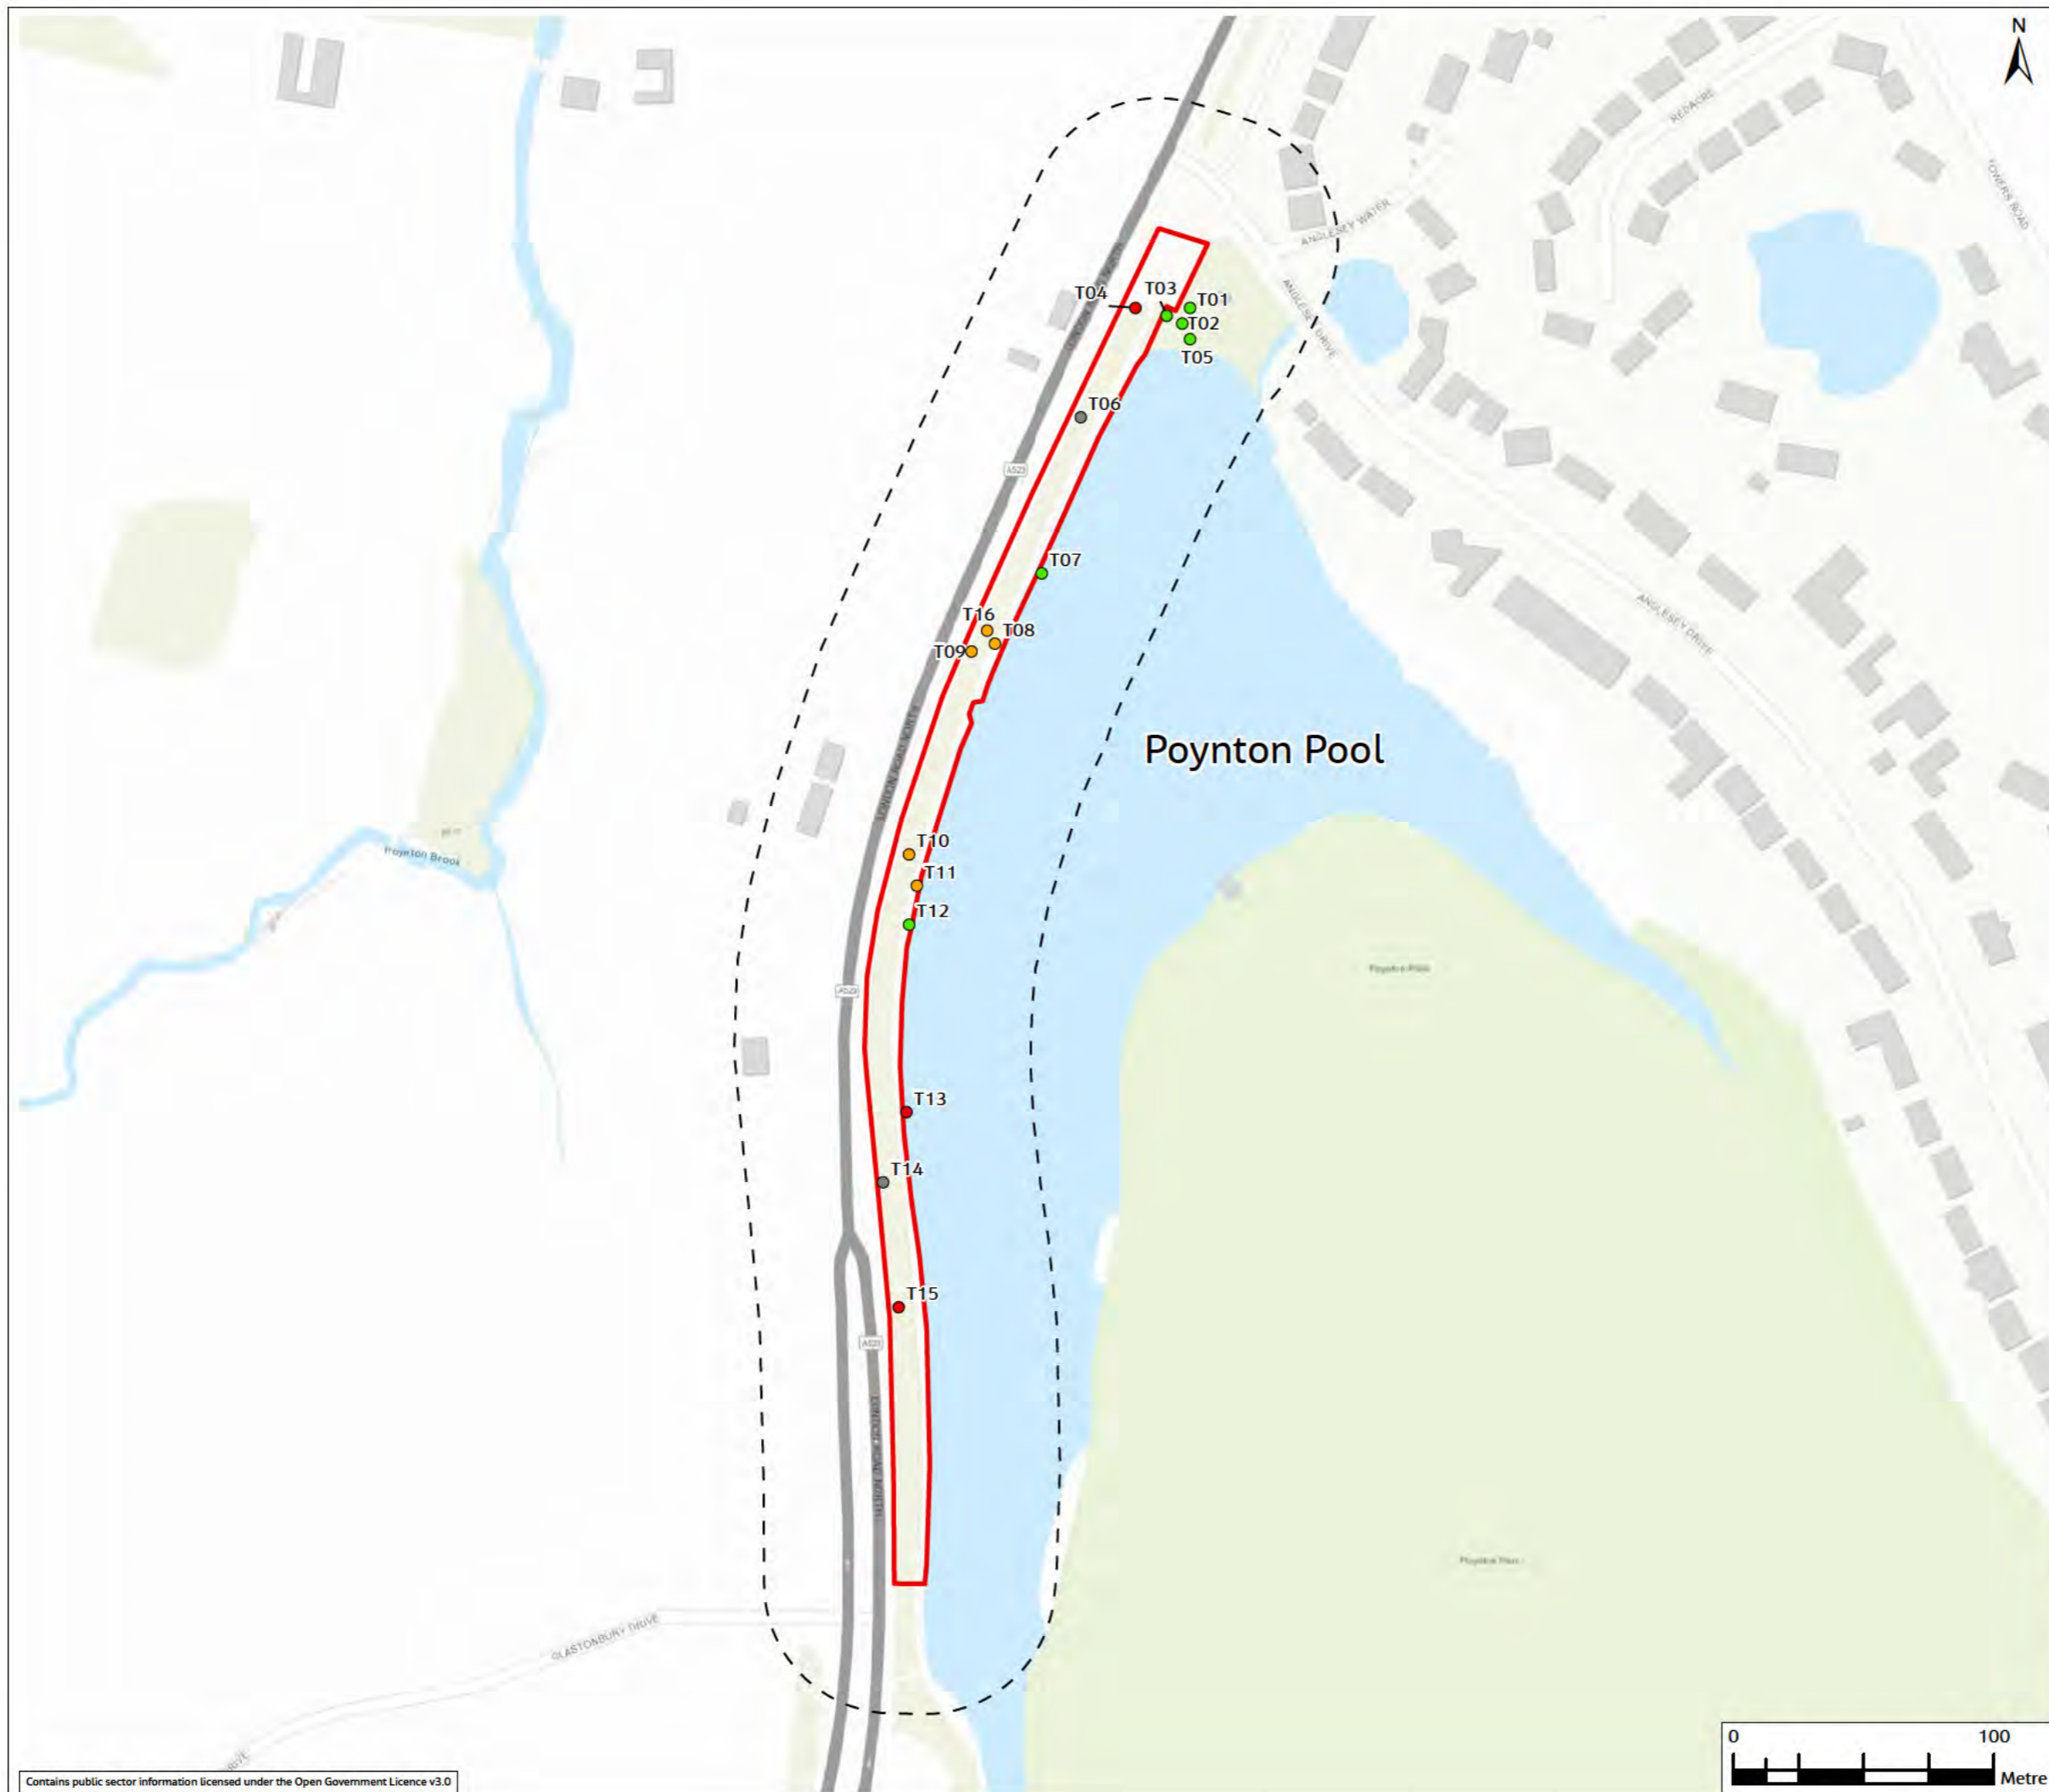
**FIGURE 1**

As a result, no further tree climb surveys were undertaken on three trees: T06, T12 and T14. Consequently, the trees now fall into the following revised BRP categories (see Table 3.2 below for a summary and Figure 1):

Drawing Title  
**GROUND LEVEL TREE ASSESSMENT GRADE FOLLOWING INITIAL CLIMB**

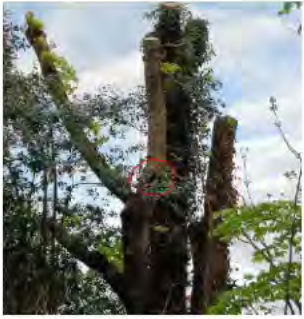
Tree No.	Grid Reference	Tree Species	Tree Age	DBH (m)	PRF No.	PRF Descriptions	Height (m)	Aspect of PRF	BRP of Tree	BRP after Tree climbing	Photograph
T04	SJ 92327 84786	Sycamore	Over Mature	0.7	1	Pollarded tree with knot hole (tear out) cavity leading into stem.	3	North	High	High

- Trees within this report identified as having a moderate or high BRP shall be removed by soft felling in sections and lowering these sections to the ground. This will be supervised by a Natural England bat licenced ecologist. Cutting through any cavities will be avoided;

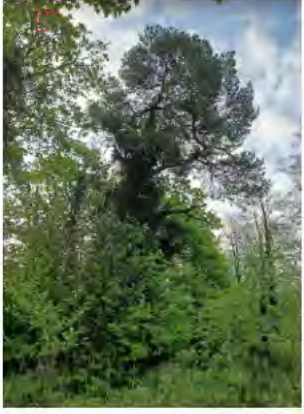
T05	SJ 92348 84774	Pine	Mature	0.5	1	Dense ivy-covered evergreen. Clear flightpaths in to feature.	Full length of main stem	N/A	Low	Low

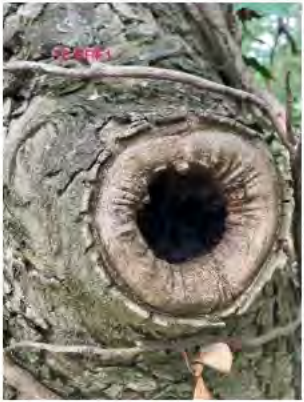
Tree No.	Grid Reference	Tree Species	Tree Age	DBH (m)	PRF No.	PRF Descriptions	Height (m)	Aspect of PRF	BRP of Tree	BRP after Tree climbing	Photograph
T06	SJ 92306 84744	Sycamore	Mature	0.5	1	Rot hole on main trunk leading into cavity	3	South	Moderate	Negligible

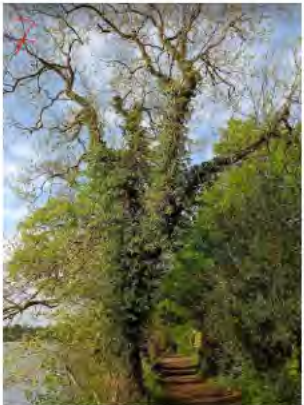
T07	SJ 92291 84684	Oak	Dead	0.6	1	Dense ivy cover on dead tree next to Lake.	Full length of main stem	N/A	Low	Low

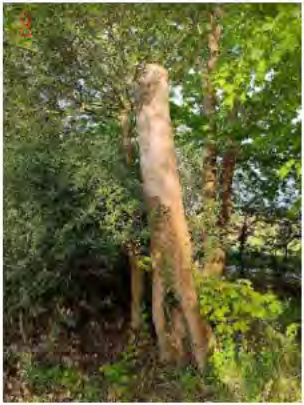
Tree No.	Grid Reference	Tree Species	Tree Age	DBH (m)	PRF No.	PRF Descriptions	Height (m)	Aspect of PRF	BRP of Tree	BRP after Tree climbing	Photograph
T08	SJ 92273 84657	Stump/ Beech	Dead	0.6	1	Dead tree stump with rotten core leading to cavity at low level	0.5	East	Moderate	Moderate

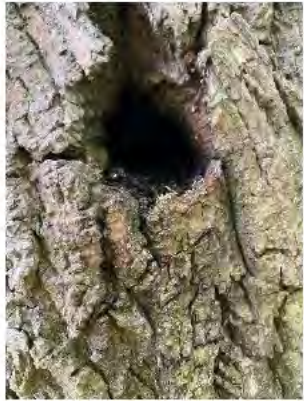
T09	SJ 92264 84654	Lime	Mature	0.8	1	Woodpecker holes on main trunk leading to cavity	4	North	Moderate	Moderate

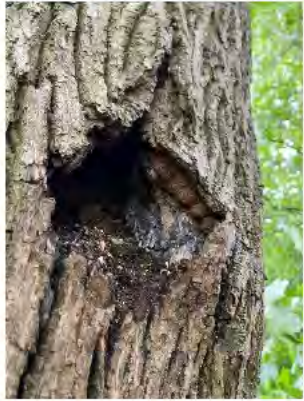
Tree No.	Grid Reference	Tree Species	Tree Age	DBH (m)	PRF No.	PRF Descriptions	Height (m)	Aspect of PRF	BRP of Tree	BRP after Tree climbing	Photograph
					2	Woodpecker holes	3.5	West

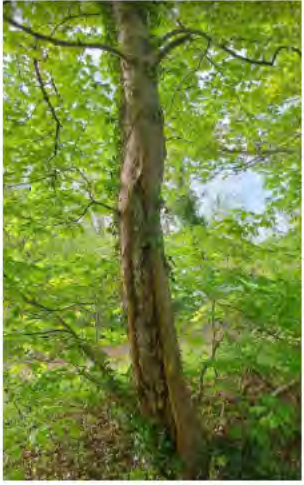
T10	SJ 92240 84576	Sycamore	Mature	0.5	1	Split in trunk leading to fissure wound	0.2	North	Moderate	Moderate

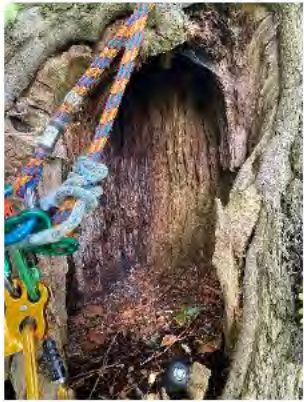
Tree No.	Grid Reference	Tree Species	Tree Age	DBH (m)	PRF No.	PRF Descriptions	Height (m)	Aspect of PRF	BRP of Tree	BRP after Tree climbing	Photograph
T11	SJ 92243 84564	Oak	Over Mature	0.7	1	Cavity on stem	0.75	North	High	Moderate

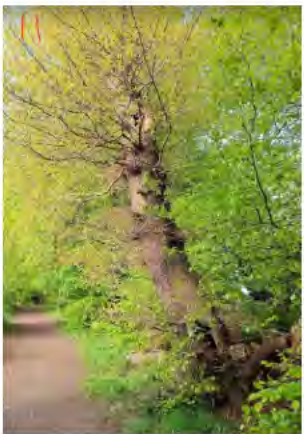
2	Cavity on stem	3	North-west

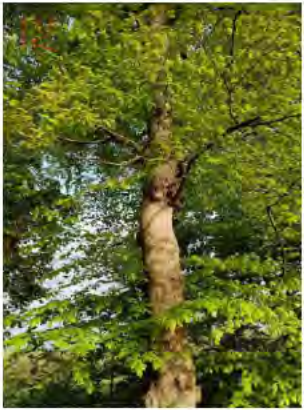
T12	SJ 92240 84549	Beech	Mature	0.5	1	Canker at ground level	0.5	East	Moderate	Low

Tree No.	Grid Reference	Tree Species	Tree Age	DBH (m)	PRF No.	PRF Descriptions	Height (m)	Aspect of PRF	BRP of Tree	BRP after Tree climbing	Photograph
					2	Canker higher up	4	East

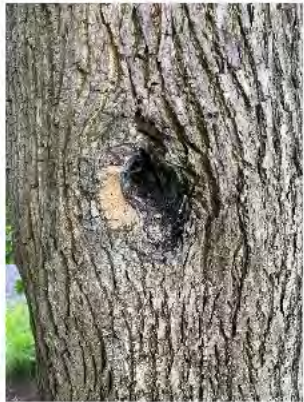
T13	SJ 92239 84477	Norway Maple	Mature	0.7	1	Woodpecker hole on main trunk	4	South- east	High	High

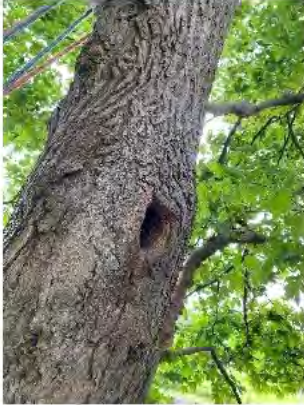
Tree No.	Grid Reference	Tree Species	Tree Age	DBH (m)	PRF No.	PRF Descriptions	Height (m)	Aspect of PRF	BRP of Tree	BRP after Tree climbing	Photograph
					2	Woodpecker hole on main stem	3.5	North-west

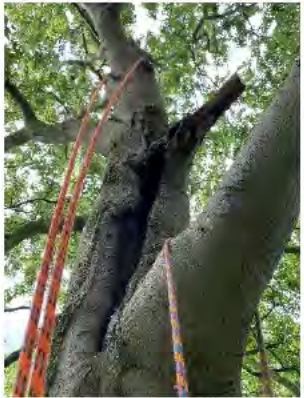
T15	SJ 92236 84402	Beech	Mature	0.7	1	Hazard Beams	9	North-west	High	High

Tree No.	Grid Reference	Tree Species	Tree Age	DBH (m)	PRF No.	PRF Descriptions	Height (m)	Aspect of PRF	BRP of Tree	BRP after Tree climbing	Photograph
					2	Large cavity of stem	9	North

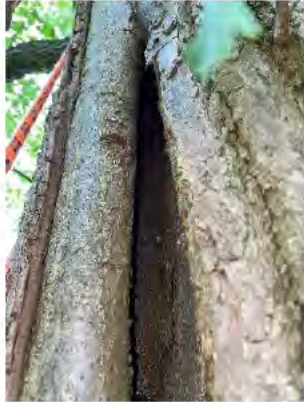
T16	SJ 92270 84662	Lime	Mature	0.8	1	Long wound on stem	2.5	South	Moderate	Moderate

Tree No.	Grid Reference	Tree Species	Tree Age	DBH (m)	PRF No.	PRF Descriptions	Height (m)	Aspect of PRF	BRP of Tree	BRP after Tree climbing	Photograph
					2	Long wound on stem	6	South
