Poynton Town Council Response to Planning Application 23/4152M – Poynton Pool Dam Embankment

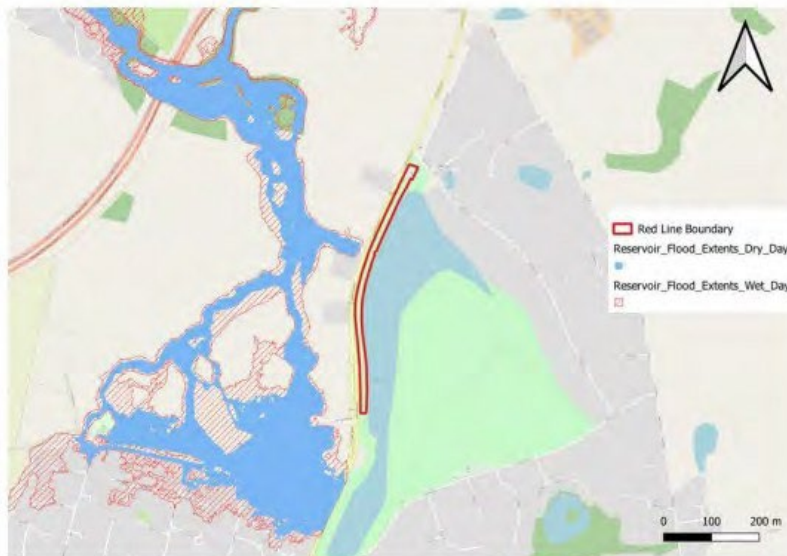
3.2 The Flood Risk Assessment shows (figure 3.3) that flooding could occur in two locations along the dam.

Figure 3-3: Extent of reservoir flood risk surrounding Poynton Lake © Environment Agency copyright and/or database right 2021. All rights reserved. Contains Ordnance Survey data © Crown copyright and database right 2010-2023.

3.3 It doesn’t appear from the flood map that the proposed works will prevent the flooding to the south of the proposed works as this area of the dam will be unaffected by the works. The Flood Risk Assessment confirms that following the works the water level within the reservoir will increase by 0.18m during the 1%, 0.1% and 0.01% AEP design flood events. Will the increased water levels result in even more flooding in the area to the south of the proposed works? In addition, it is noted that the Flood Risk Assessment concedes that the higher levels of water in the dam will

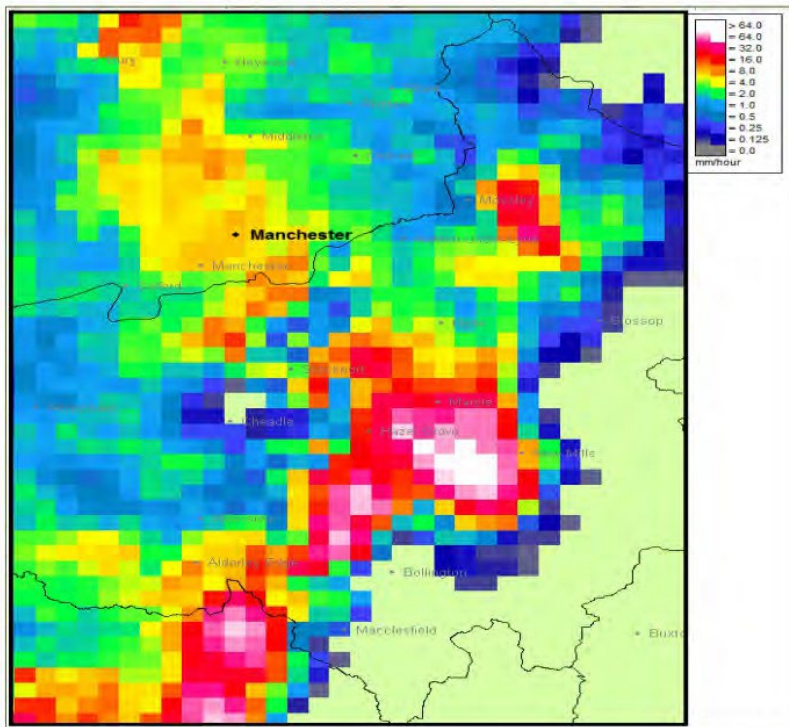
Figure 2 Hyrad Image; 11th June 2016

From the hyrad image it is clear to see that this rainfall fell within the catchment.

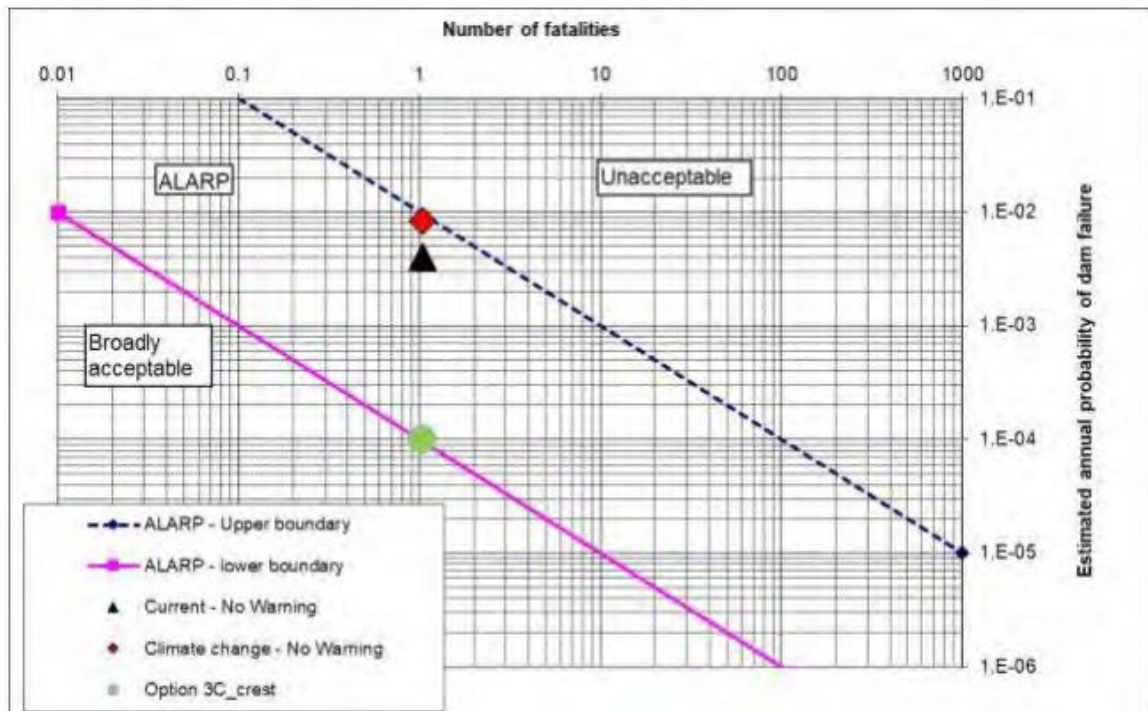
5.2 Section 1.4 and 1.5 of the Summary Options Report states that the risk of loss of life and property damage to those living downstream is unacceptably high. However, the Jacobs Initial Options report had to be amended following the discovery by Friends of Poynton Pool of a significant error showed that the risk was not in the unacceptable zone but actually in the As Low as Reasonably Practicable (ALARP) region. Please see below.

Figure 4-3 FN Frequency-Consequence Chart plot of societal risk

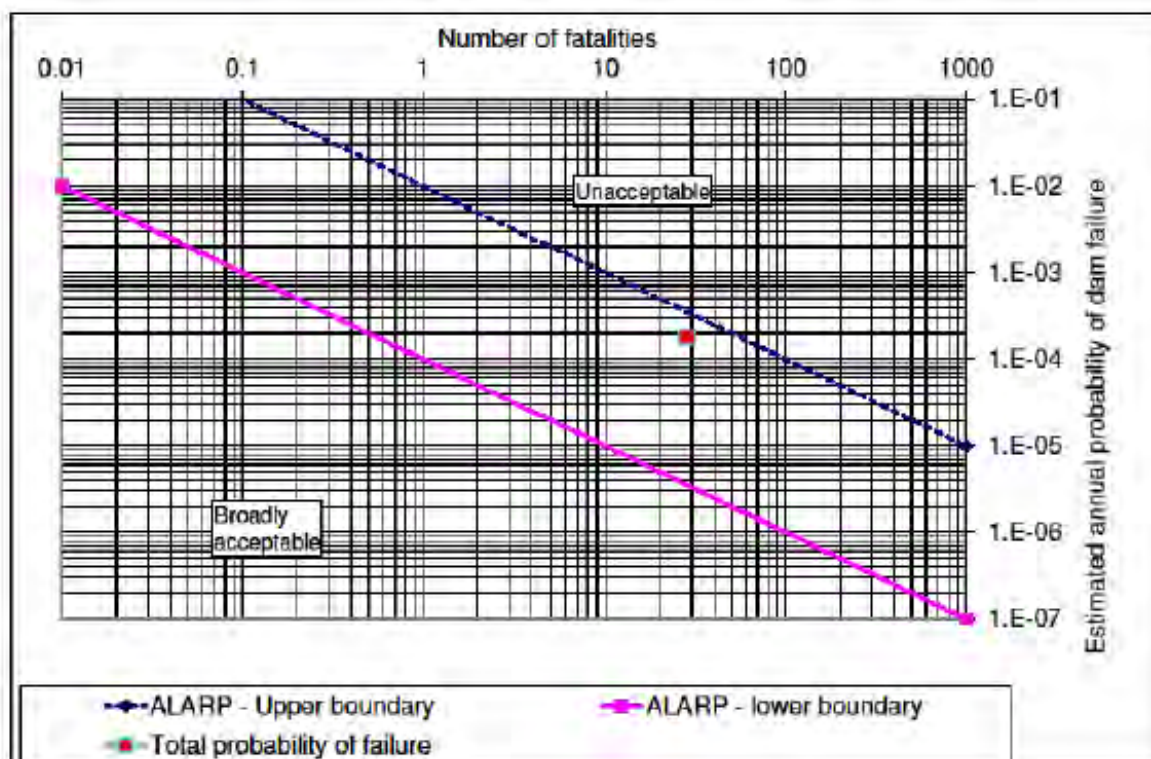
to nuclear accidents, that the upper line should pass through the (100, 10^{-4}) point, that is, the point at which the risk of an incident in which there are ≥ 100 fatalities has a likelihood of once per 10,000 years.¹³ The gradient of the line is another issue. A gradient of -1 is roughly speaking risk neutral in that it does not apply extra weight to high fatality incidents. The upper line on Figure 2 fits the HSE criteria in that it passes through (100, 10^{-4}) and has a gradient of -1. The lower line mirrors the upper but is set at probabilities which are 100 times lower.

Figure 2: Example of FN plot (EA p146)

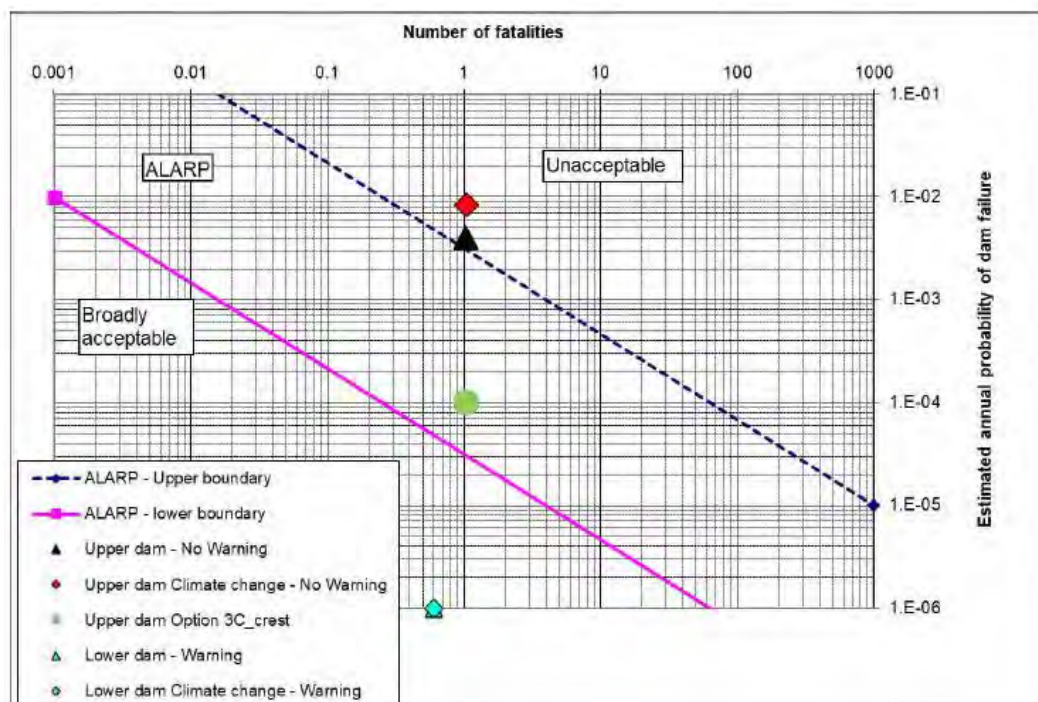
4.4 Figure 3 shows an FN plot as reported by Jacobs (p31). There are several points marked on it. The black triangle is the (1.04, $1/250$) point based on the likelihood of dam failure of $1/250$ per annum with 1.04 fatalities as reported by Jacobs. According to the Jacobs report this indicates that the current risk from the dam is unacceptable (because the point is above the upper dashed line). However, the line is not positioned according to the EA or HSE proposals and its origin is unknown. Were the HSE criteria for the position of the upper line used then the estimated current risk from the dam would be in the ALARP region.

Fig 3: Jacobs FN plot (11/6/21, p31)
