Response to planning consultation 23/4152M re The Dam Embankment of Poynton Pool, Poynton Park, London Road North, Poynton.

1. Background

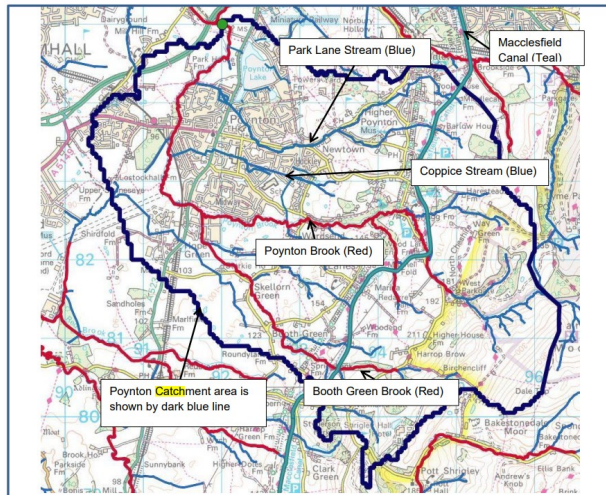
Figure 12 Indicative hydrological catchment of Poynton Brook

The applicant has not provided a substantive response only stating that previous flooding events were in a different catchment. They were not. The section 19 report¹ on Flooding in Poynton in 2019 identifies the Poynton Brook catchment (Figure 12) which clearly includes the pool and its entire direct and indirect catchment (see comparison with catchment taken

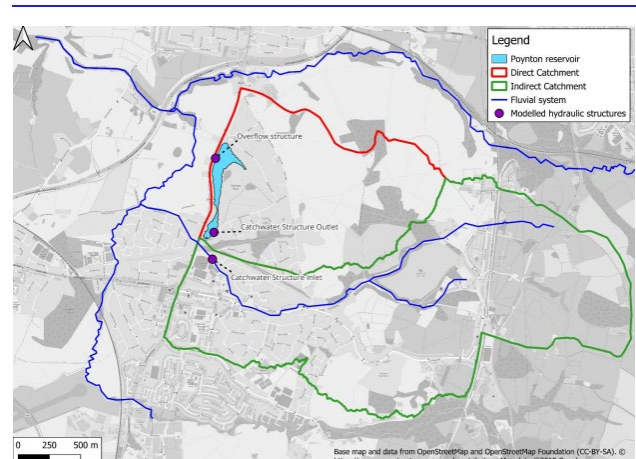
Poynton Reservoir Hydrology and Modelling Report

from the October 2025 Hydrology and Modelling Report). No explanation has been provided as to the discrepancies in the various reports and why the model appears to be so at odds with the observed reality (see Town Council's first response to the planning application for further details on historical flooding).

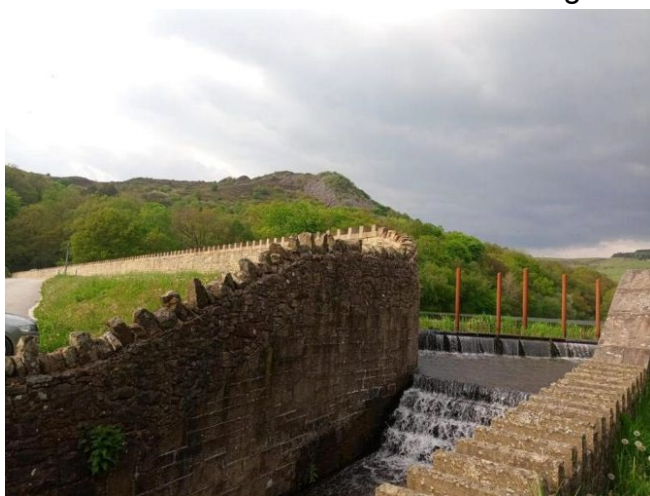
Currently XXX but should be XX Friends of Poynton Pool would argue that their scheme is less impactful than removing the trees. The labyrinth weir will be buried in the embankment and submerged on the upstream face. Although the structure would be visible from London Road as a vertical wall 12m long and 1.5-2m above pavement level; it could be

clad with stone to minimise visual impact. The image below is of the spillway and wave wall at Tegg's Nose Reservoir in Macclesfield Forest where a similar approach to cladding was used.

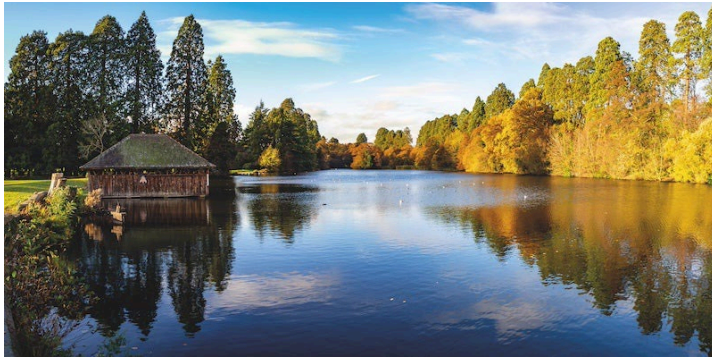
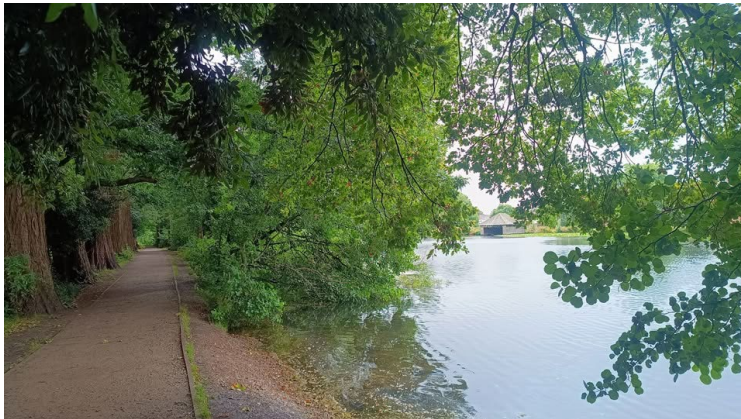
The Planning Case Officer is also referred to the successful scheme at Tredegar House in South Wales which is similar to Poynton Pool. The National Trust and Planning Authority adopted a scheme which did not involve the mass removal of trees and was sympathetic to the local landscape and the amenity value to the local community (see photograph below).
