Please can you provide me with a list of what information (relevant to the planning application) you consider to be inaccurate or requires updating, together with evidence to demonstrate why you believe this to be the case?

- Volume of Water –Paragraph 1.2 of the Summary Options Report states that the reservoir stores a volume of approximately 130,000m³. However, the Environment Agency and Cheshire East concede that the actual volume of the reservoir is unknown. Friends of Poynton Pool have carried out a basic survey of the pool which appears to indicate that the volume of the pool is significantly less than the current recorded volume of 130,000m³. At a meeting on the 13th November the Environment Agency agreed to undertake a bathometric survey of the reservoir.

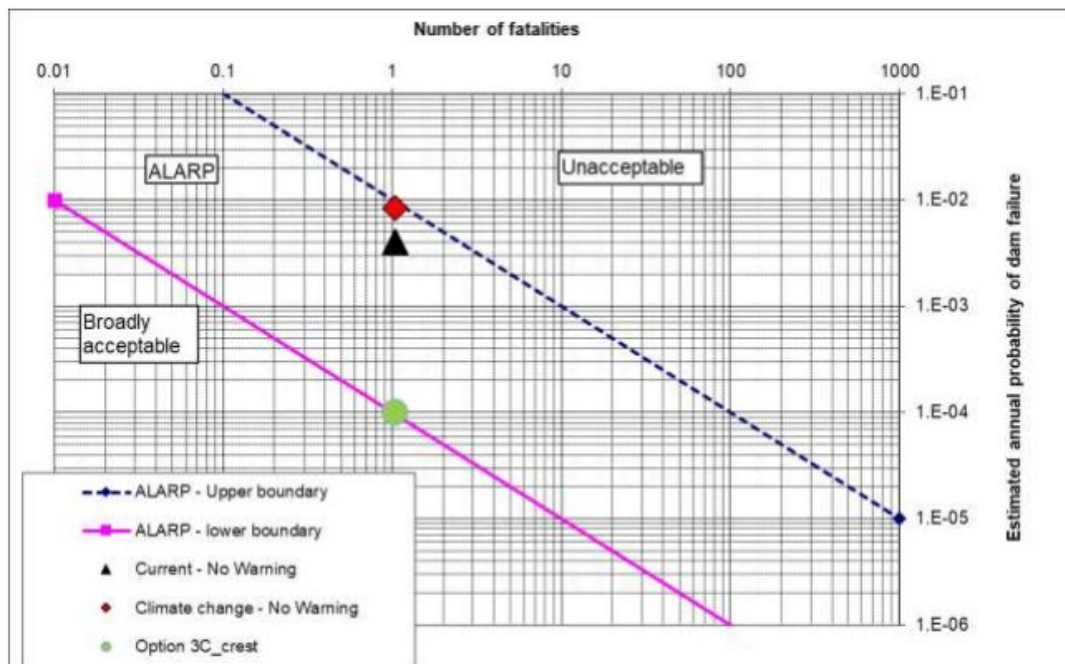
Figure 4-3 FN Frequency-Consequence Chart plot of societal risk

Section 1.4 and 1.5 of the Summary Options Report states that the risk of loss of life and property damage to those living downstream is unacceptably high. However, the Jacobs Initial Options report had to be amended following the discovery by Friends of Poynton Pool of a significant error showed that the risk was not in the

unacceptable zone but actually in the As Low as Reasonably Practicable (ALARP) region. Please see below
